Appendices

Sioux Falls Wastewater Treatment and Collection System Master Plan

Existing Facilities Condition Assessment Technical Memorandum

Appendix 3.C – Existing Facilities Condition Assessment Lift Station Review Power Point Presentation

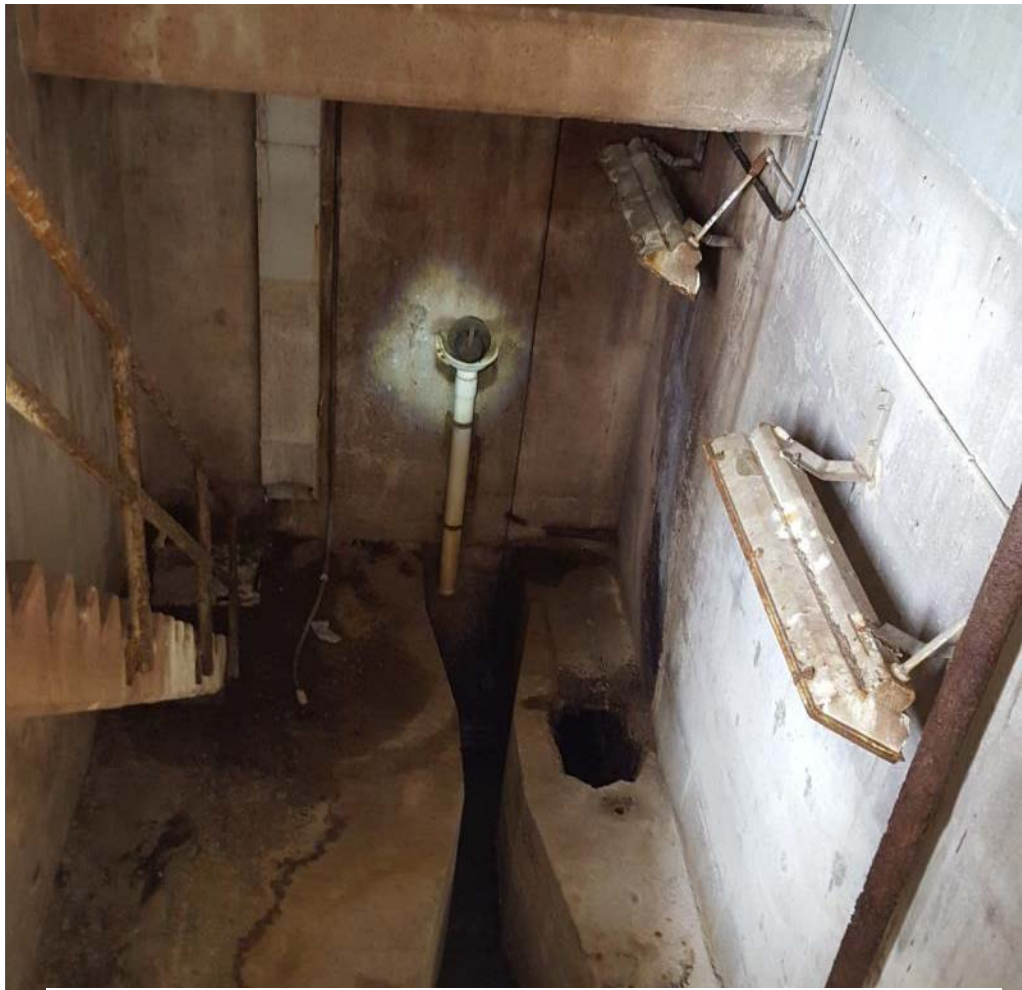
Wet Well Access Below Flume SCBA Entrance Only

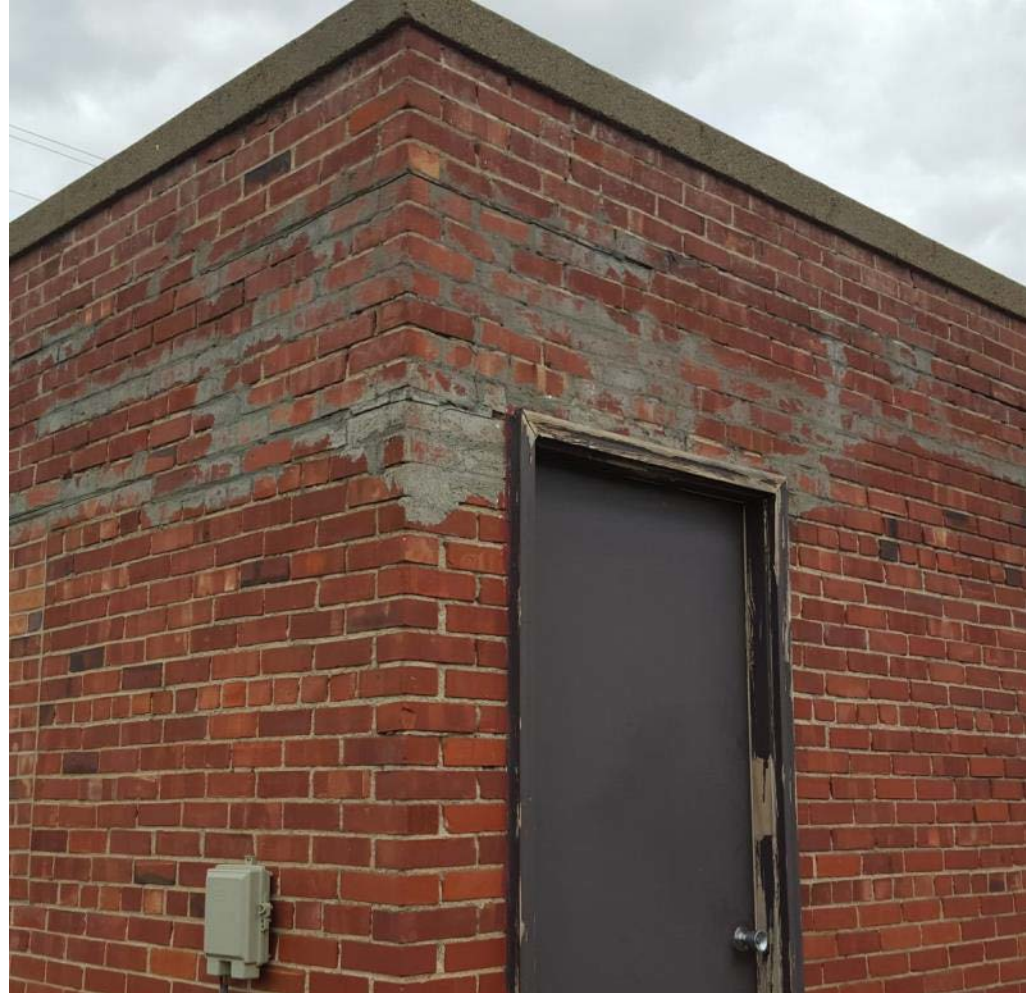
Structural Condition Poor – Needs a complete Rebuilt

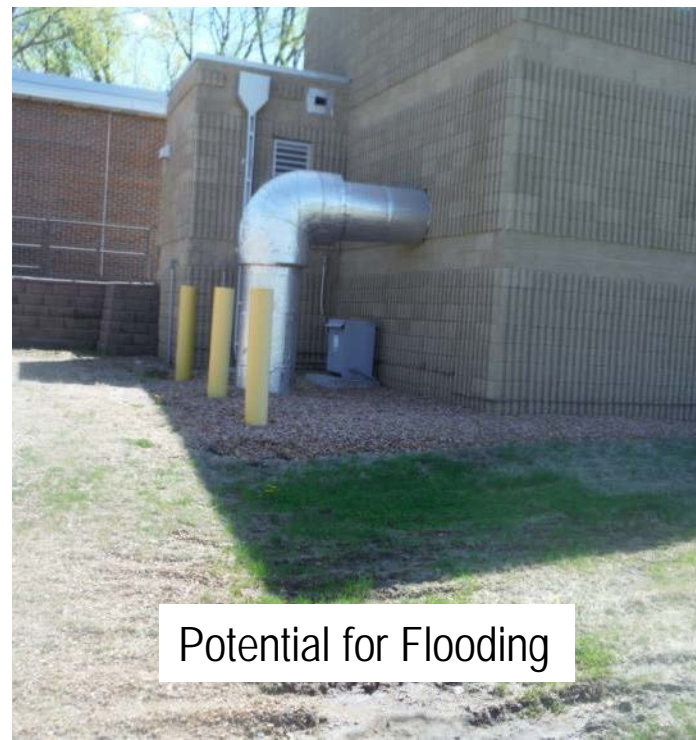
Ventilation in
Electrical
Room and
Connected
Pump Room is
Inadequate

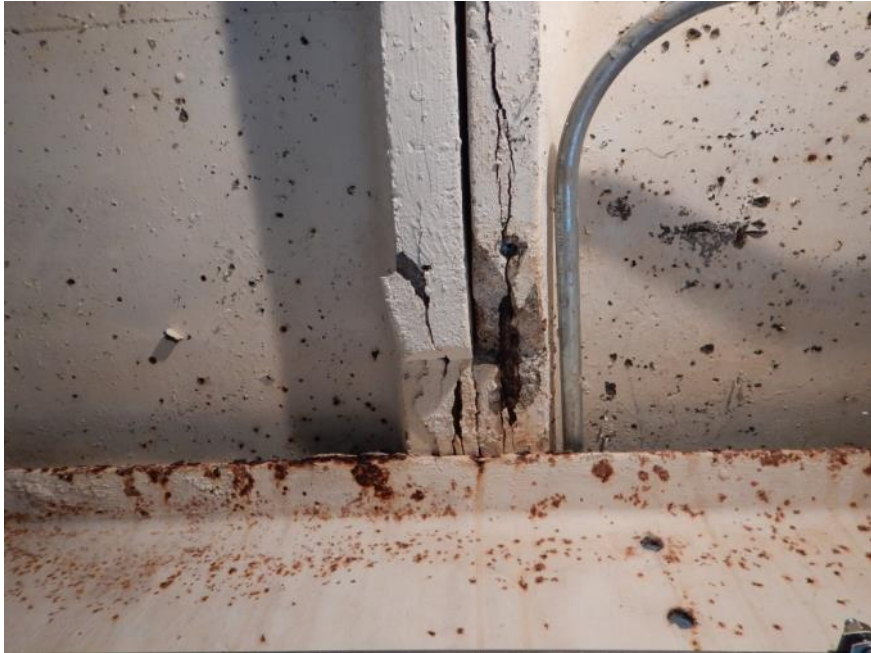
Deteriorated Interior Roof and Humidity

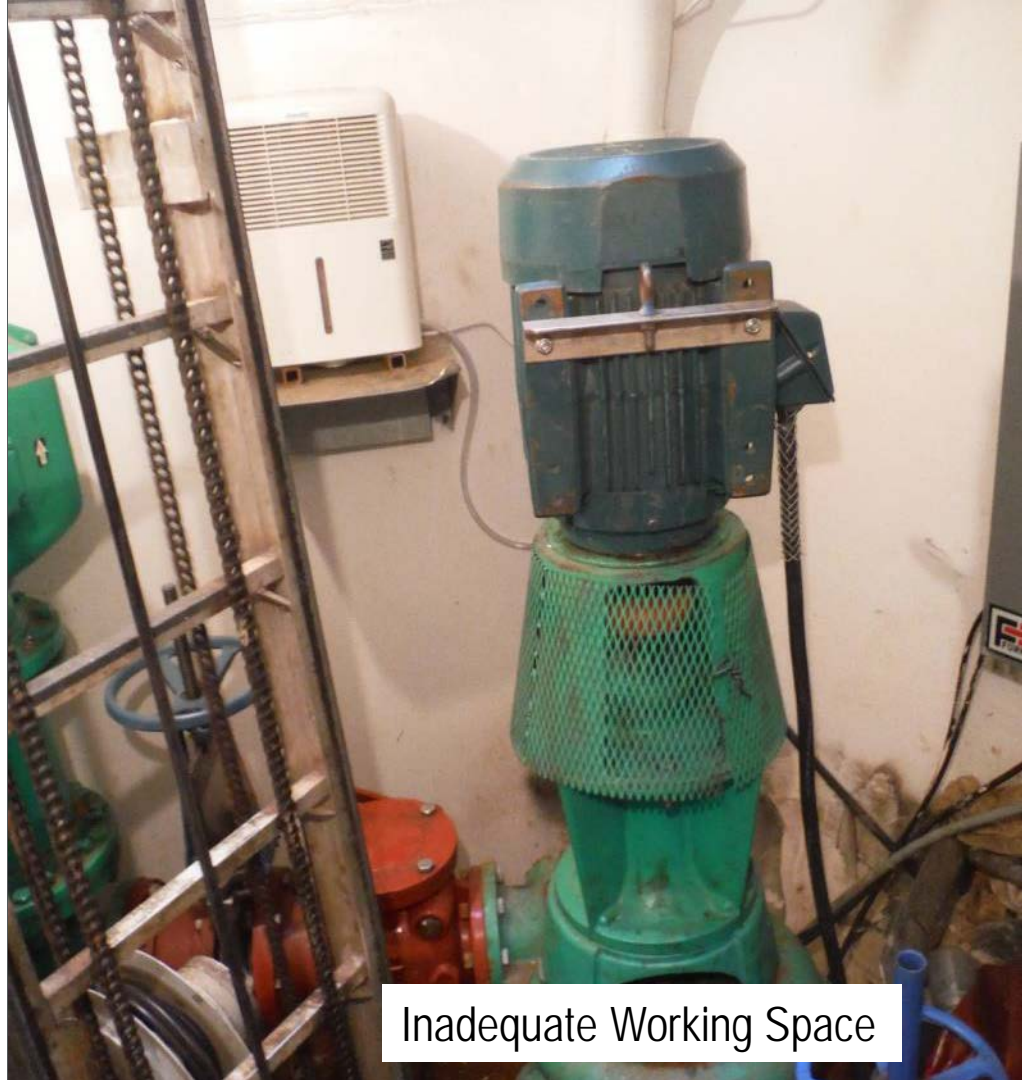
Pumps Plug-Cannot Run on VFD's
Pump Number No. 2 Potential Bearing Issue
Only Access is down Elevator in Tubular
Access Shaft

Inadequate Working Space

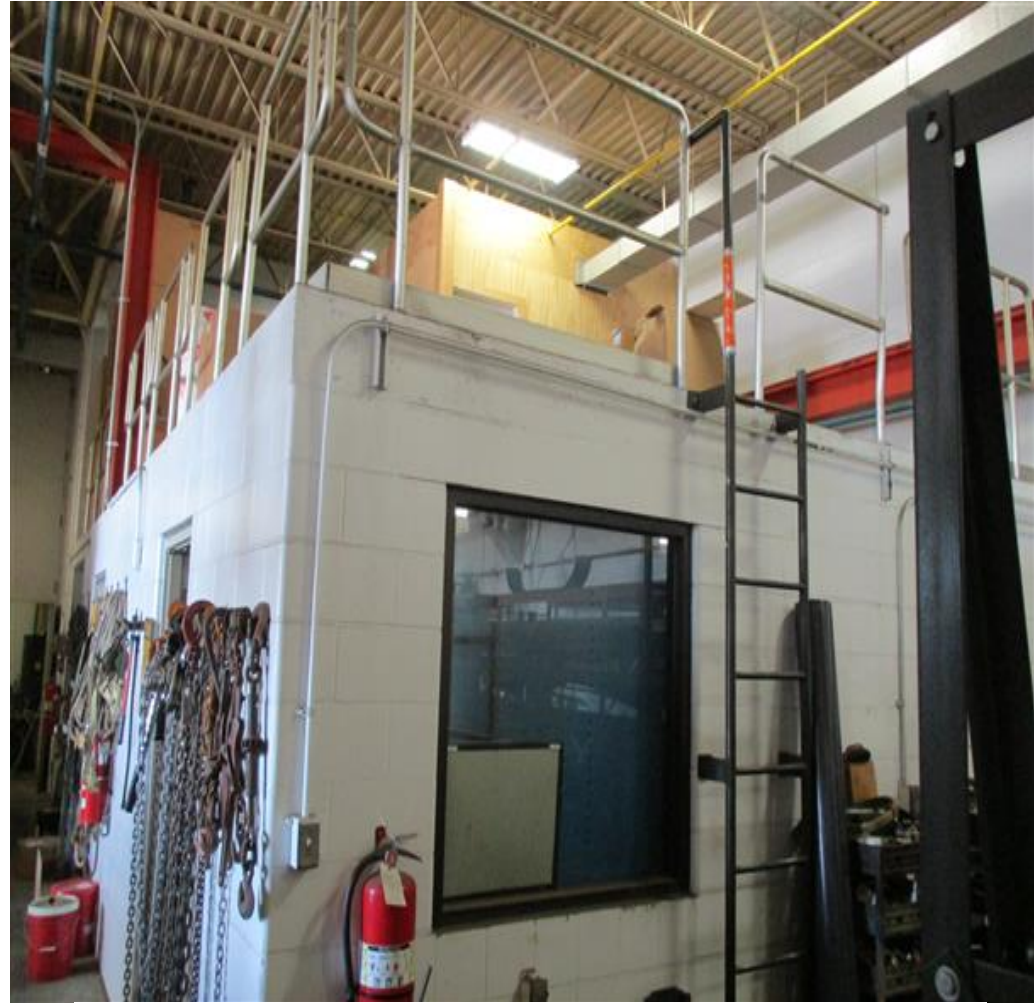
Mezzanine – Missing Ladder Rail and Toe Plate

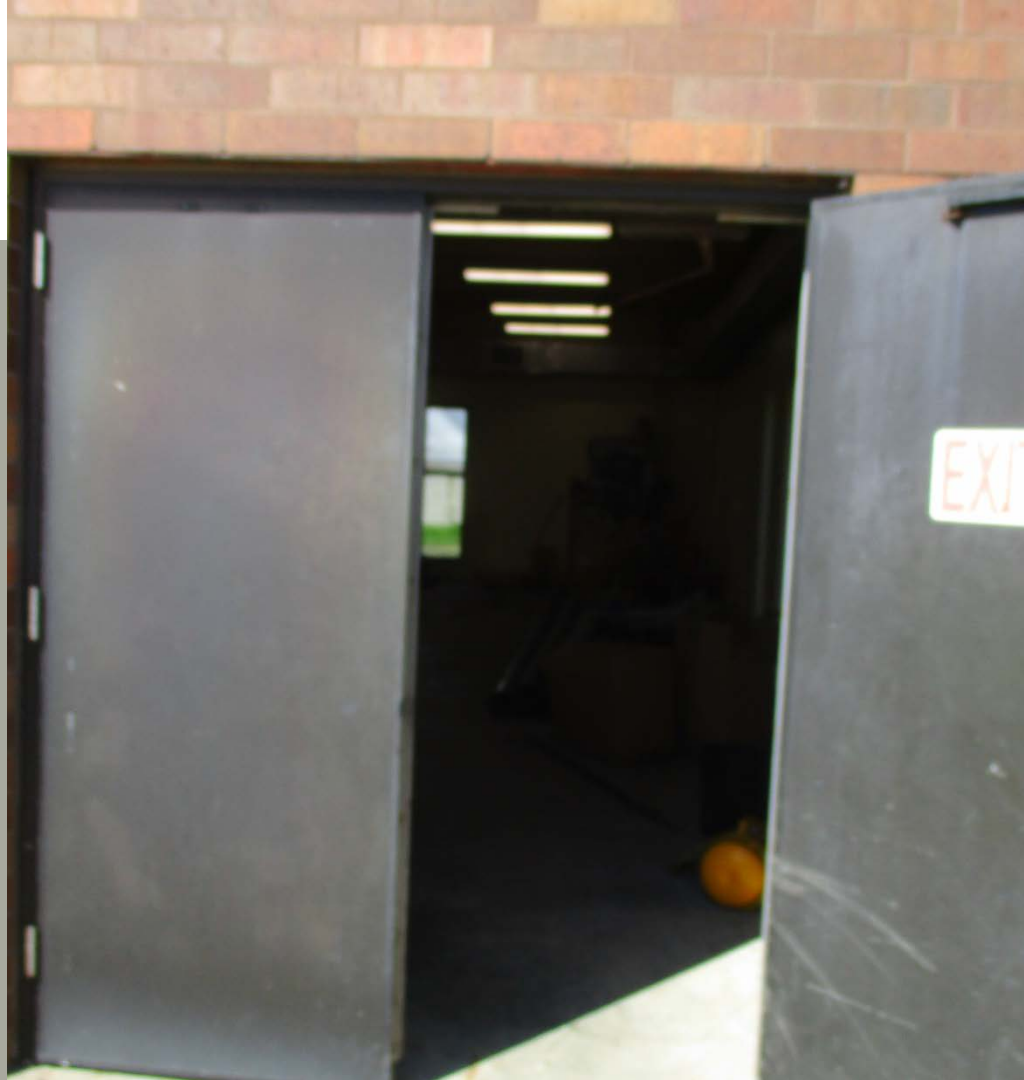
SLUDGE PUMPING BUILDING (4)

- Conduits, electrical and utility boxes are showing signs of deterioration.
- Lacking heat at times due to competing heat requirements on hot water system.
- *Condensation issue in building.*

- High Priority
 - Upgrade Electrical
- Medium Priority
 - Evaluate capacity of hot water heating system.
 - *Evaluate supplemental heating source – possibly natural gas.*

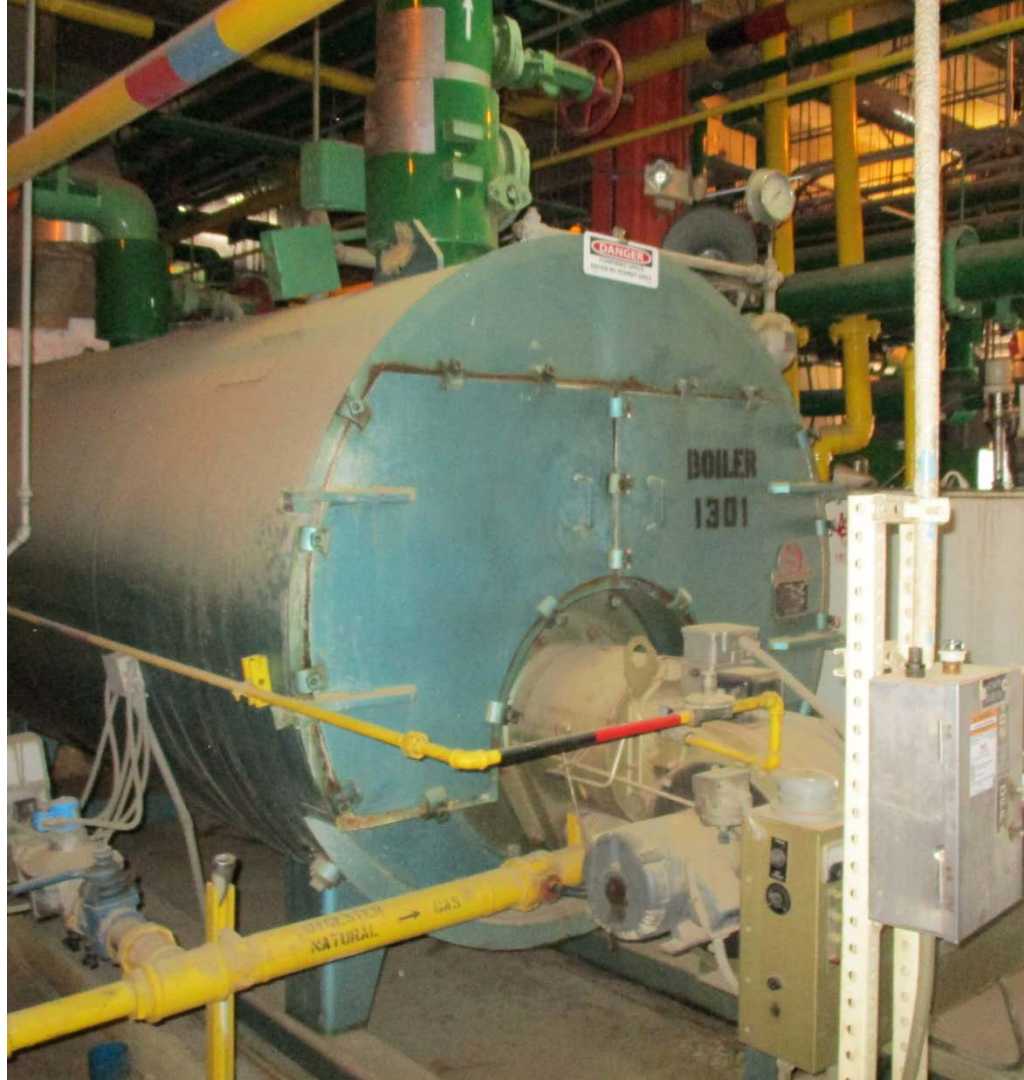
ENERGY RECOVERY (13)

- Boilers and Boiler Pumps are outdated.
- Room has a common wall with the digester, which is an NFPA 820 issue.
- Roof system is being replace under current CIP.
- Roof exhaust fans #3 & #4 are original.
- *Issues with operation, function, and size of door on south side of building.*

- High Priority
 - Replace boilers and boiler pumps.
 - Replace older roof exhaust fans.
 - *Evaluate replacement of south door with new roll-up door.*

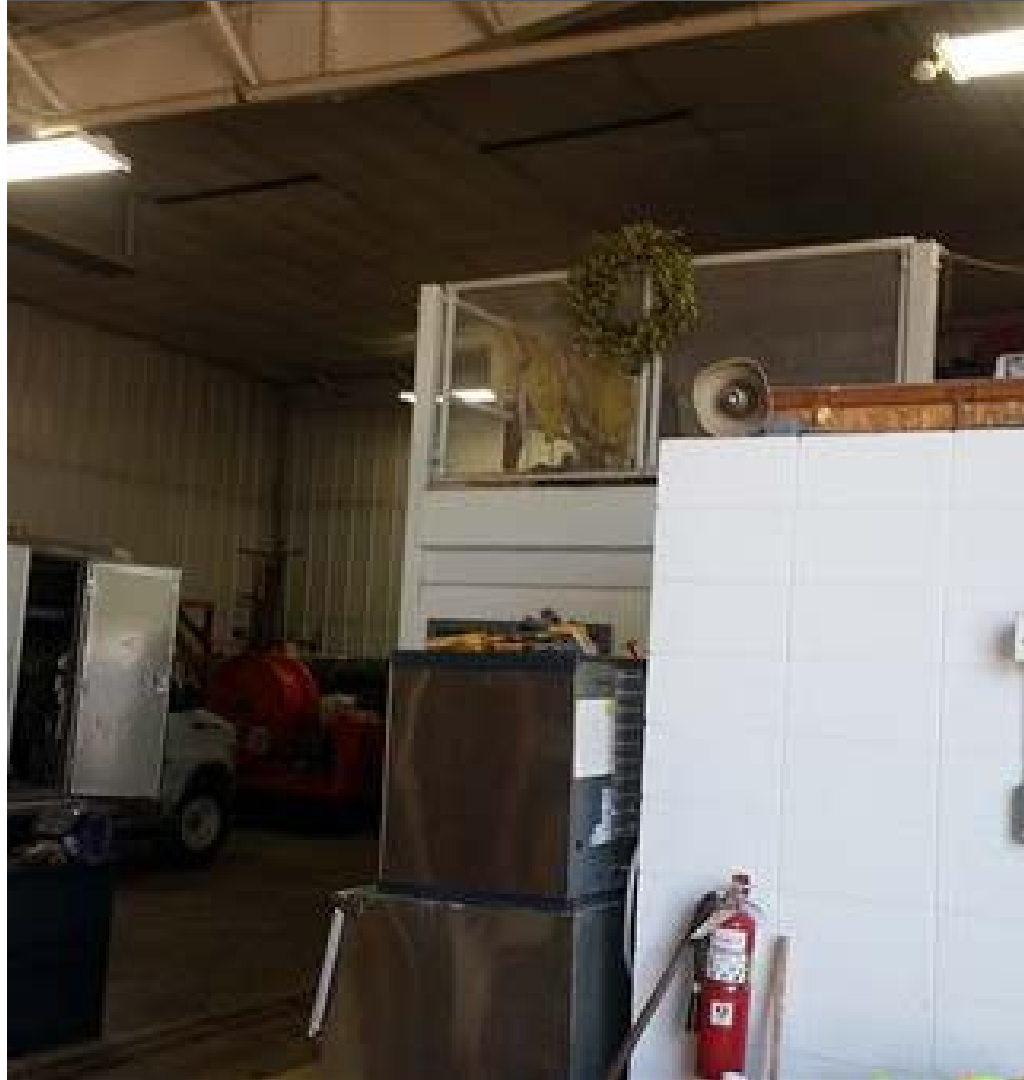
- Original metal roof installed in 1995.
- Limited office space *for 21 persons*.
- *There are no shower and locker room facilities for personnel.*
- HVAC has old tube heaters that soot.

- High Priority
 - Update HVAC system.
 - Expand office area into SW corner of Building *and add shower and locker room facilities.*
- Medium Priority
 - *Address when replacement of the metal roof should be replaced.*
