BOARD OF HISTORIC PRESERVATION WEDNESDAY JULY 12, 2023 4:00 PM City Center, Cooper Conference Room, 110 Sioux Falls, SD

Regular Meeting Minutes for June 21, 2023 Tuthill Park House

ASSOCIATES
	FIELD OBSERVAT	ION REPORT
Project:	Structural Assessment 421 North Spring Avenue Sioux Falls, South Dakota	NOFESSIO
Job No.:	VOA230200	REG. NO MI
Report No.:	1	GREGE
Date:	May 18, 2023 1:30 pm - 2:15 pm	HANNESTAD
By:	Greg Hannestad, P.E.	CON DAKO
Others Prese	ent During this Site Visit	Ang farment

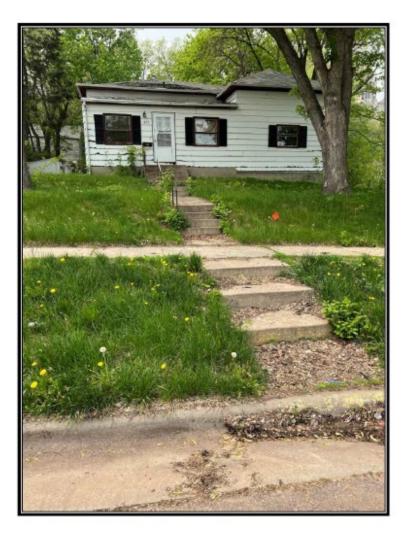
Photo 1: This view is from the street (N Spring Av) looking west toward the front of the house.

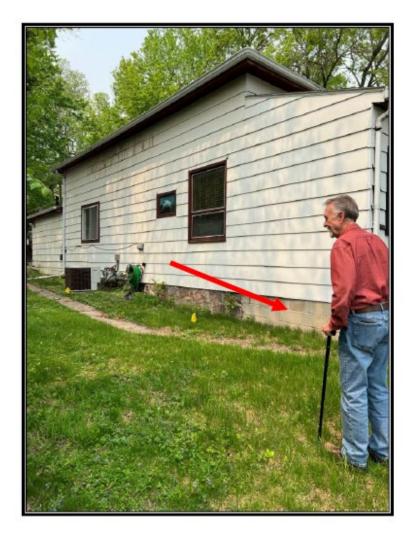
Photo 2: Looking northwest toward the south side of the house. The foundation (indicated by the red arrow) appears to be more-modern than the original quartzite stone basement walls.

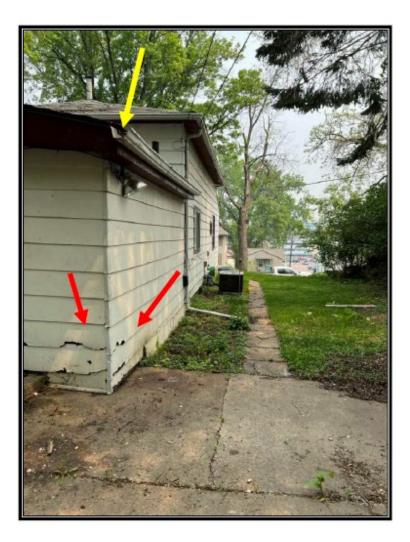
Photo 3: Looking east along the south wall. The siding has deteriorated at this southwest corner of the house (indicated by the red arrows), likely due to long-term exposure to moisture. Note that the roof gutter is open at this corner (indicated by the yellow arrow). This rear portion of the house appears to be an addition.

- 1. Refer to comments accompanying each photo.
- This house, in general, appears to be deteriorated, but sound. The shingles and siding were very deteriorated. Direct views of the actual structure was very limited due to the application of wall and ceiling finishes.

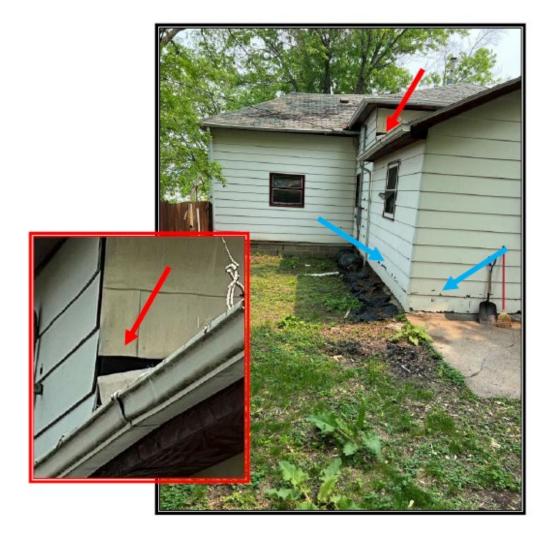
Photo 4: Looking east along the north side of the house. The siding is deteriorated (indicated by the <u>blue</u> arrows) at several areas along this wall.

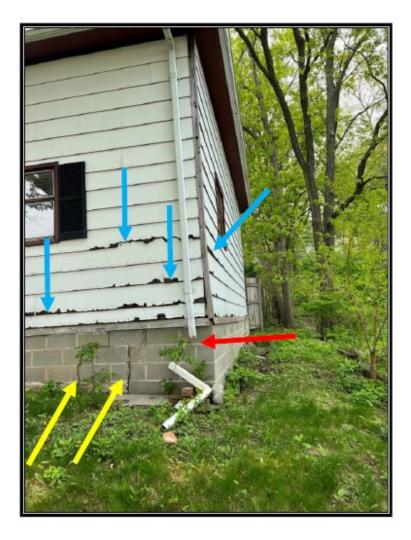
Photo 5: Looking toward the northeast corner of the house. The downspout has been dislodged at this corner (indicated by the red arrow). The siding is deteriorated (indicated by the blue arrows) at several areas along this wall. The foundation has also deteriorated at this corner (indicated by the yellow arrows).

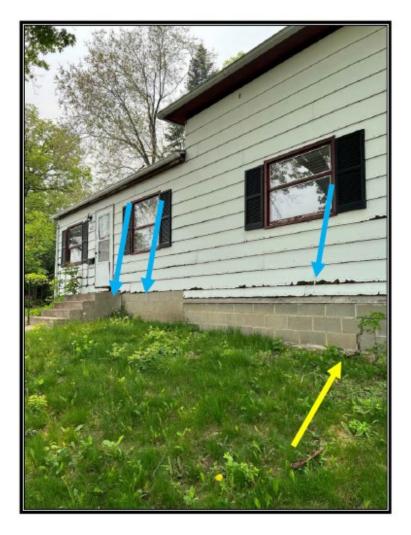
Photo 6: View looking southwest toward the front door. The siding is deteriorated (indicated by the blue arrows) at several areas along this wall. The deteriorated foundation is also seen in this photo (indicated by the yellow arrow).

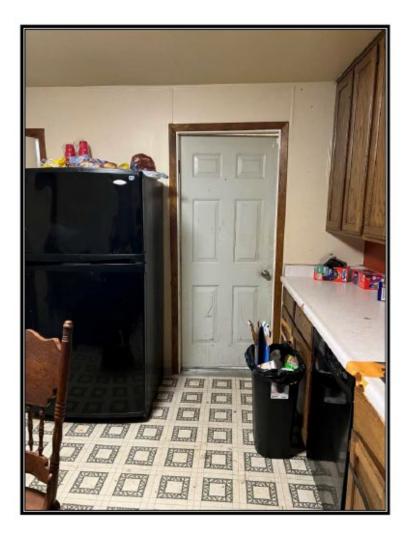
Photo 7: This is the Kitchen/Dining addition at the rear (west) end of the house. This view is looking south.

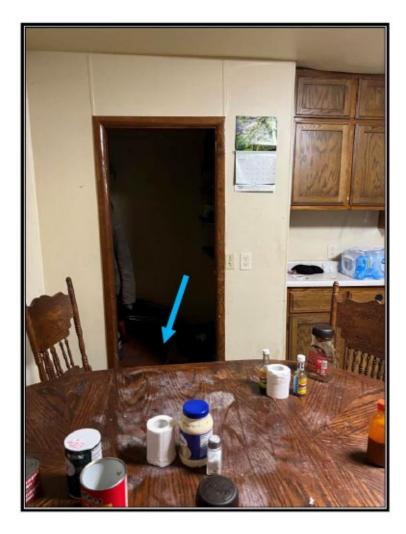
Photo 9: Looking east in the Kitchen/Dining toward the closet. The floor of this closet is a door to access the basement (indicated by the blue arrow).

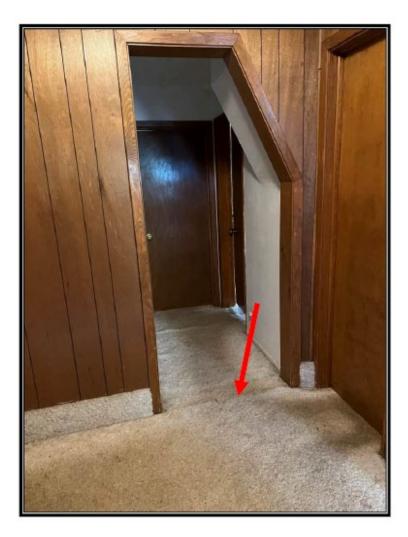
Photo 14: View looking north in the bedroom area of the house. The north portion (north of the red arrow) appears to be an addition.

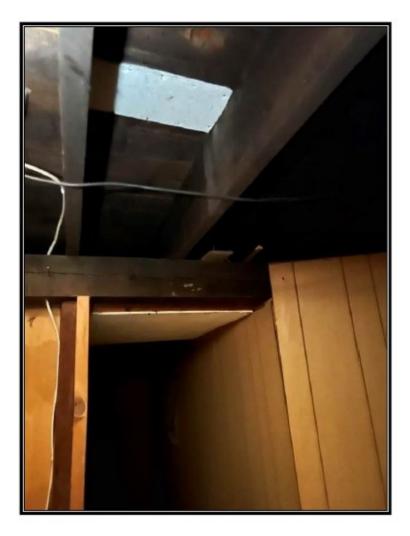
Photo 19: This view is looking up toward the wood floor joists.

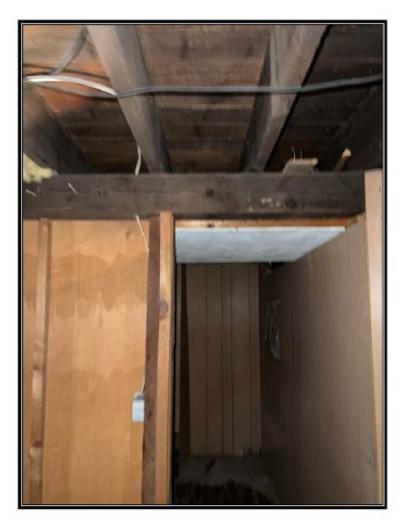
Photo 20: Another view of the wood floor joists.

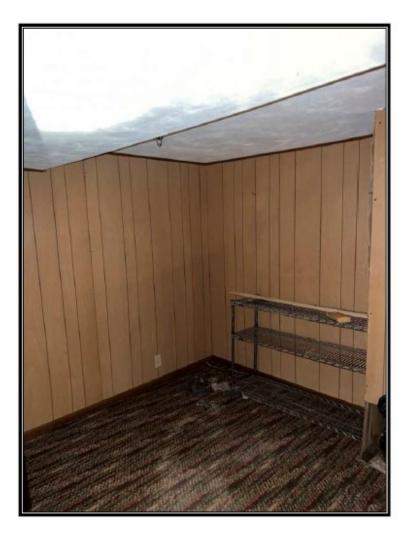
Photo 21: A room in the mazement. The basement walls have been covered so are not exposed to view.

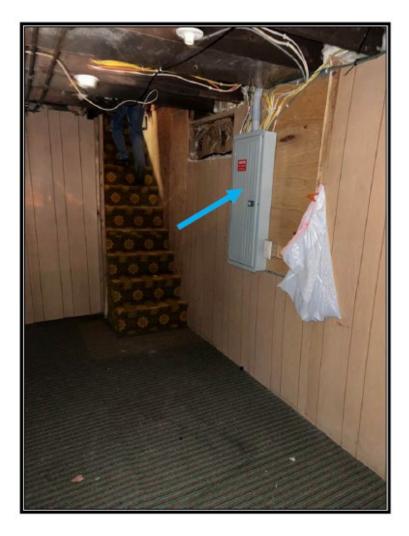
Photo 23: View looking west toward the stairs to the basement. The electric panel (indicated by the blue arrow) is mounted to the north wall.

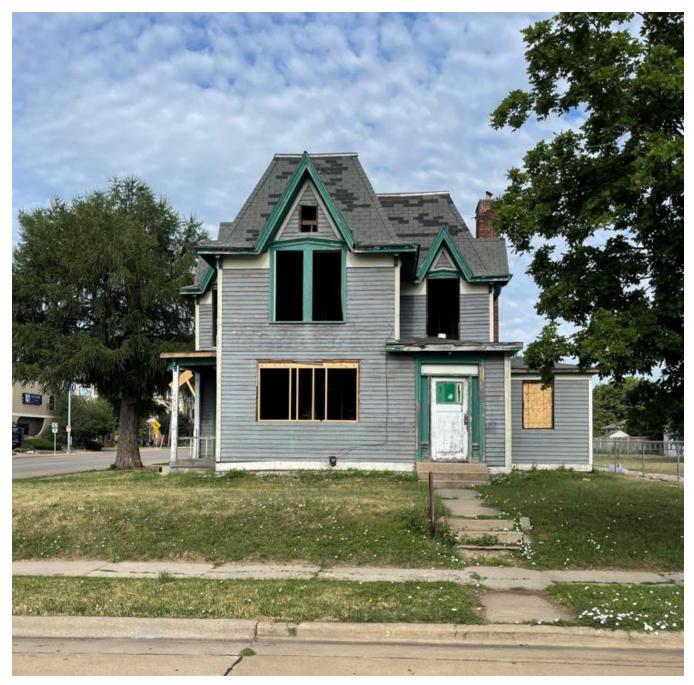
Above: 2023 Photo prior to vinyl siding and windows being removed.
