Appendices

Sioux Falls Wastewater Treatment and Collection System Master Plan

Existing Facilities Condition Assessment Technical Memorandum

Appendix 3.C – Existing Facilities Condition Assessment Lift Station Review Power Point Presentation

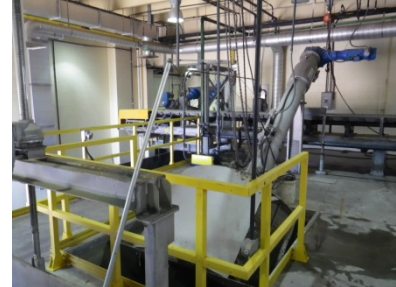
Rotary Drum Screen #1

- There are spots of corrosion on the drums of the fine screens. However, this happened shortly after the fine screens were installed and no significant additional corrosion has occurred. These are constructed of 304 stainless steel.

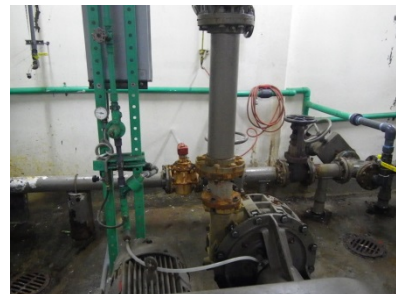
Grit Pump and Discharge Valve

- Visible spots of corrosion on the grit pump discharge piping and check valves in the old grit washer room.

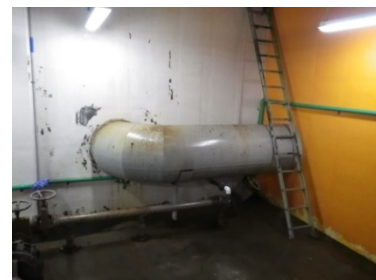
Grit Basin Influent Pipe

- Grit basin influent pipe in the grit basement shows signs of corrosion on the exterior of the pipe. The condition of the interior of the pipe is unknown, but is part of the original plant and is anticipated to be in poor condition due to the environment.

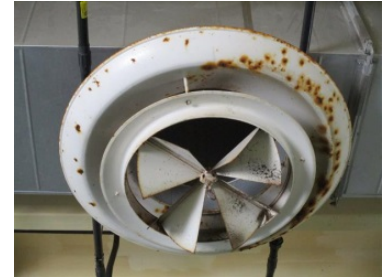
Mechanical Diffuser/Cover

- Moderate rusting is apparent on the mechanical diffuser/cover.
- Concrete floor at the overhead door is moderately deteriorating.
- Brick is moderately damaged on the SE corner of the building.

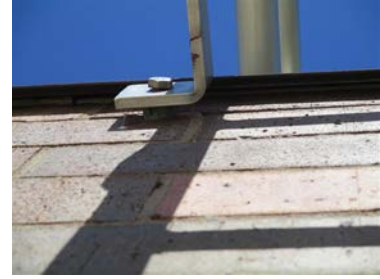
Roof Access Ladder

- The roof access ladder has at least three bolts at the top of the ladder that are not anchored causing the ladder to come loose from the wall.
- The screening portion of the facility has a new roof, but the rest of the building is original. A new roof is needed on the older, grit portion of the building and is on the current CIP.
- Old exterior doors are in poor condition.
- Concrete on the influent channel to the grit chamber is severely corroded.

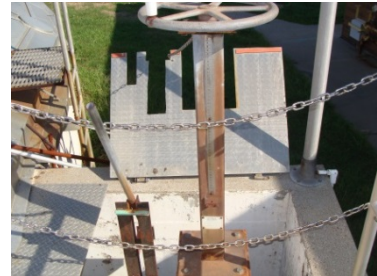
Primary Clarifier #1 Telescoping Valve Operator

- Process
 - Corrosion is visible on the operator stand, gears, and the telescoping valves for the scum pits.

- If still used, replace the scum telescoping valves on the clarifiers, otherwise remove the telescoping valves.
- Architectural/Structural
 - Recoat exterior concrete surfaces with the next five (5) years.

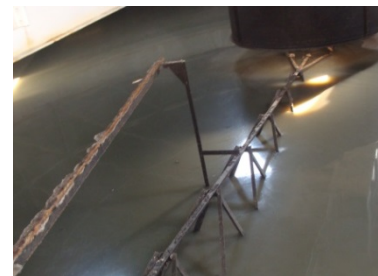
Primary Clarifier #4 Rake Arm

- The clarifier mechanisms, including the center column, influent well, drive cage, arms, skimmer, cross collectors; weirs and scum trough were installed in 1986 with the original plant. The mechanisms appear to be in good condition and have been maintained on a regular basis. However, continued maintenance on the original equipment may no longer be cost effective and replacement needs to be evaluated.

- Process
 - Replace the clarifier mechanism drives.
 - Evaluate replacement or sandblasting and coating of all metals surfaces including the center column, influent well, drive cage, arms, skimmer, cross collectors; weirs and scum trough.

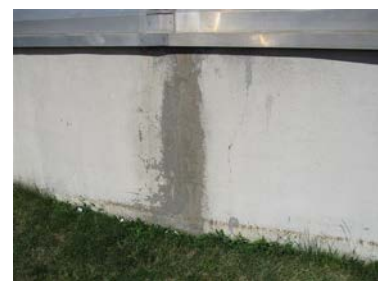
Concrete Basins

- The drain valves for the primary clarifiers are difficult to operate.
- Architectural/Structural
 - Concrete basins are in good condition. There is some discoloration on the exterior walls of the clarifiers and the grout or paint coating is wearing off in some locations.

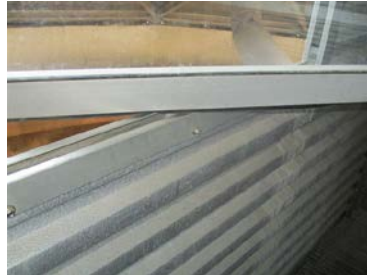
Operable Observation Window

- The step at the entrance door to the walkway bridges is showing signs of severe corrosion.
 - The operable observation windows of the catwalk are showing signs of extensive wear on the weather stripping seals and hardware. Most are very hard to open with the exception of a couple that the hardware has been severely damaged.

- Restore interior concrete surfaces with gunite, epoxy grout or coating.
 - Replace the entire window systems on the windows of the catwalks that are severely damaged and replace the weather stripping on the remaining windows to minimize further corrosion.

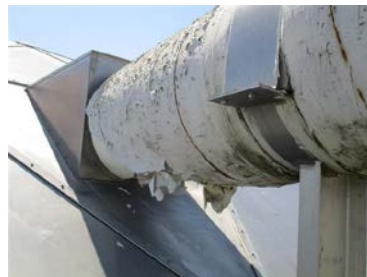
Odor Control Ductwork

- The insulation wrap on the odor control ductwork is severely deteriorated. HDR recommends replacing all of the insulation on every system.
 - The interior concrete has some minor cracking in all four clarifiers with some spalling of concrete on the interior walls.

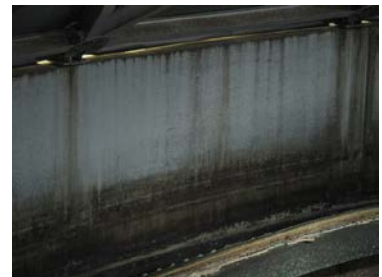
Interior of Clarifiers

- The paint and coatings on the interior of the clarifier have severely deteriorated.
 - The domes are original and are in good condition except for a few areas with minor damage at the concrete structure and minimal corrosion.

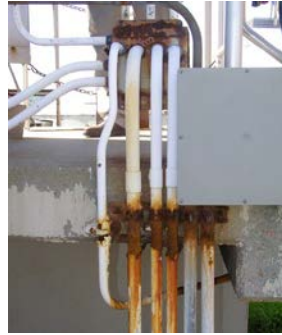
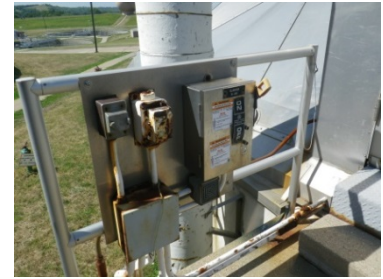
Electrical Box at Entrance to Primary Clarifier

- Severe corrosion on the electrical boxes at the access platform to the clarifier walkway bridges.
- Lightning protection down-leads are missing or broken.

- Electrical
 - Replace all the conduit and associated electrical equipment between Sludge Pumping and the access platforms.
 - Repair the lightning protection system.

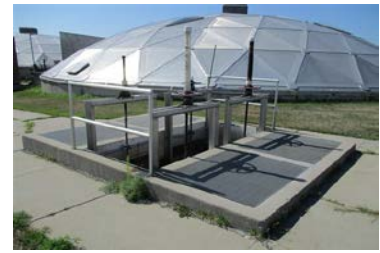
Slide Gates of Splitter Manhole #3

- Process
 - The slide gates stick and are difficult to operate.
- Architectural/Structural
 - Concrete appears to be in good condition.
 - Aluminum grating and hand railing are in good condition

- Process
 - Replace the four (4) fabricated aluminum slide gates. Should consider stainless steel replacements.

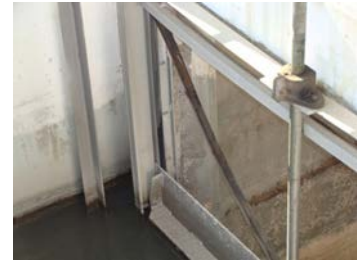
Slide Gate 06VAL007

- Process
 - The slide gates stick and are difficult to operate.

- Gasket seals are pulling away from the gate guides as indicated by the photo of Slide Gate 06VAL007.
- Architectural/Structural
 - Concrete appears to be in good condition. However, there is some spalled concrete behind the frame of Slide Gate 06VAL015.
 - Aluminum grating, ladders, and hand railing are in good condition.

- Process
 - Replace the four (4) fabricated aluminum slide gates. May want to consider replacement with stainless steel gates.
 - Replace the one (1) bypass sluice gate. May want to consider replacement with stainless steel gate.
- Architectural/Structural
 - Repair the spalled concrete.

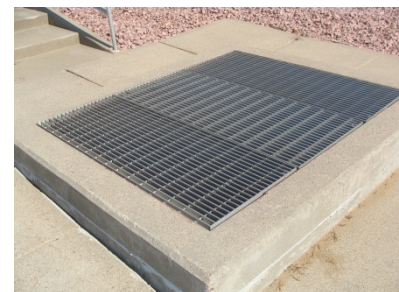
- Civil/Site
 - Concrete sidewalk steps at Manhole #8 are difficult to clear snow with UTV.
- Architectural/Structural
 - Concrete appears to be in good condition.

- Civil/Site
 - Evaluate grading options or sidewalk configurations to eliminate sidewalk steps.
 - Replace sidewalks with wider sidewalks to accommodate the UTV.

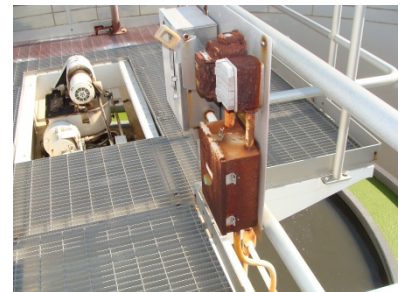
Electrical Box on Walkway of First Stage Intermediate Clarifier #2

- Process
 - The clarifier mechanisms, including the center column, influent well, drive cage, arms, skimmer, and scum trough were installed in 1986 with the original plant. The mechanisms appear to be in good condition and have been maintained on a regular basis.
 - Manually actuated drain (Humus) valves need to be assessed – they are original and difficult to operate.
 - Ground has eroded away under the concrete support for the drain valve operator stands.
- Architectural/Structural
 - Concrete basins are in good condition. There is some discoloration on the exterior walls of the clarifiers.
 - The access walkway and center platform are in good condition.
- Electrical
 - Electrical boxes on the walkways have severe surface corrosion as indicated in the adjacent photo.

- Process
 - Fill and grade under the concrete supports for the drain valve operator stands.
 - Replace the mechanism drives.
- Electrical
 - Replace the electrical boxes and conduit that have corrosion.

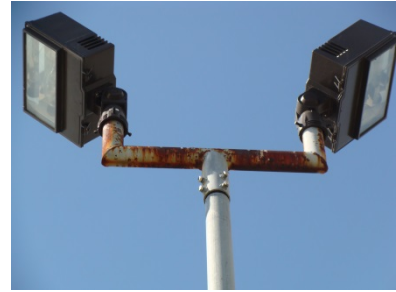
Light Fixture Support at Manhole #9

- Process
 - The sluice gates stick and are difficult to operate.
- Architectural/Structural
 - Concrete appears to be in good condition.
 - Aluminum grating is in good condition.
- Electrical
 - Corrosion of support pipe for the light fixtures as indicated by the photo.

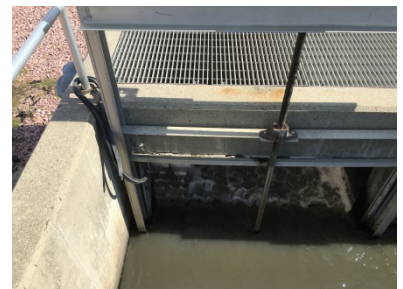
Slide Gate 08VAL014

- Process
 - The slide gates stick and are difficult to operate.
 - Gaskets seals are pulling away from the gate guides as indicated by the photo of Slide Gate 08VAL014.
- Architectural/Structural
 - Concrete appears to be in good condition.
 - Aluminum grating and hand railing are in good condition

- Process
 - Replace the four (4) fabricated aluminum slide gates.
 - Replace the one (1) bypass sluice gate.

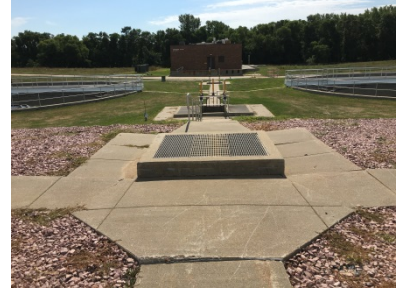
Manhole #10

- Civil/Site
 - Concrete sidewalk is settling around Manhole #10.
- Architectural/Structural
 - Concrete appears to be in good condition.

- Replace concrete sidewalks around Manhole #10. Replace with wider sidewalks.

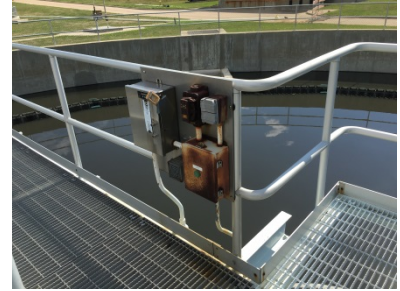
Electrical Box on Walkway of Second Stage Clarifier #1

- Process
 - The clarifier mechanisms, including the center column, influent well, drive cage, arms, skimmer, and scum trough were installed in 1986 with the original plant. The mechanisms appear to be in good condition and have been maintained on a regular basis.
- Architectural/Structural
 - Concrete basins are in good condition. There is some discoloration on the exterior walls of the clarifiers.
 - There is deterioration of the concrete at the guardrail post locations.
 - The access walkway and center platform are in good condition.
- Electrical
 - Electrical boxes on the walkways have severe surface corrosion as shown in the adjacent photo.

- Process
 - Replace the mechanism drives.
- Architectural/Structural
 - Repair concrete at the guardrail post locations to minimize safety hazards.
- Electrical
 - Replace the electrical boxes and conduit that have corrosion.

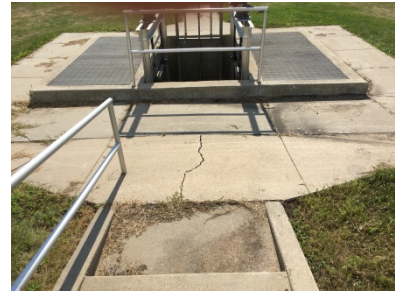
Sidewalks at Splitter Manhole #7

- Civil/Site
 - Concrete sidewalk around Splitter Manhole #7 is settling and cracking.
 - Concrete sidewalk steps at Manhole #7 are difficult to clear snow with UTV.
- Process
 - The slide gates stick and are difficult to operate.
- Architectural/Structural
 - Concrete appears to be in good condition.
 - Aluminum grating and hand railing is in good condition

- Civil/Site
 - Replace sidewalks around Splitter Manhole #7. Replace with wider sidewalks.
 - Evaluate grading options or sidewalk configurations to eliminate sidewalk steps.
- Process
 - Replace the two (2) fabricated aluminum slide gates and the one (1) sluice gate.
 - Replace the one (1) bypass sluice gate.
 - May want to consider replacement with stainless steel gates.

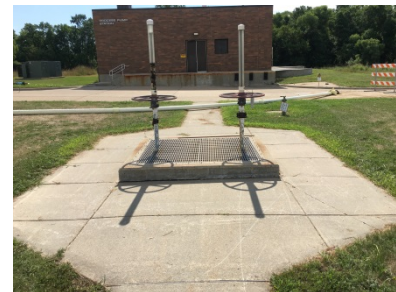
- Civil/Site Work
 - Concrete site walk around Manhole #11 is cracked and settling
- Process
 - The sluice gates stick and are difficult to operate.

- Architectural/Structural
 - Concrete appears to be in good condition.
 - Paint is peeling of the operator pipe stand.
 - Aluminum grating is in good condition

- Civil/Site Work
 - Replace cracked and settled sidewalks. Replace with wider sidewalks were practical.
- Process
 - Replace the two (2) sluice gates. May want to consider replacement with stainless steel gates.

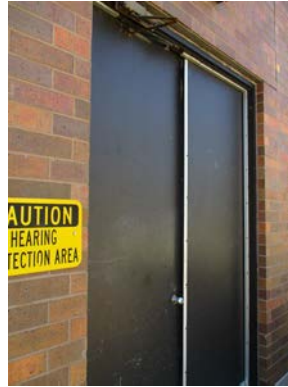
North Side Exterior Doors

- Process pumping building structure appears to be in good condition.
 - The brick veneer is in good condition, but with a few signs of settling.
 - The exterior doors on the north side of the building do not shut properly.

- Process
 - Replace the humus line with glass-lined piping.
- Architectural/Structural
 - Repair or replace the exterior double doors on the north side of the building.
 - Replace the three (3) exterior single access doors.
 - Replace the sealant and backer rod on the masonry control joints throughout the building. Tuck-point as necessary where water has damaged brick and CMU.
 - Install a landing and stairs on the rear exit for safety reasons.
 - Replace sealant and backer rod on all windows to eliminate future water damage.
 - Repair leaking from wetwell to drywell.
- Electrical
 - Replace electrical conduit and junction box near the entrance.

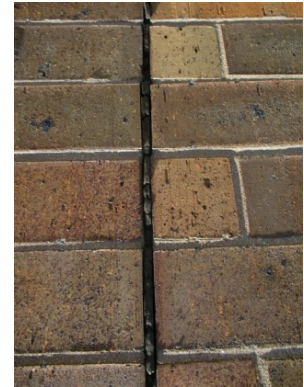
Masonry Control Joint Sealant

- The exterior and interior masonry control joint sealant is significantly deteriorating.
 - The rear exit is missing a stoop and stairs.
 - Interior paint is deteriorating due to condensation and water intrusion around windows.

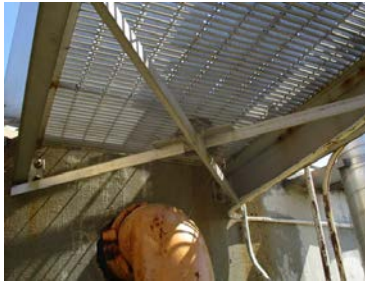
Landing on Thickener #2 Sways

- The stair and landing on Thickener No. 2 sways and is not properly secured to the structure. This is potentially a safety concern.
- The tunnel floors are completely wet with condensation. This poses a safety hazard for slipping.
- The South end of the tunnel at the Digester Building has severe water damage due to a failing expansion joint system. This expansion joint location is at a low point on the site and high concentrations of rain and ground water accumulate over this location.
- The roofing and scupper is failing thus causing severe water damage to the CMU and brick veneer on the Exit Stair Tower.
- Access door is in poor condition.

- Restore interior and exterior concrete surfaces of the thickener tanks with gunite or epoxy grout.
- Repair stairs and landing at Thickener No. 2.
- Remove the ground cover required to replace any damaged waterproofing membrane and the entire expansion joint system. Recommend installing a drainage system to divert water away from this low spot on the site.
- At the Exit Stair Tower, replace a large portion of the brick veneer on the east side of this structure as well as tuck-pointing other portions of the brick veneer and interior CMU wall.
- On exit stair tower replace the ballasted loose laid EPDM roof and install a new scupper/flushing system before any tuck-pointing work is done to eliminate this from reoccurring.
- Replace the single access door at the exit stair tower.

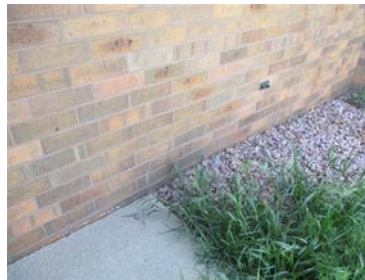
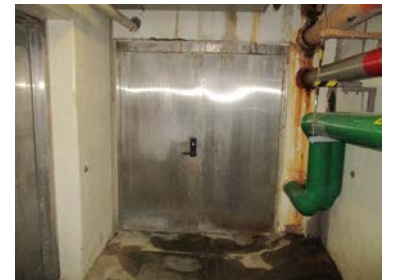
Exterior South End of Tunnel

Interior South End of Tunnel

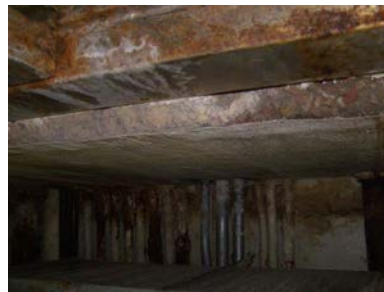
Electrical Conduits in Tunnel

- Significant corrosion of conduits at the platforms.
- Conduits in the tunnel at the wall penetration to the Digester Building are failing due to corrosion.

- Electrical
 - Replace conduit at Thickener platforms.
 - Repair drainage issues to stop water leaks into tunnel, and then replace failed conduits.
- Mechanical
 - Review NFPA 820 to see if the Odor Control is compliant with the current NFPA standards.

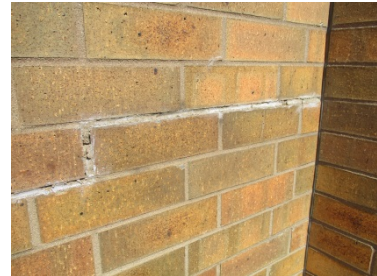
Water Damage to Brick Veneer

- There is water damage to brick veneer system. A tuck-pointing project is under way on this building. This roof is currently scheduled to have a new roof system installed throughout this structure.

- Architectural/Structural
 - Look at installing drain tile at east end of tunnel (west side of digester building). Intercept water to keep away from north and west sides of the digester building.
 - Flashing and roofing needs to be done to eliminate the source of water problems.
 - Replace the single exterior access door and three (3) sets of exterior double doors.
- Electrical
 - Review NFPA 820 and make appropriate corrections.

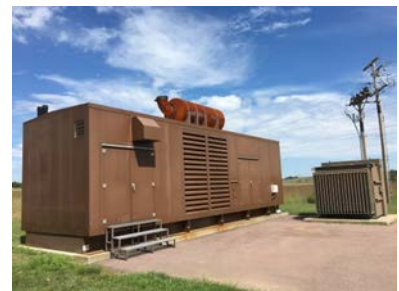
Standby Generator

- General
 - Muffler/exhaust is rusty.
 - Rusting on the enclosure
 - Rust discoloration of the concrete slab of enclosure
 - Step to electrical room doors has no handrail or platform, unsafe condition.
- Civil
 - Pavement surface needs to be resurfaced (some low spots)
 - No settlement of the concrete driveway, but concrete looks worn.
 - Open joints at concrete approach pavement and bituminous pavement.
- Electrical
 - The generator room was extremely hot when inspected.
 - The paralleling switchgear feeds a pad mounted sectionalizing gear, which divides the power delivery into two circuits to the Control Building.

- Civil
 - Replace/repair pavement as part of Civil/Sitework improvements project.
- Electrical
 - EPA emissions requirements will require significant exhaust treatment or even engine replacement to run the generator if the utility service is still available.
 - The facility staff indicated that service reliability could be improved if a utility bypass circuit was installed that would bypass the generator and associated paralleling switchgear.

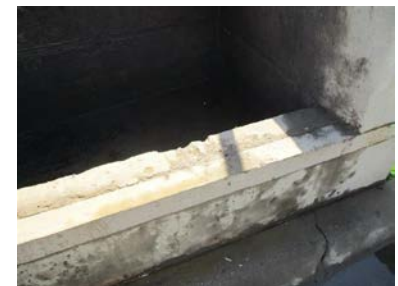
Concrete at Face of Dumping Area

- Architectural/Structural
 - The structure appears to be in good condition.
 - The concrete is moderately deteriorating at the face of the dumping area.

- Continue to provide maintenance as required.
- Remove the electrical conduit and wiring, as it is no longer used.

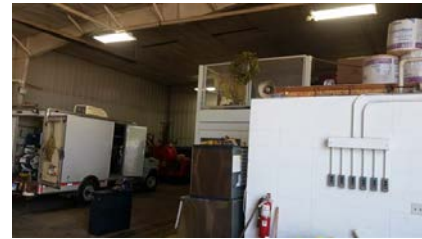
Interior of Equipment Storage Building

- Architectural/structural
 - The metal building is in good condition and all overhead doors are operational.
 - The roofing is the original metal roof installed in 1995 and is in good condition for being 20 years old.
 - The office area in this building will be expanded to the west to take up the entire north bay of the building.
- Mechanical
 - HVAC has old tube heaters that have soot buildup when running.

- Architectural/Structural
 - Add larger office area in southwestern corner of building.
 - Add restrooms and locker room facilities.
 - New roof should be put into the CIP for replacement in the next five years.
- Mechanical
 - Update HVAC system, including a new HVAC system for proposed expanded office area.

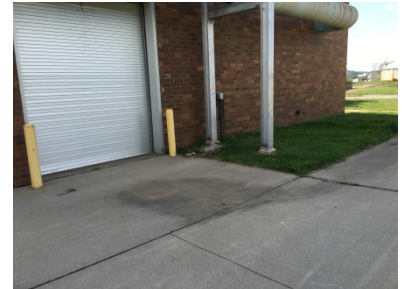
Overhead Door on Northwest Side of Control Building

- The exterior sealant and backer rod is significantly deteriorating.
 - The roof is the original built-up roof.
 - The exterior access doors are weathered and in poor condition.

- Replace the two (2) single access doors.
- Mechanical
 - Replace/upgrade the entire HVAC system.
- Electrical
 - The two switchgear south loop circuits (cabling) are routed in the same conduit. Separation will improve reliability of the distribution loop.

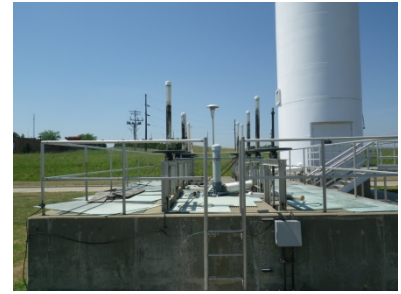
Splitter Manhole #1

- Process
 - Coating on gate operator handwheels is cracking.
 - Very little corrosion on the gate guides above grating.
- Architectural/Structural
 - The walls have minor cracking.

- Process
 - Evaluate raising the concrete walls, as it is critical hydraulically. Water splashes out of the structure at or above a flow of 35 MGD. This would require modifications or replacement of the slide gates, grading, and lime feed piping.

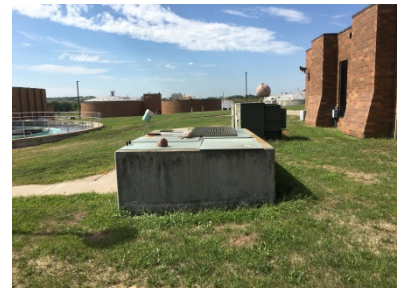
Manhole #1

- Concrete appears to be in good condition.
- Aluminum grating appears to be structurally sound, but has mineral (calcium) buildup on the surface.

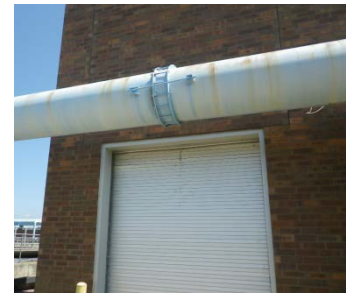
Aeration Header Piping

- Process
 - There is some corrosion on the air header piping and leaking is occurring at the couplings.
 - There is visible corrosion on the influent piping and valves.

- The Sanitaire Coarse Bubble Diffusers appear to be in good condition.
 - In general, aeration basin inlet valves are in good condition.
 - The aeration basin air piping has leaks and the valve actuators need to be replaced.

- Process
 - Evaluate updating the aeration system with fine bubble aeration.
 - Replace the valve actuators
 - Look at sloping the bottom of the basins or putting in a center channel for better draining.
- Architectural/structural
 - Repair the cracked surface concrete on aeration basins.
 - Repair the concrete on the floors of the basins that is cracking and spalling.
- Electrical
 - Replace the electrical junction boxes, support systems and PVC conduit.

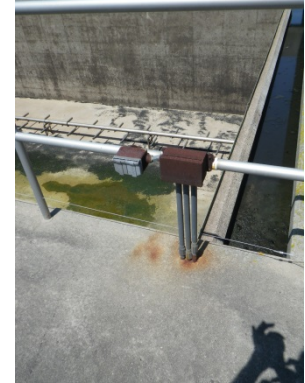
Electrical Junction Box at Aeration Basin #4A

- Electrical
 - A mixture of conduit material has been used; PVC, PVC coated RGS and aluminum. The PVC conduit is expanding and contracting with the weather so it is not straight.
 - There is corrosion on the electrical junction boxes and support systems around the aeration basins.

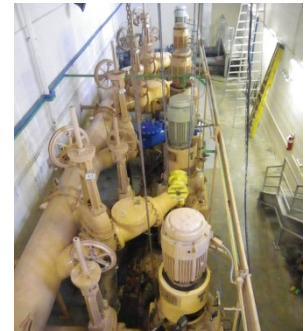
RAS Pumps #1, #2, #3, #4, & #5

- Process
 - All RAS and WAS pumps are original.
 - Slight grinding/vibration was noted in RAS Pump No. 3 during the inspection.

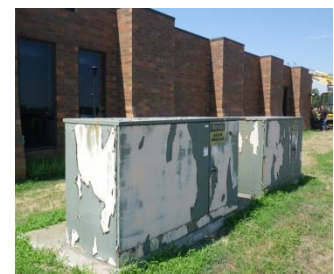
Electrical Transformers at the RAS Building

- Mechanical
 - The HVAC system is original and needs to be replaced
- Electrical
 - Review NFPA 820 ratings for this building.
 - The transformer enclosures are in poor condition, with paint peeling off over 90% of the entire enclosures.

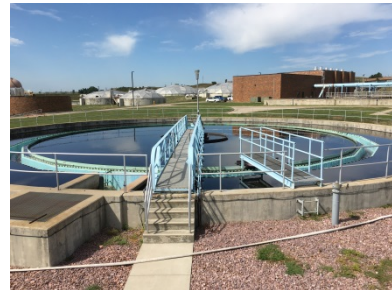
Final Clarifier #1

- Process
 - Mechanisms are old, with corrosion on many of the

structural members, compromising the structural integrity of the mechanisms.

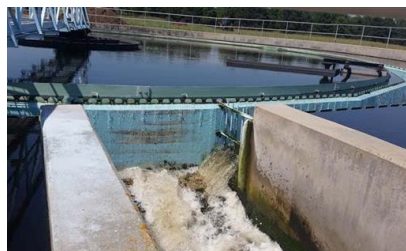
Paint and Coating of the Final Clarifiers

- The tank structures appear to be in good condition overall.
 - The paint and coatings are in good condition for the age of the clarifiers.
 - Some of the concrete steps and sidewalk show signs of significant settling.

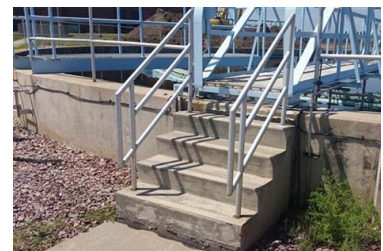
Concrete Steps and Sidewalk to the Final Clarifiers

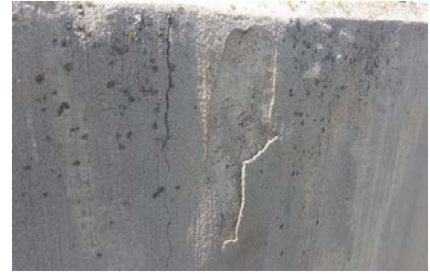
- There is mild to moderate delamination of the parge/skim coating on the clarifier tanks.

Parge/Skim Coating on the Clarifier Tanks

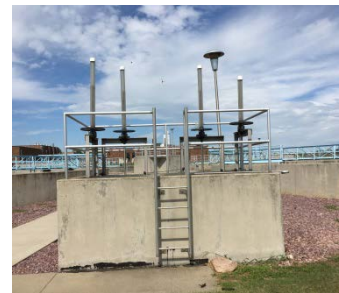
Manhole #2

- Architectural/structural
 - Concrete appears to be in good condition.

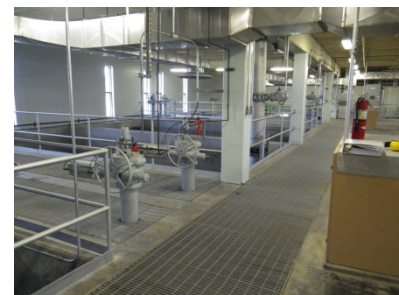
Effluent Filter Room

- The filter media and equipment were replaced in 2011 and are in good condition.
- Valve actuators were not replaced with the filter upgrades in 2011. Need to assess actuators for replacement.

- The elevation of the filter bypass weir restricts the amount of flow to the filters.
- Architectural/structural
 - The structure seems to be in good condition overall with a few small signs of settling.

- Process
 - Adjust bypass weirs.
 - Replace valve actuators.
- Architectural/Structural
 - Repair the masonry damage and grout on the south side of the building.
 - Repair cracks (inside and outside) on the southwest wall to eliminate water intrusion.
 - Replace the control joint sealant and backer rod throughout the building exterior. Tuck-point as necessary where water has damaged brick and CMU.
 - Replace sealant and backer rod on all windows to eliminate future damage.
 - Repaint the walls in the lower pipe gallery in the next 5 years.

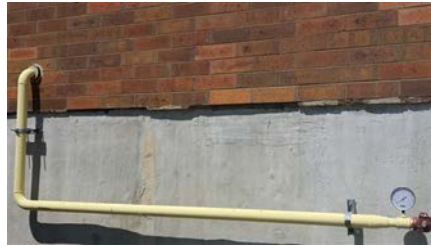
- The brick veneer is in good condition with few signs of settling.
 - The masonry grout on the exterior concrete wall on the south side of the building is deteriorating.

South Side Exterior Concrete Wall

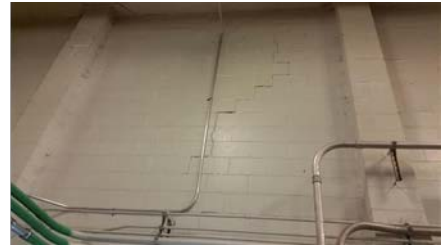
- There is moderate cracking on the inside face of the southwest wall of the building.
 - The exterior sealant is significantly deteriorating.
 - Paint is deteriorating due to condensation and water intrusion around windows.

Interior Southwest Wall

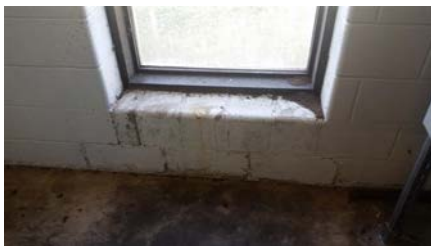
Window in Filter Building

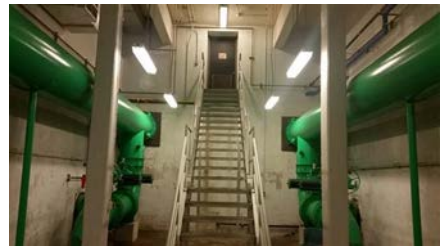
- The wall paint finish in the lower pipe gallery is deteriorating and peeling.
 - The roof was replaced in 2011 and is in good condition.
 - Exterior doors are weathered and in poor condition.

Lower Pipe Gallery

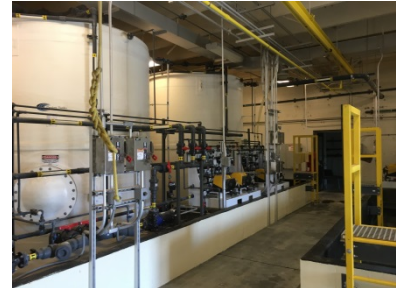
Sodium Hypochlorite Feed Pumps and Storage Tanks

- Civil/Site
 - Concrete sidewalk around the building is settling away from building.
- Process
 - New chemical storage and feed equipment for chlorination and dechlorination were installed in 2013 and is in good condition.
- Architectural/structural
 - The structure seems to be in good condition overall with a few small signs of settling. The brick veneer is in good condition with few signs of settling.
 - The exterior stairs are deteriorating on the north side of the building. This deterioration does not require any immediate repairs at this time.
 - Exterior access doors are weathered and in poor condition.
- Mechanical
 - Building HVAC System was replaced in 2013 and is in good working condition.
- Electrical

- Service pad mounted transformers have corrosion.
- Electrical equipment is manufactured by GE. MCC is 7700 Line.
- Had difficulty overriding the PLC to manually operate the chemical feed pumps under local control.

- Civil/Site
 - Replace Sidewalks
- Architectural/structural
 - Rehabilitate exterior stairs.
 - Replace the one (1) set of exterior double doors and the three (3) single access doors.

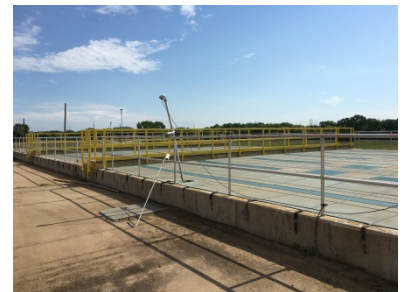
Chlorine Contact Basins

- Architectural/structural
 - Concrete of contact basins are in good condition.

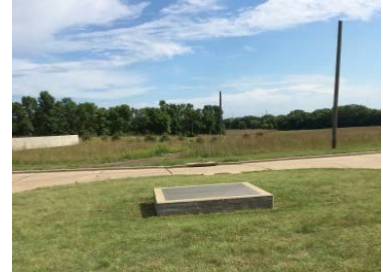
Manhole #3

- Architectural/structural
 - Concrete appears to be in good condition.
 - Aluminum grating appears to be in good condition.

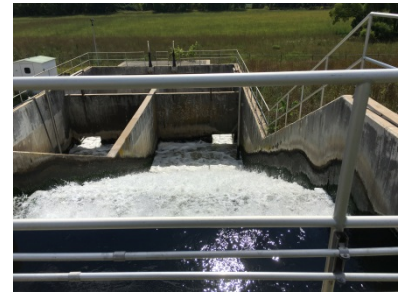
South Half of Cascade Aerator

- Cascade aerator is in good condition.

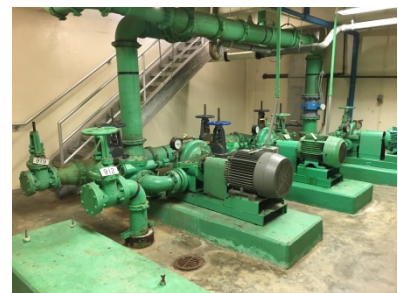
Non-Potable Water Pumps #2, #3, & #4

- Process
 - The Non-Potable Water Pumps and the In-Plant Waste Pumps are original and replacement should be considered.
 - In-Plant Waste Pumps appear to use an excessive amount of seal water.
 - Corrosion is very visible on the In-Plant Waste Pumps.
 - There is no hydro pneumatic tank on the NPW system or VFDs to adjust pump speed to meet NPW demands. To avoid frequent on-off cycling, plant staff attempts to make sure

- Process
 - o Installation of a constant pressure non-potable water pumping system with variable frequency drives is recommended.
 - o Add VFDs to the In-Plant Waste Pumps.

- o Evaluate replacement of the Non-Potable Water Pumps and the In-Plant Waste pumps.
 - o Replace and update the strainers on the NPW system.
 - o Repair or replace link seals around piping that exits building.

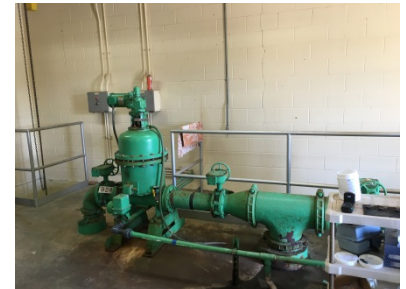
NPW Strainer

- o water is in use year round at an appropriate rate.
- o NPW strainers are original and replacement should be considered.
- o Water intrusion is occurring through link seals in the In-Plant Waste Pumping drywell (Lower Level). There is staining on the concrete walls as a result of the leaking seals.

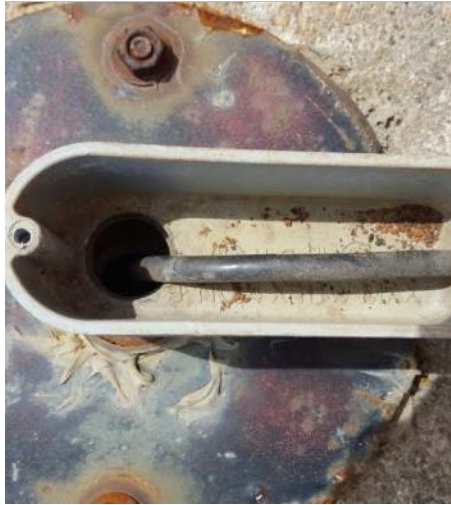
No Electrical Seal-Offs
Between Wetwells and
Control Panel

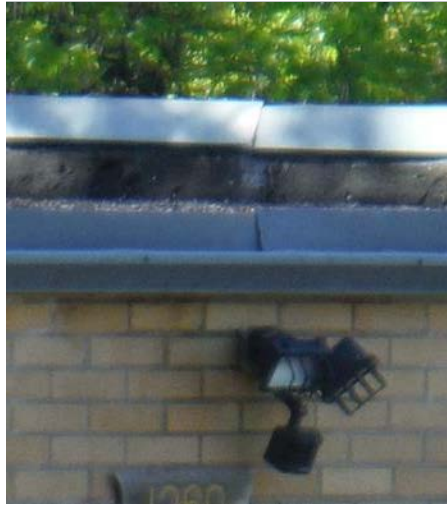
Deterioration of
Roofing Material

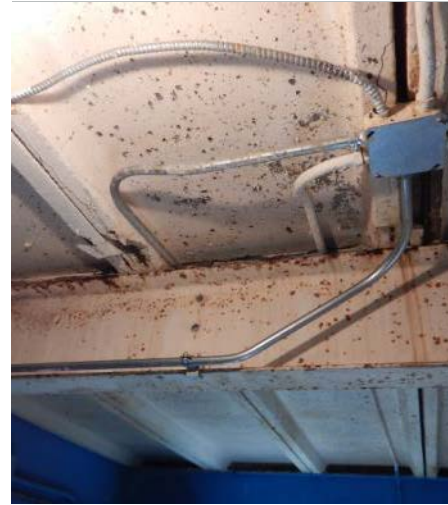
Adequate Ventilation –
Supply and Exhaust
Fans - Current NFPA
Requires 6 ACH in
Pump Rooms. If not
they are then Classified
as Class 1 Division 2

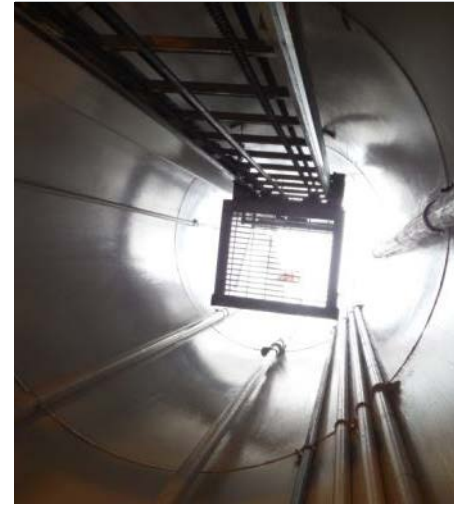
Safe Access to
Pumping Rooms

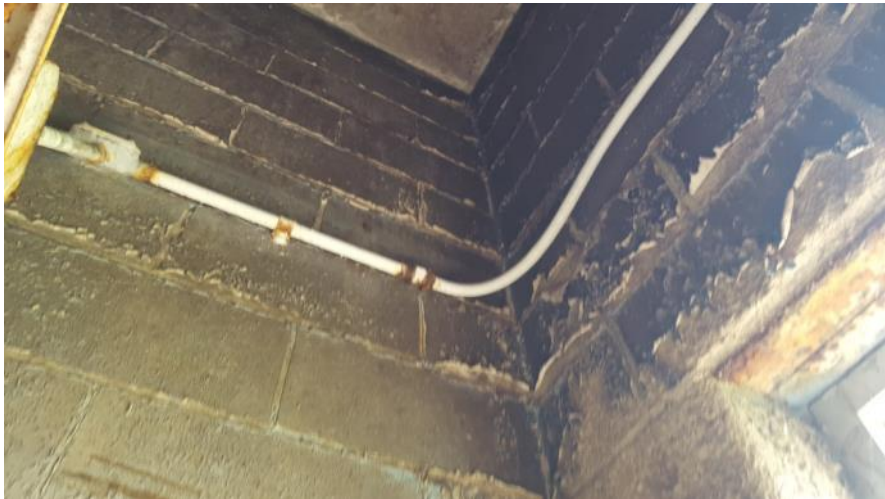
Rusted and Corroded Conduits and Railings In Wetwell

Wet Well Access Below Flume SCBA Entrance Only

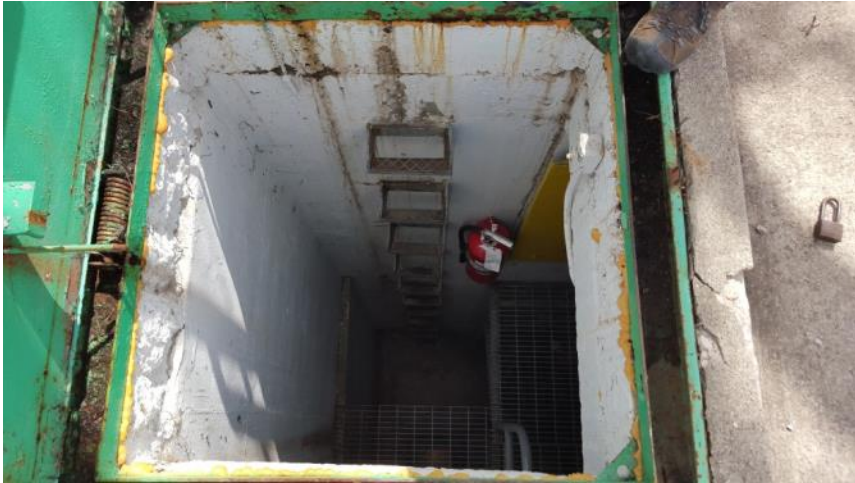
Dry Well (Pump Room) Access Via
Manhole Steps

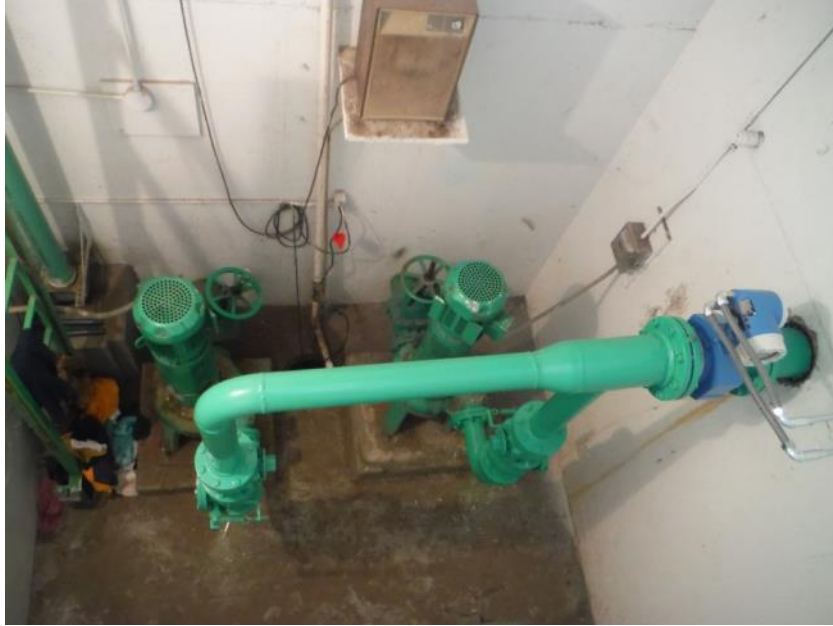
Tight Working Quarter

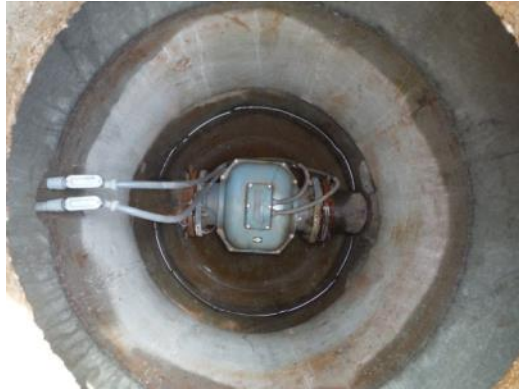
Submerged Flow Meter

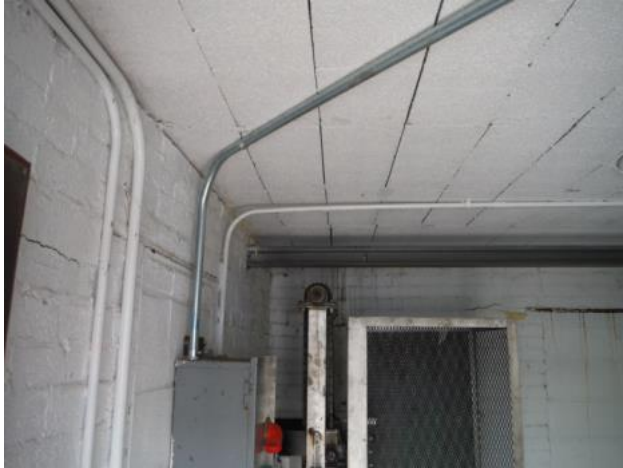
Deteriorated Bldg Interior and Roof

Structural Condition Poor – Needs a complete Rebuilt

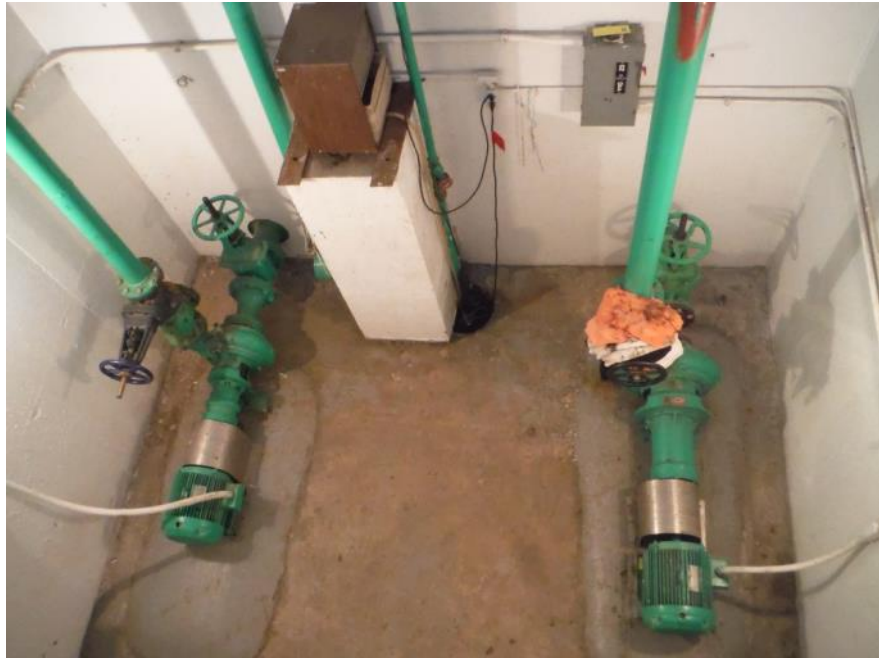
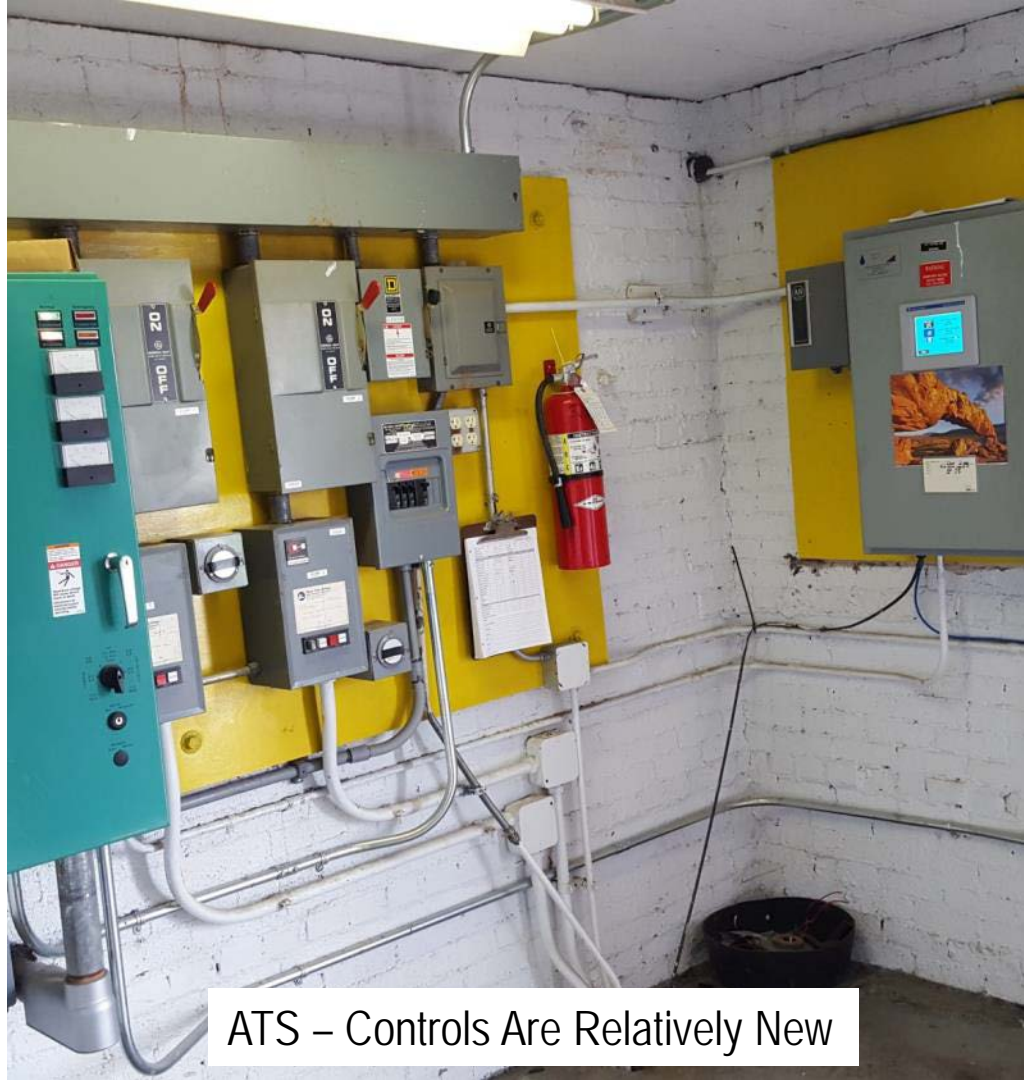
Station Only Serves a Small Area with Minimal Flow. Pump No.1 is in Good Condition, Pump No. 2 has some potential bearing issues.

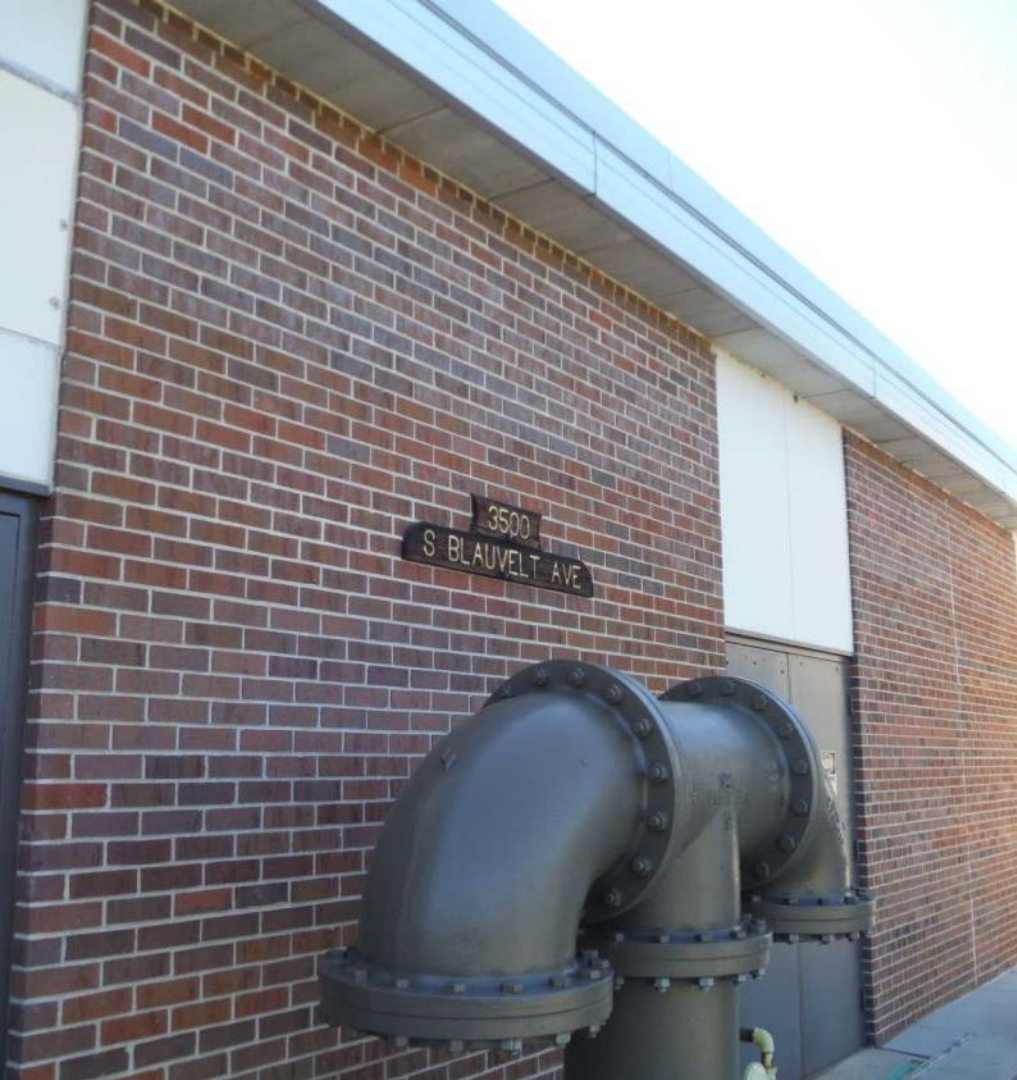
**PS-218 TUTHILL PARK
3500 S. BLAUVELT**

Ventilation in
Electrical
Room and
Connected
Pump Room is
Inadequate

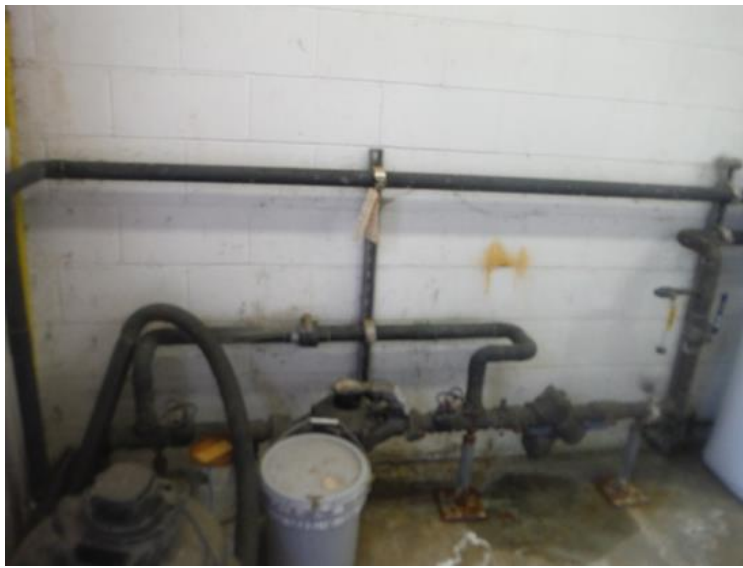
Potential for Flooding

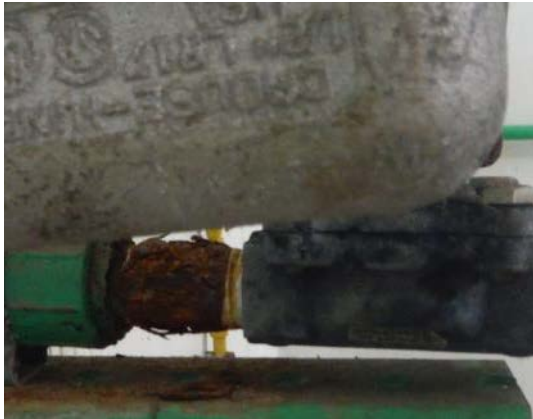
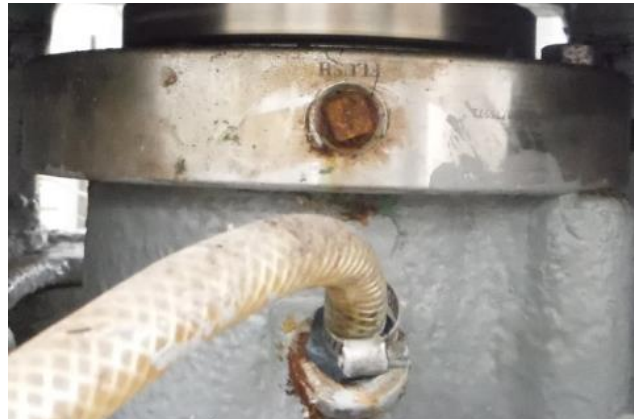
Seal Water Supply and Connections to Seals Should be Corrected

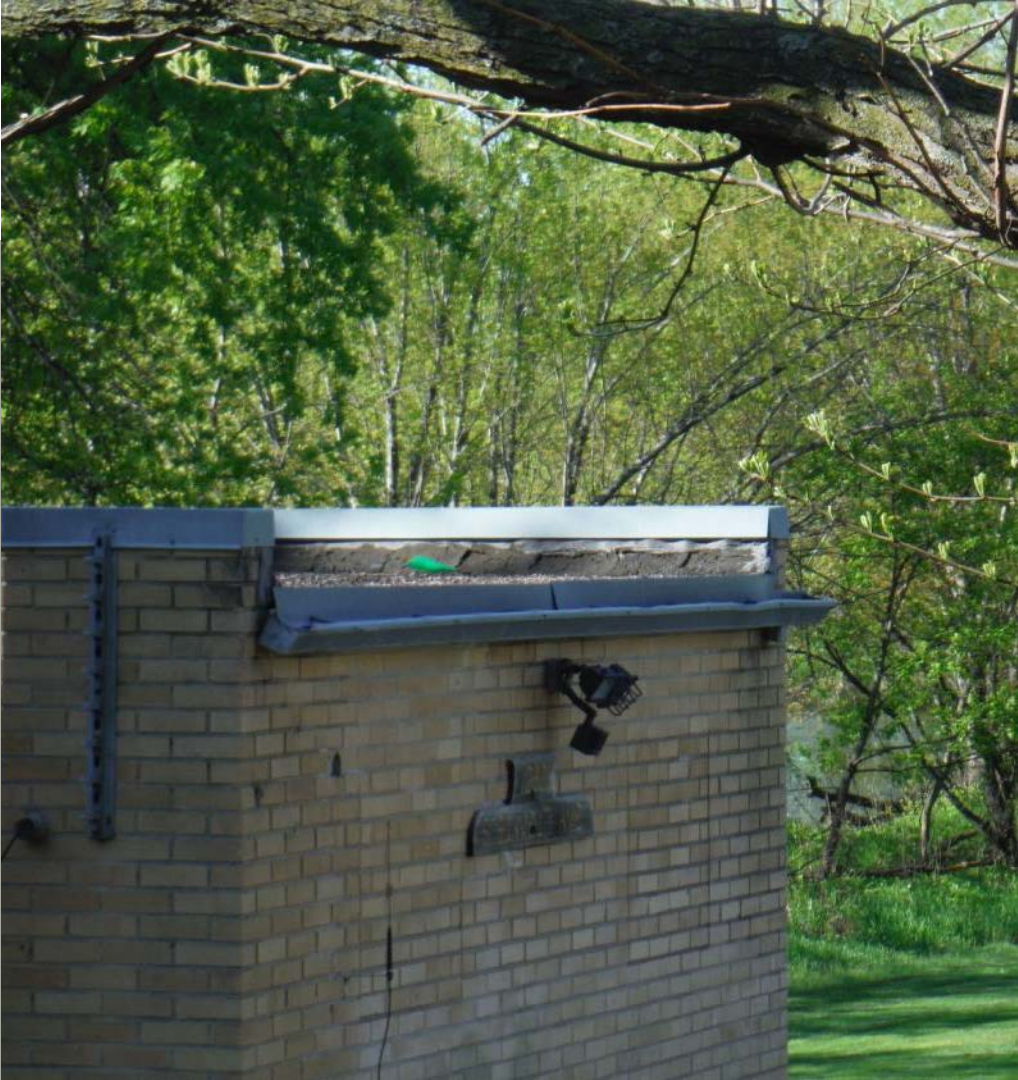
**PS- 220 ROCK ISLAND
1260 S BLAUVELT**

Deteriorated Interior Roof and Humidity

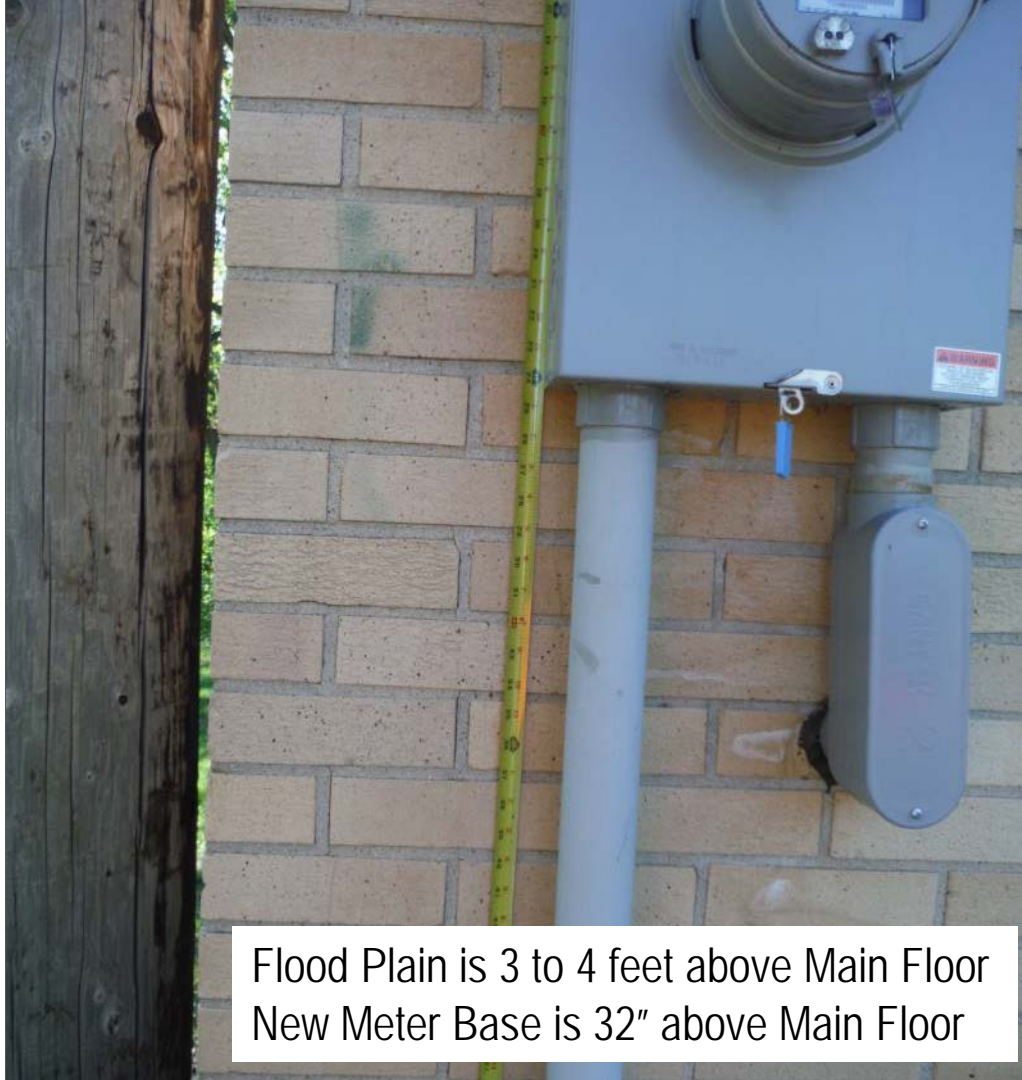
Flood Plain is 3 to 4 feet above Main Floor
New Meter Base is 32" above Main Floor
