Appendices

Sioux Falls Wastewater Treatment and Collection System Master Plan

Existing Facilities Condition Assessment Technical Memorandum

Appendix 3.C – Existing Facilities Condition Assessment Lift Station Review Power Point Presentation

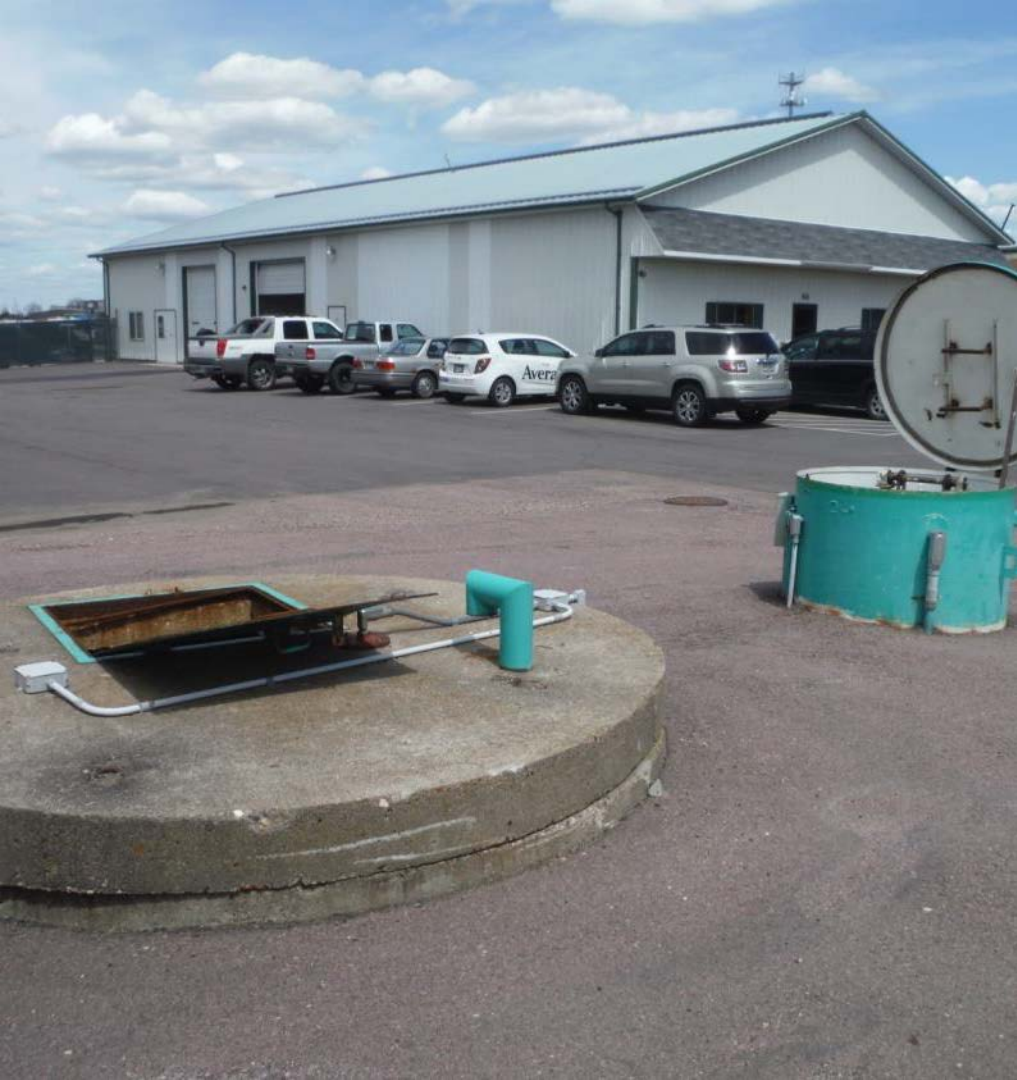
PS- 224 50TH NORTH STREET

Pumps Plug-Cannot Run on VFD's
Pump Number No. 2 Potential Bearing Issue
Only Access is down Elevator in Tubular
Access Shaft

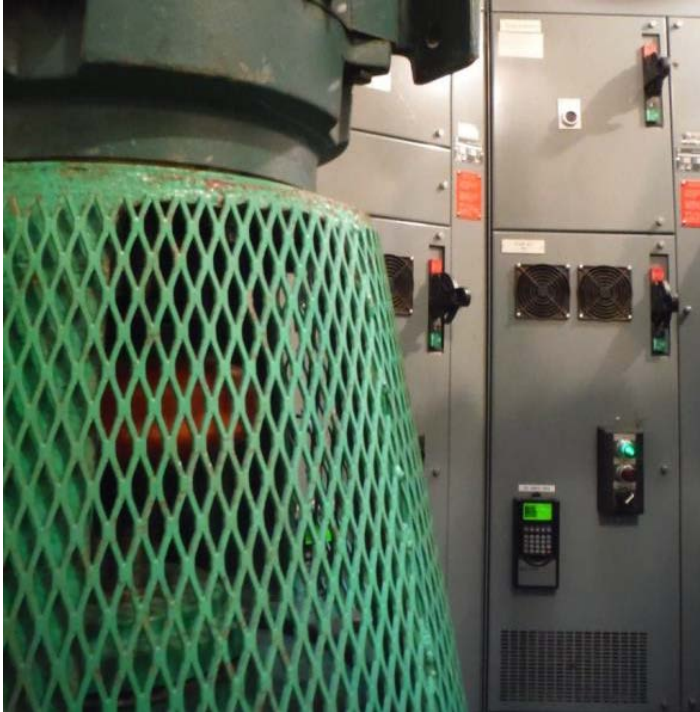
Inadequate Working Space

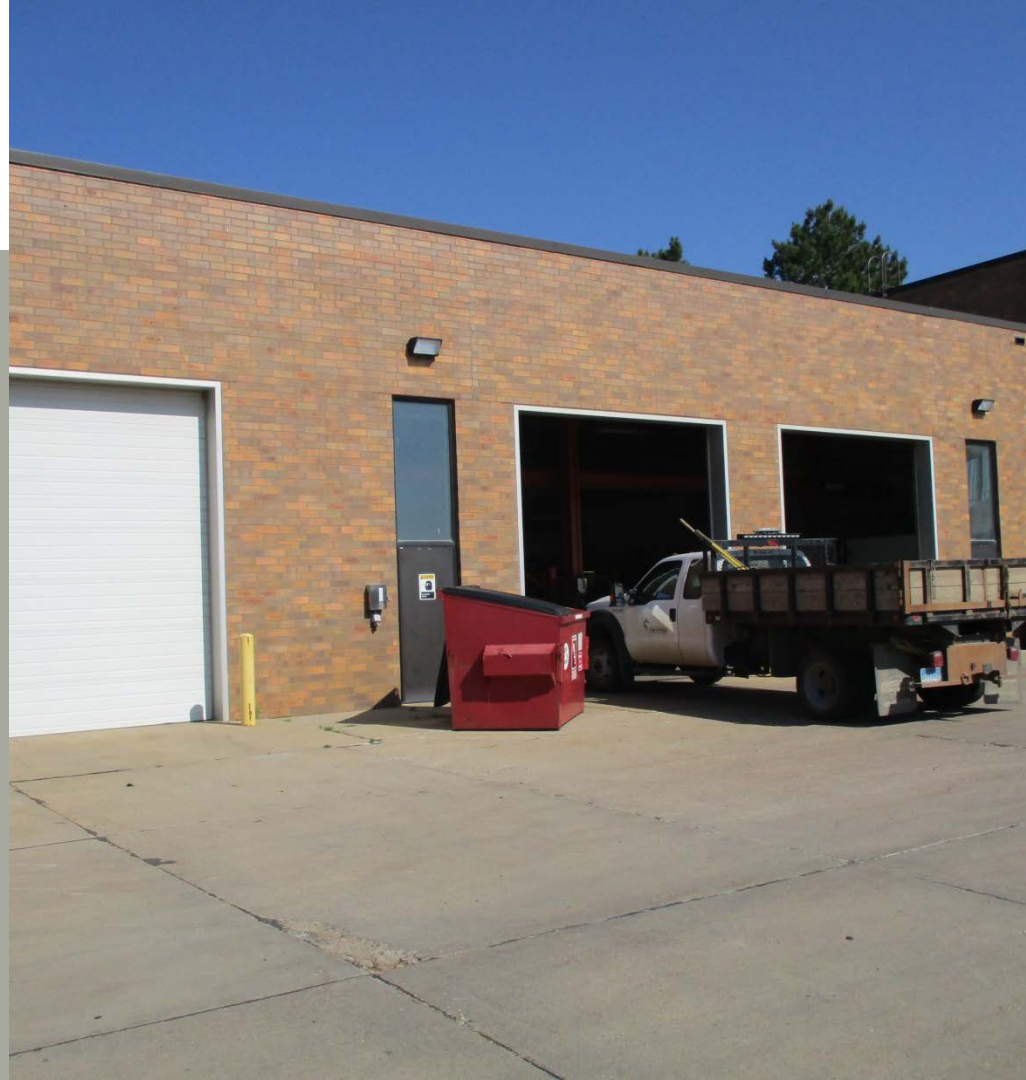
MAINTENANCE BUILDING (2)

Roof – Age/Condition & Reliability

HVAC – Age/Condition & Reliability

Mezzanine – Missing Ladder Rail and Toe Plate

- High Priority
 - Replace Roof System *and upgrade HVAC System.*
 - Replace missing ladder rail and toe plate at mezzanine

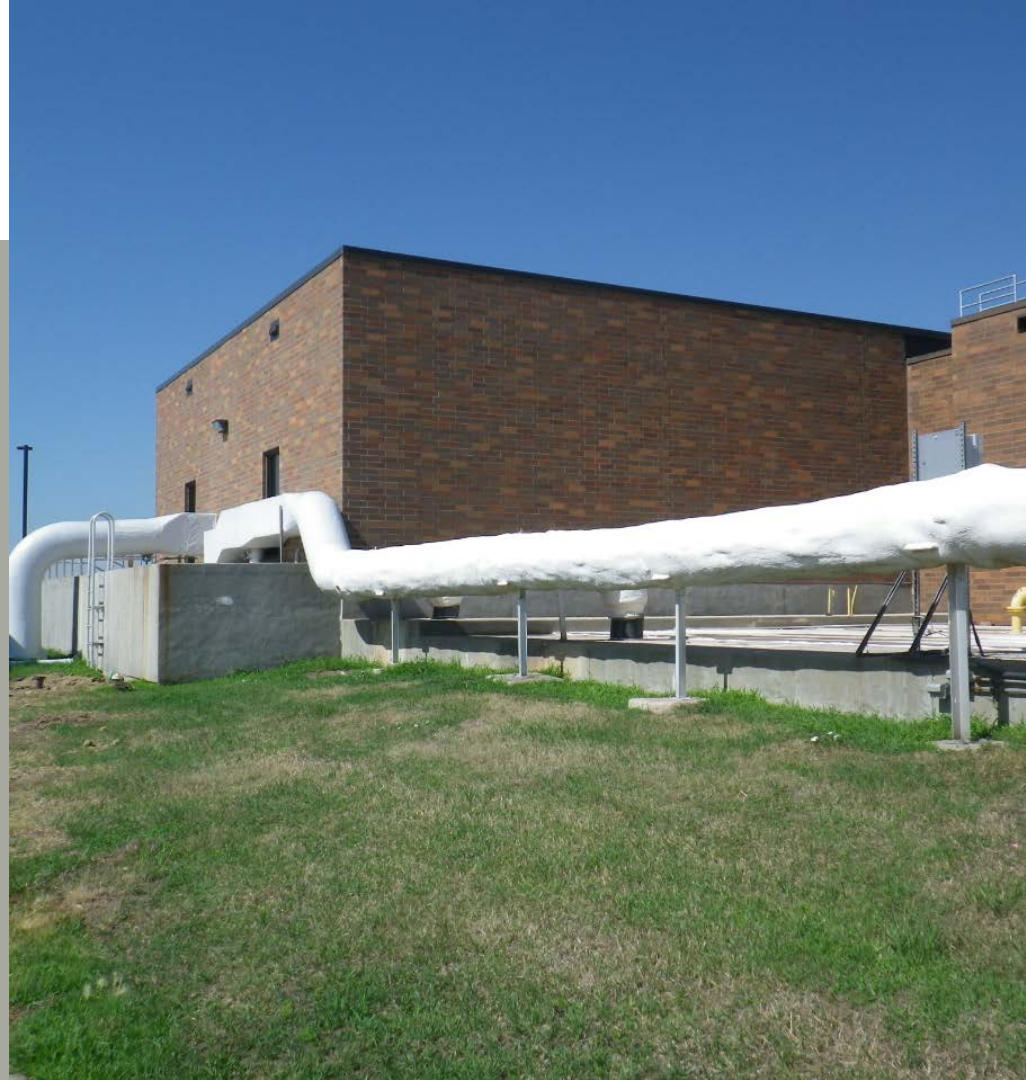
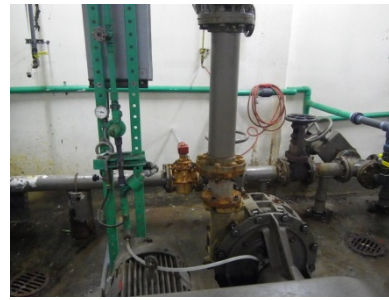
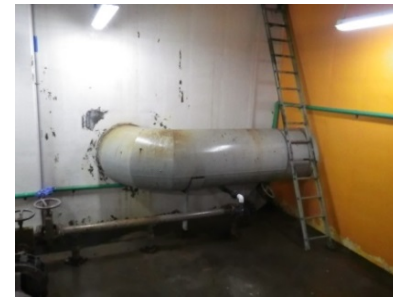
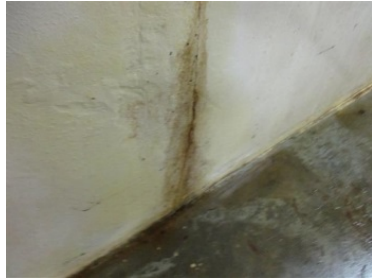
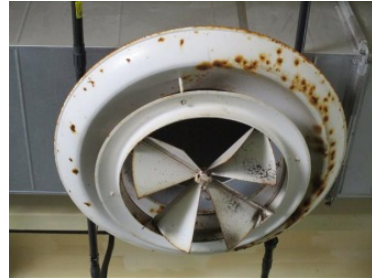
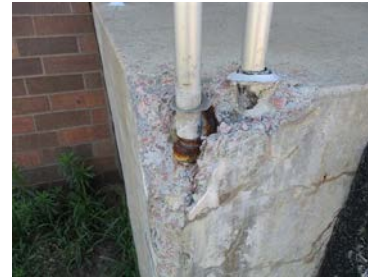
GRIT BUILDING (3)

- Age/Wear & Reliability of Blowers #1 and #3
- Deterioration of grit pump valves & piping.
- Deteriorated concrete around stairway railing
- Settling/separation of sidewalks & Stoops
- Age & Reliability of Roof, HVAC, and Electrical
- Damaged and missing brick
- *Electrical Seal-offs and NFPA 820 Code*

- High Priority
 - Replace concrete around stairway railing and replace sidewalks & stoops.
 - Replace roof system *and upgrade HVAC System in grit part of building.*
 - Repair brick and roof access ladder.
 - Upgrade electrical in grit part of building
 - *Check impact of improvements on code issues.*
- Medium Priority
 - Replace Blower #1 and #3
 - Rehab piping and replace valves.
 - Repair concrete floor at overhead door of Screen Room.

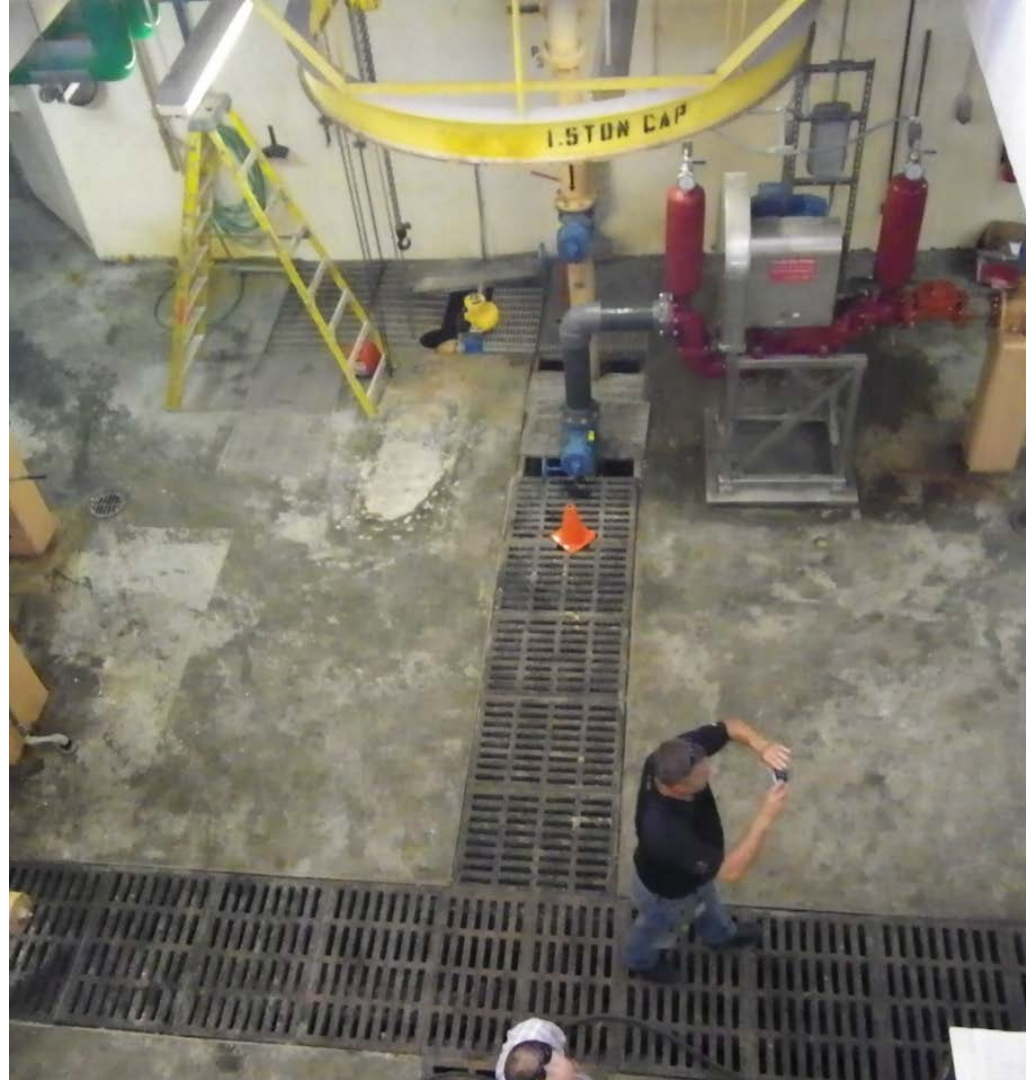
- Conduits, electrical and utility boxes are showing signs of deterioration.
- Lacking heat at times due to competing heat requirements on hot water system.
- *Condensation issue in building.*

- High Priority
 - Upgrade Electrical
- Medium Priority
 - Evaluate capacity of hot water heating system.
 - *Evaluate supplemental heating source – possibly natural gas.*

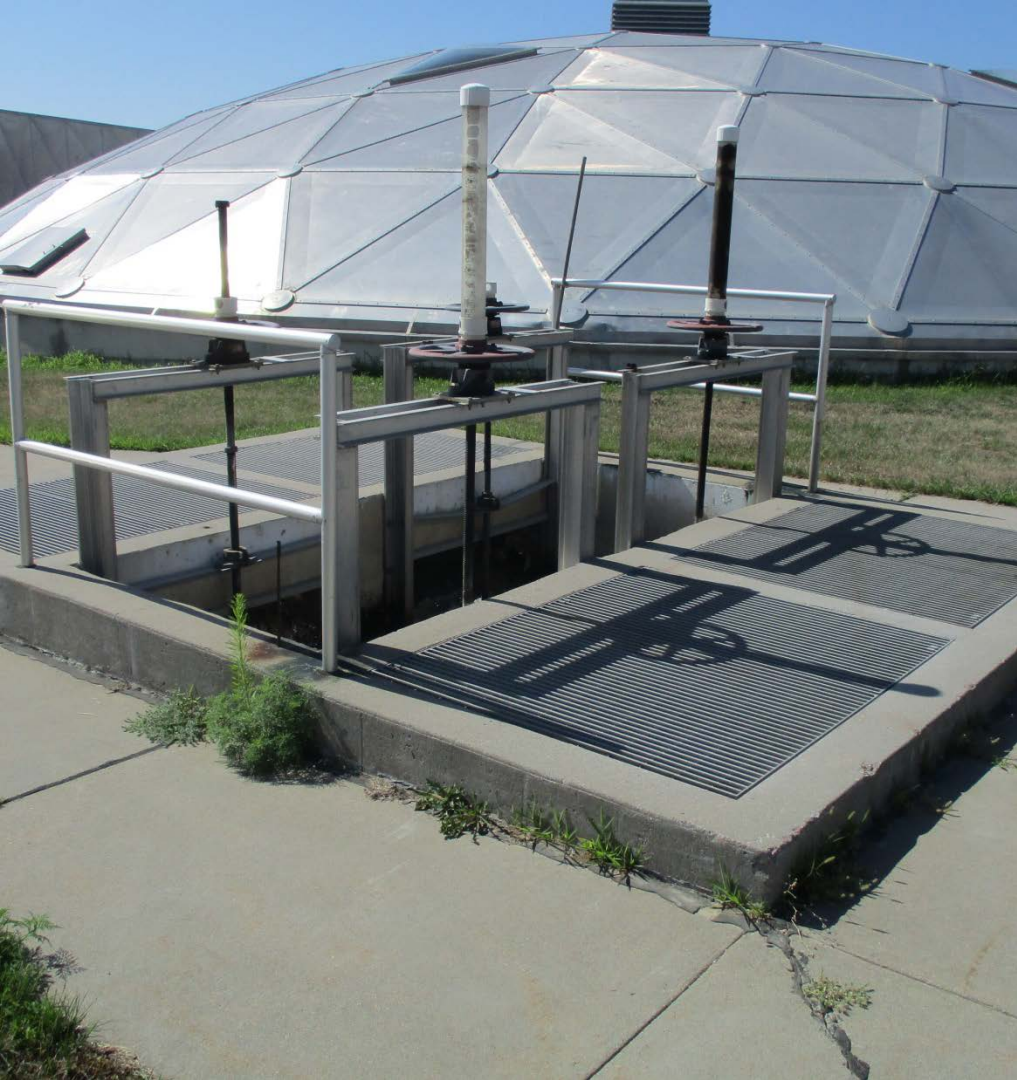
PRIMARY CLARIFIERS (5)

- Cracks/deterioration of concrete surfaces.
- Age/wear and reliability of mechanisms.
- Worn seals around observation windows of catwalks.
- Corrosion and operation of telescoping and drain valves.
- Corrosion on electrical conduit and boxes.
- Missing down-leads on lighting protection system.
- Slide gates in Splitter MH #3 difficult to operate.

- High Priority
 - Replace window systems on the catwalks.
 - Repair the lightning protection system.
 - *Replace all the conduit and associated electrical equipment between Sludge Pumping and the access platforms.*
- Medium Priority
 - Replace the clarifier mechanism drives *and provide a spare drive* .
 - Evaluate replacement or rehab of sludge collection equipment.
 - If still used, replace the scum telescoping valves. Replace the drain valves
 - Replace the slide gates in Splitter MH#3.
 - Restore interior & exterior concrete surfaces.
 - Review NFPA 820 to see if the Odor Control is compliant with the current NFPA standards.

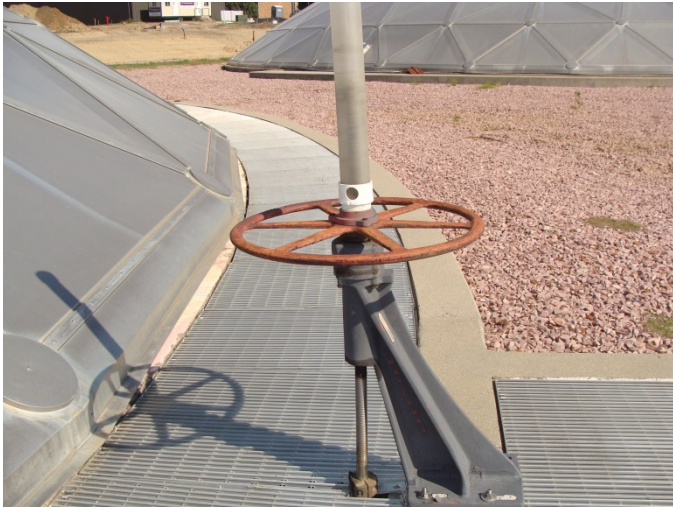
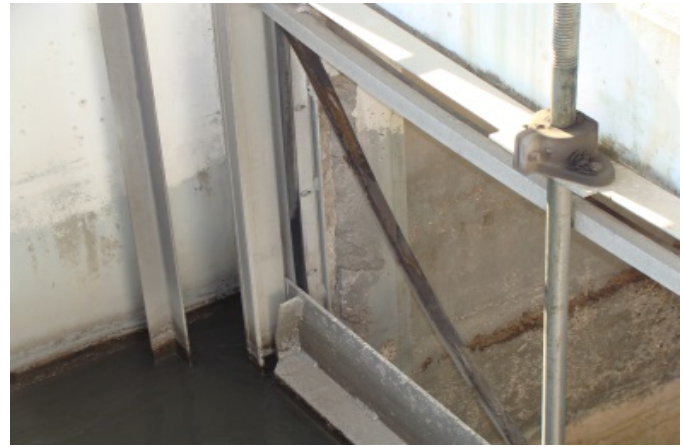
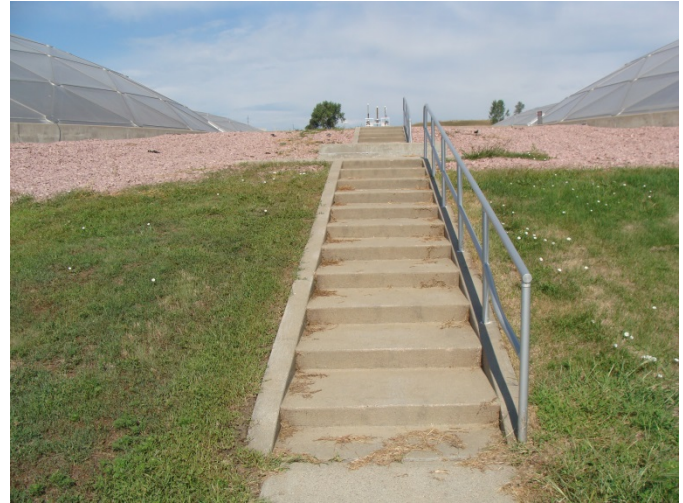
FIRST STAGE TRICKLING FILTERS (6)

- Effluent gates of TFs – unable to operate
- Slide gates of Splitter MH#4 - difficult to operate
- Steps at MH#8 – difficult to clear snow

- Medium Priority
 - Replace Slide Gates in Splitter MH#4 Slide Gates.
 - Evaluate grading options or sidewalk configurations to eliminate sidewalk steps.
 - *Replace effluent gates on the 1st Stage TFs.*

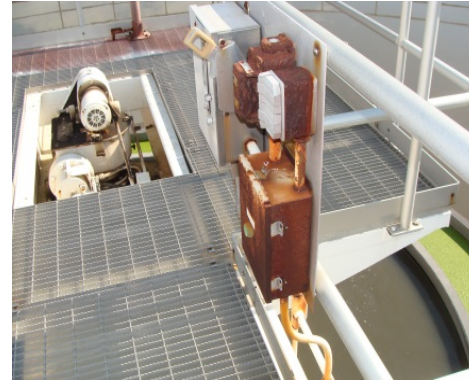
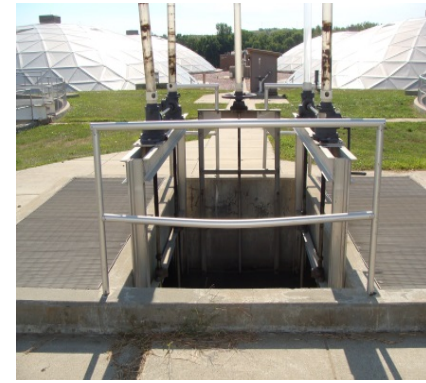
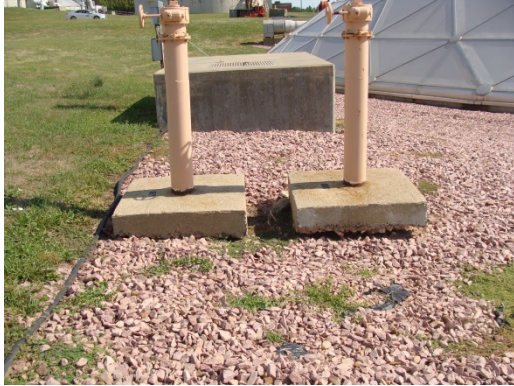
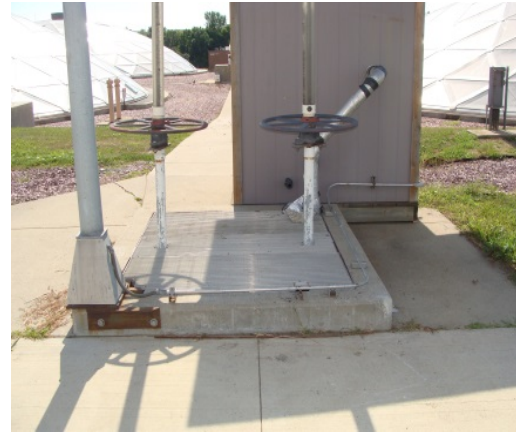
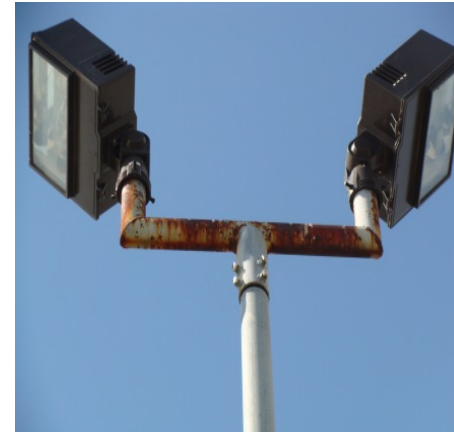
FIRST STAGE INTERMEDIATE CLARIFIERS (7)

- Mechanism drives – age & reliability.
- Ground eroded under humus drain valve.
- Discoloration of exterior concrete walls.
- Corrosion of electrical boxes and conduit.
- Slide gates in Splitter MH#5 and MH #9 are difficult to operate.

- *High Priority*
 - *Replace electrical boxes and conduit.*
- Medium Priority
 - Replace mechanism drives
 - Fill and grade under valve supports
 - Replace slide gates in Splitter MH#5 and MH#9.

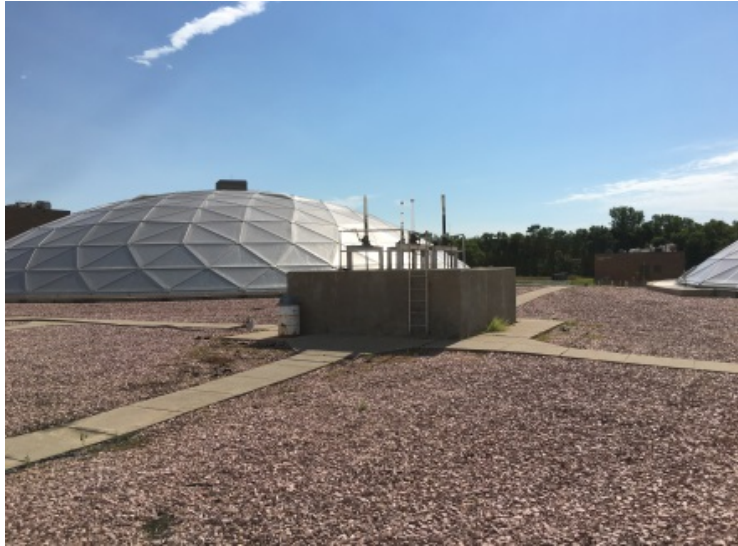
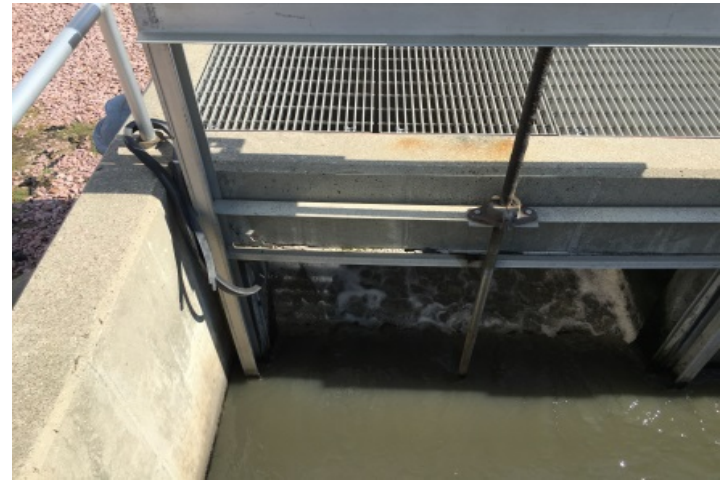
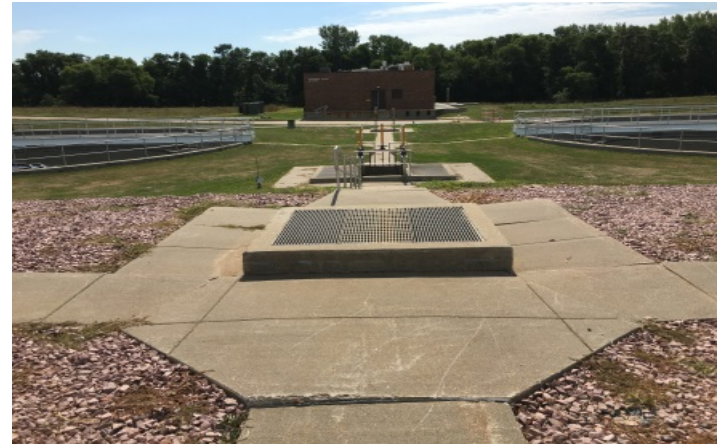
SECOND STAGE TRICKLING FILTER (8)

- Effluent valves are difficult to operate
- Slide gates in Splitter MH#6 are difficult to operate.
- Sidewalks settling around MH#10.

- Medium Priority
 - Replace the slide gates in Splitter MH #6.
 - Replace sidewalk around MH#10.
 - *Replace the effluent valves on the 2nd Stage TFs.*

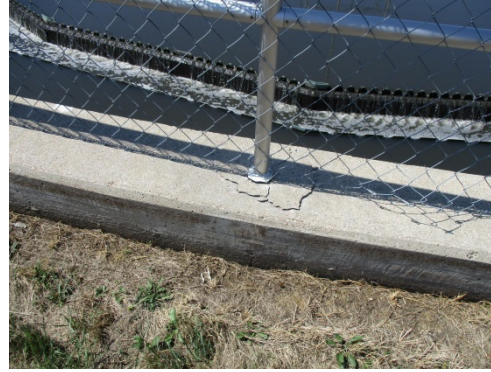
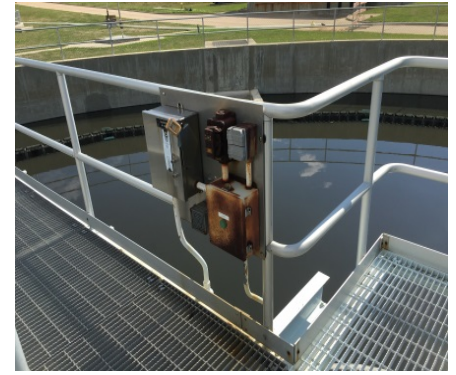
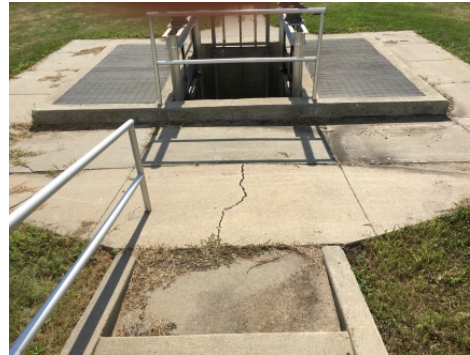
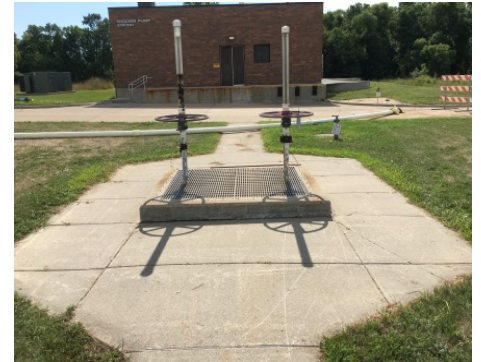
SECOND STAGE INTERMEDIATE CLARIFIER (9)

- Mechanism drives – age & reliability.
- Discoloration of exterior concrete walls.
- Deterioration of concrete at guardrail posts
- Corrosion of electrical boxes and conduit
- Slide gates in Splitter MH#7 and MH #11 are difficult to operate
- Concrete cracking and settling around Splitter MH#7 and MH#11.
- Steps at Splitter MH#7 make clearing snow difficult.

- *High Priority*
 - *Repair concrete at guardrail posts*
 - *Replace electrical boxes and conduit.*
- Medium Priority
 - Replace mechanism drives
 - Replace slide gates in Splitter MH#7 and MH#11
 - Replace cracked & settled sidewalks
 - Evaluate grading options or sidewalk configurations to eliminate sidewalk steps.

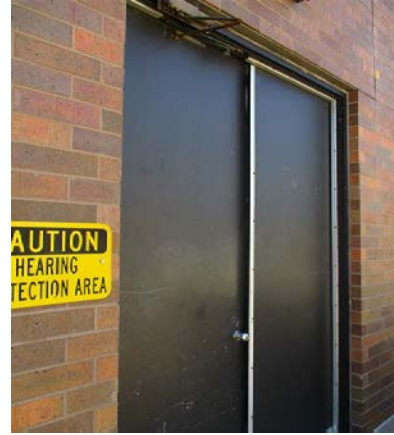
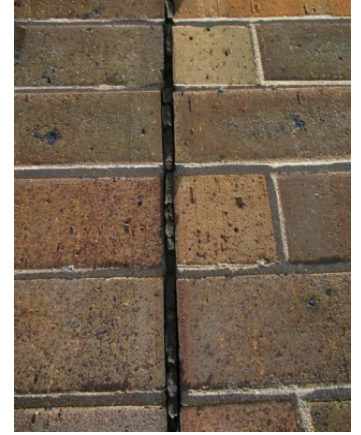
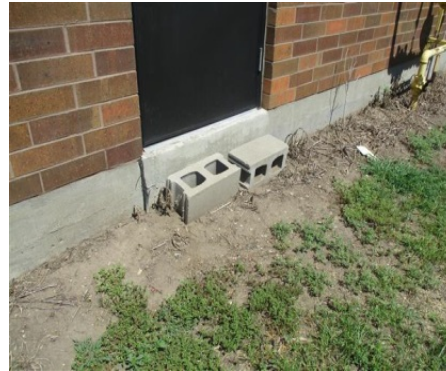
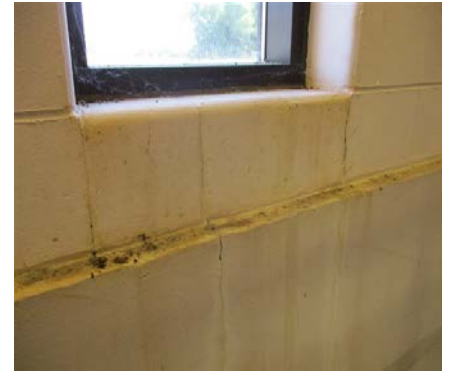
PROCESS PUMPING (10)

- Recirculation pumps are original.
- Humus piping is thin from wear.
- Exterior north doors do not shut properly.
- Exterior/interior masonry sealant is deteriorated
- Rear exit is missing stoop and stairs.
- Interior paint is deteriorated due to water intrusion around windows.
- Leaking *from wetwell* into drywell.
- Corrosion on electrical j-box near entrance.

- *High Priority*

- *Repair leaking from wetwell to drywell.*
- *Replace electrical conduit and junction box near entrance.*

- Replace humus line – glass lined pipe
- Repair or replace doors on north side.
- Replace sealant and backer rod in masonry joints
- Tuck point masonry.
- Install landing and stairs at the rear exit for safety reasons.
- Replace sealant and backer rod on all windows.

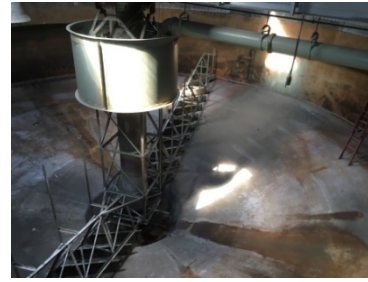
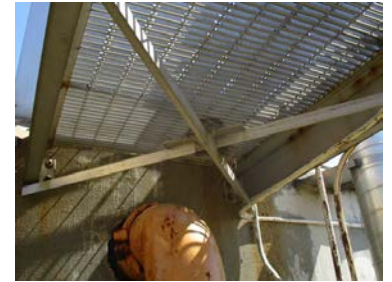
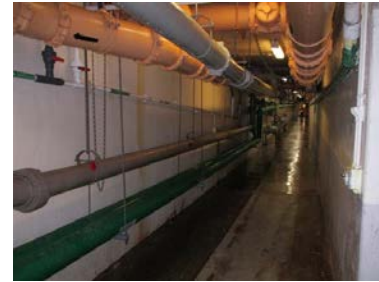
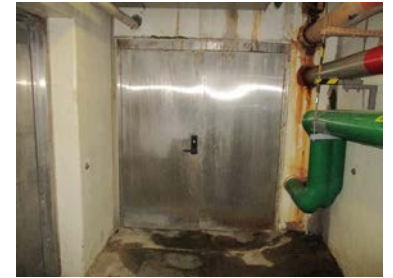
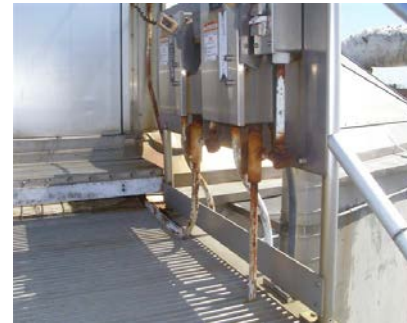
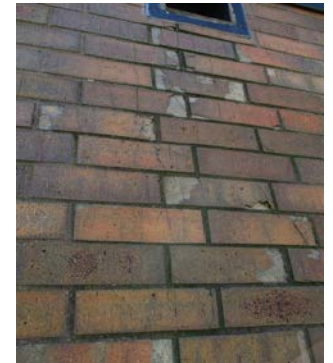
GRAVITY THICKENERS/TUNNELS (11)

- Metal deterioration on thickener mechanism.
- Pitting/deterioration of thickener tank walls.
- Exposed aggregate on exterior thickener walls.
- Stair and landing on Thickener #2 sways
- Deterioration/corrosion of piping in tunnel.
- Tunnel floor is completely wet.
- Severe water damage at south end of tunnel.
- Roofing and scupper failing at Exit Stair Tower.
- Significant corrosion of conduits at the thickener platform.
- Corrosion on electrical conduit in Tunnel.

- High Priority
 - Replace thickener mechanisms.
 - Repair stairs and landing at Thickener #2
 - Install drainage system to divert water away from tunnel walls.
 - At exit stair tower of tunnel replace brick and tuck point.
 - Replace roof and install new scupper/flashings at exit stair tower.
 - Replace/repair electrical conduit at thickener platform and in Tunnel.
 - *Restore interior/exterior concrete surfaces of thickeners.*
 - *Rehab supports for odor control blowers.*
 - *Sandblast and recoat piping.*

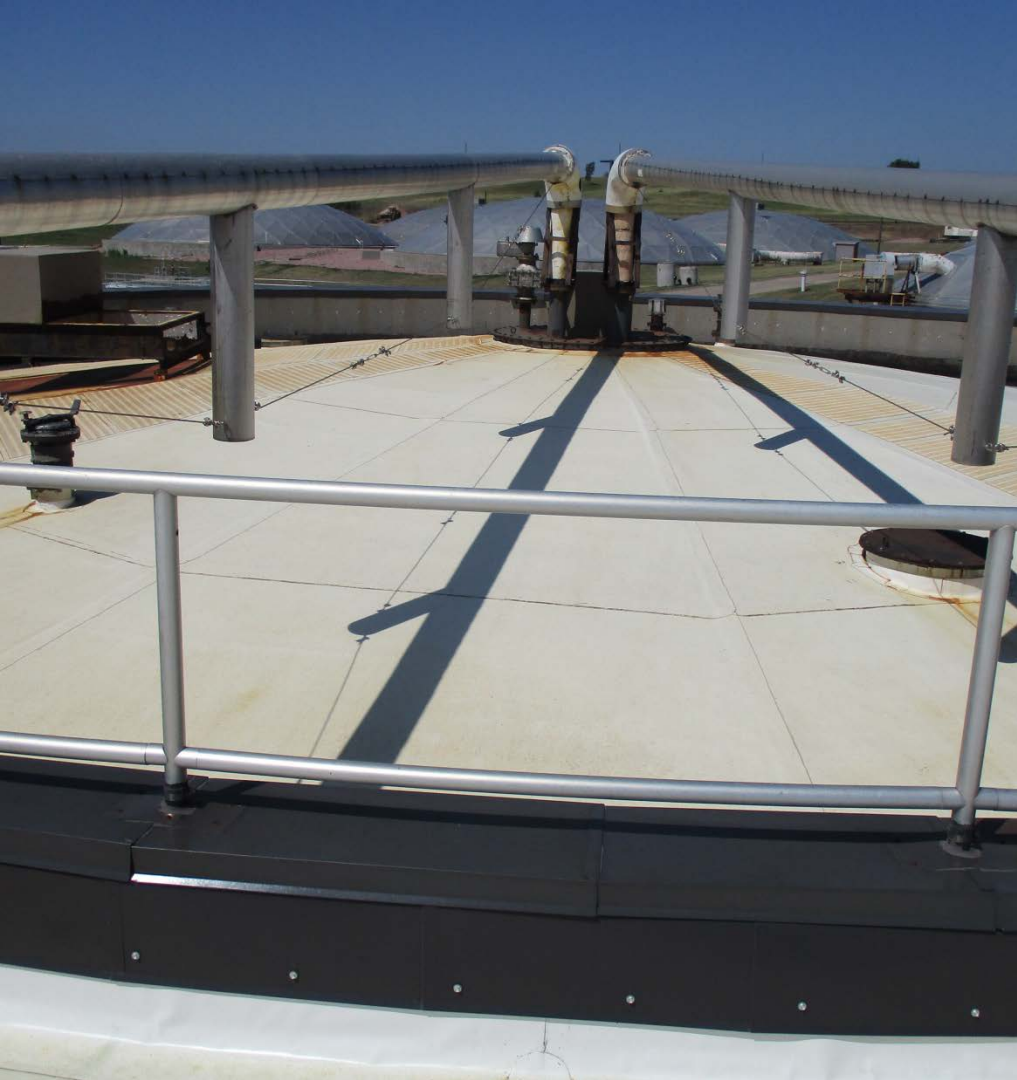
DIGESTER BUILDING (12)

- Upgrades to digester facility are being done current CIP.

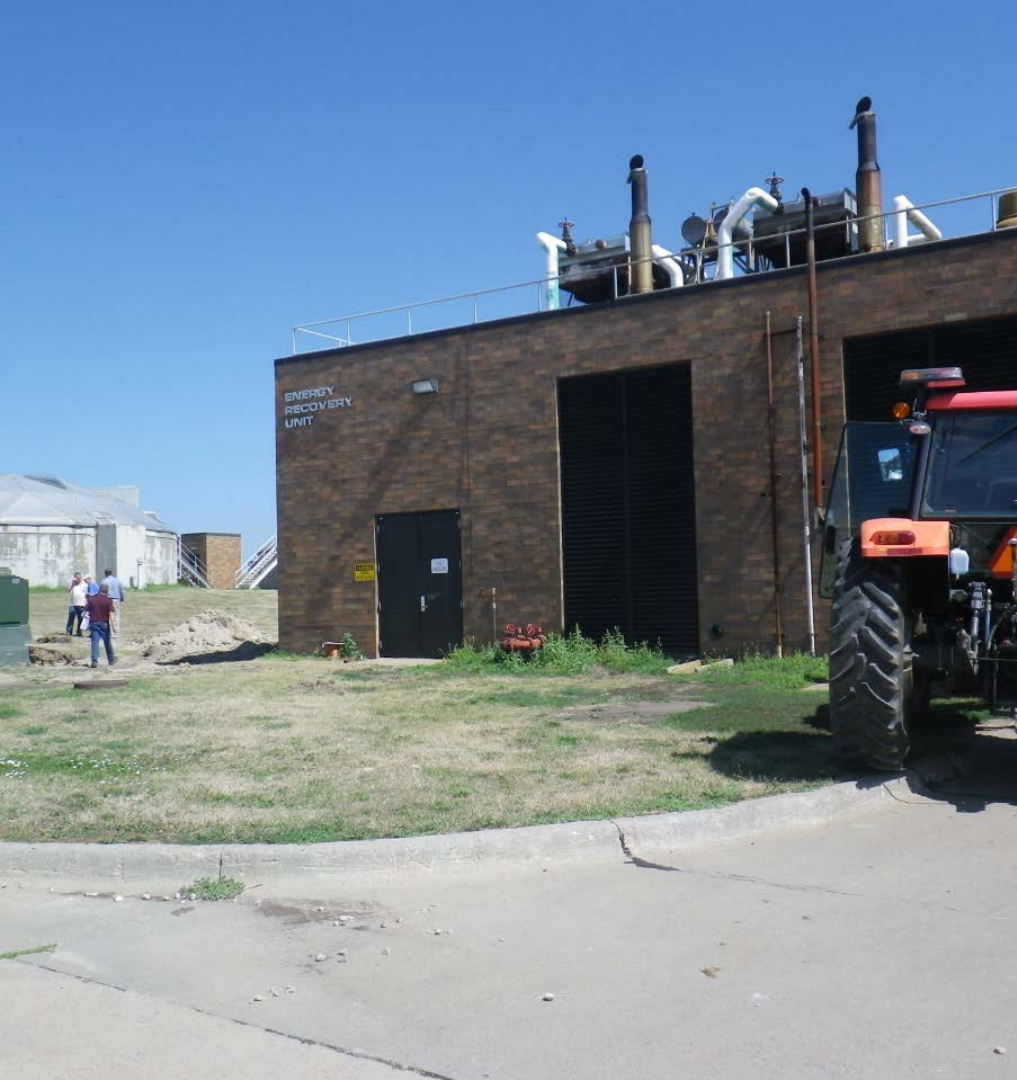
ENERGY RECOVERY (13)

- Boilers and Boiler Pumps are outdated.
- Room has a common wall with the digester, which is an NFPA 820 issue.
- Roof system is being replace under current CIP.
- Roof exhaust fans #3 & #4 are original.
- *Issues with operation, function, and size of door on south side of building.*

- High Priority
 - Replace boilers and boiler pumps.
 - Replace older roof exhaust fans.
 - *Evaluate replacement of south door with new roll-up door.*

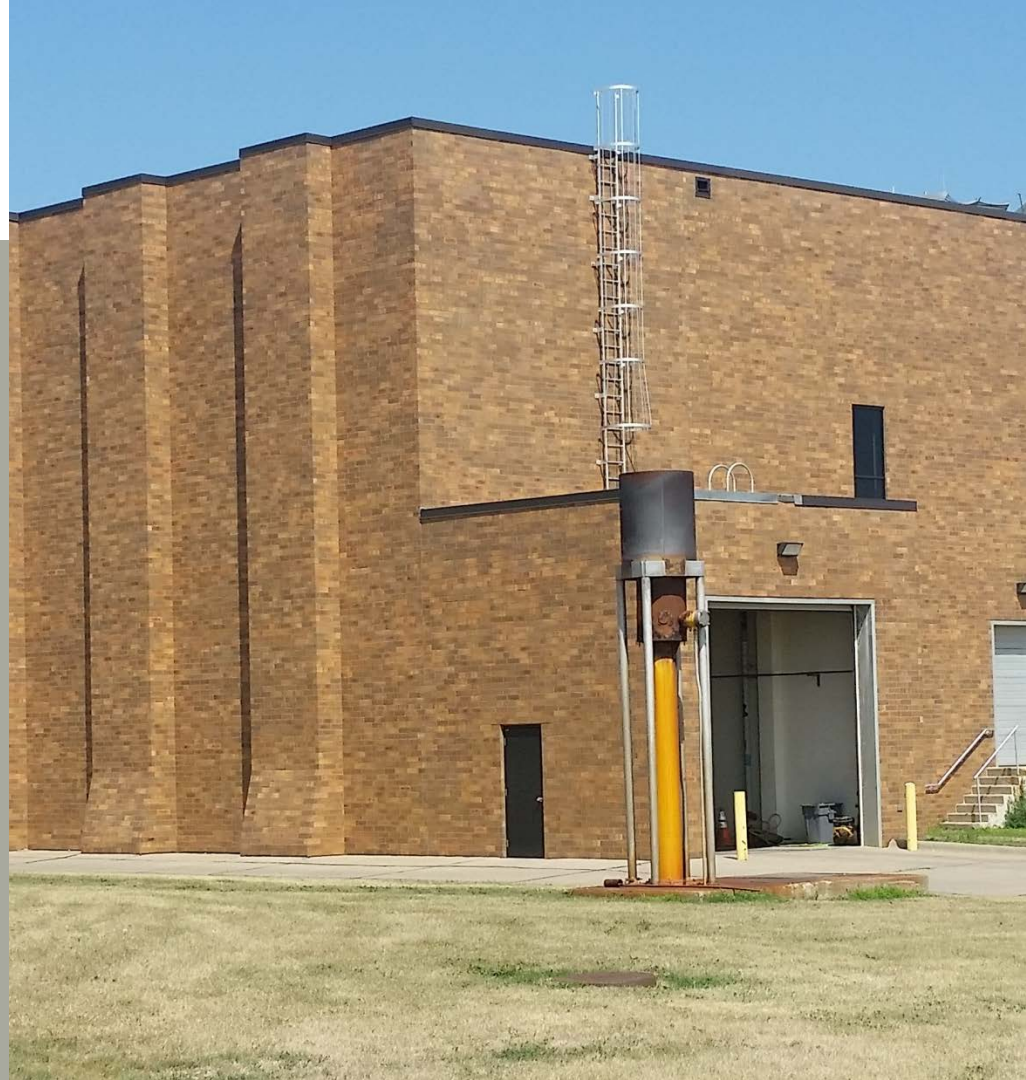
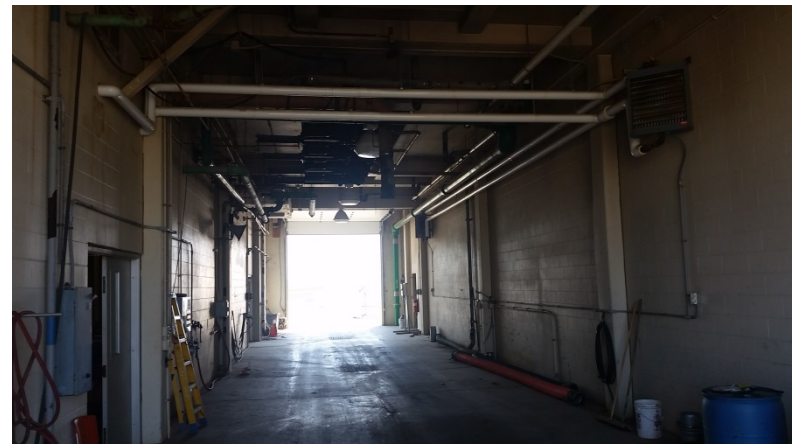
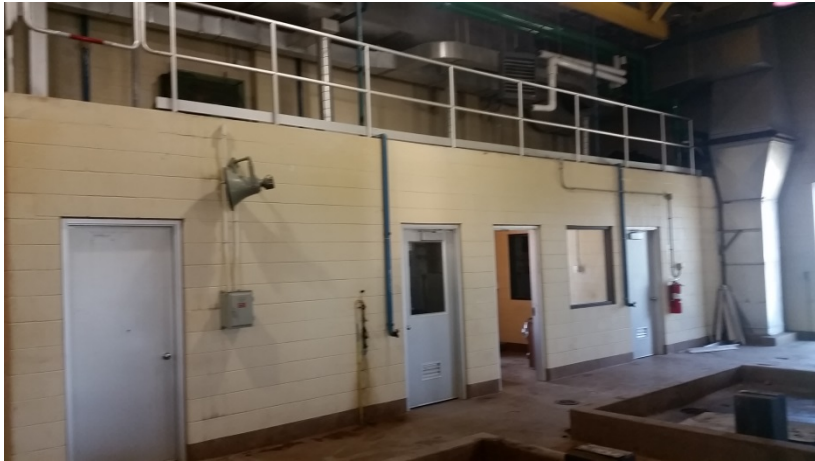
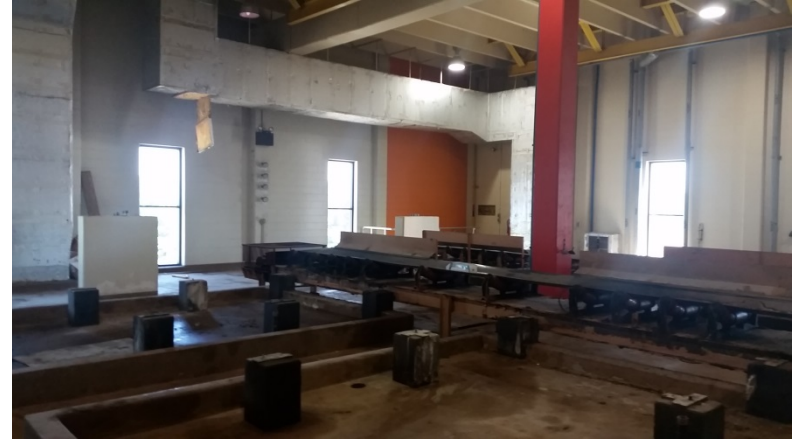
SOLIDS DEWATERING (14)

- Roof is original – concern due to age/condition & Reliability.
- HVAC is outdated – concerns due to age & reliability.
- Switchgear damaged by water (roof leak).

- Identify what needs to be included in the future dewatering project.
- *Make sure updates include replacement of existing MCC.*
- *Improvements will be tied to FOG Project.*

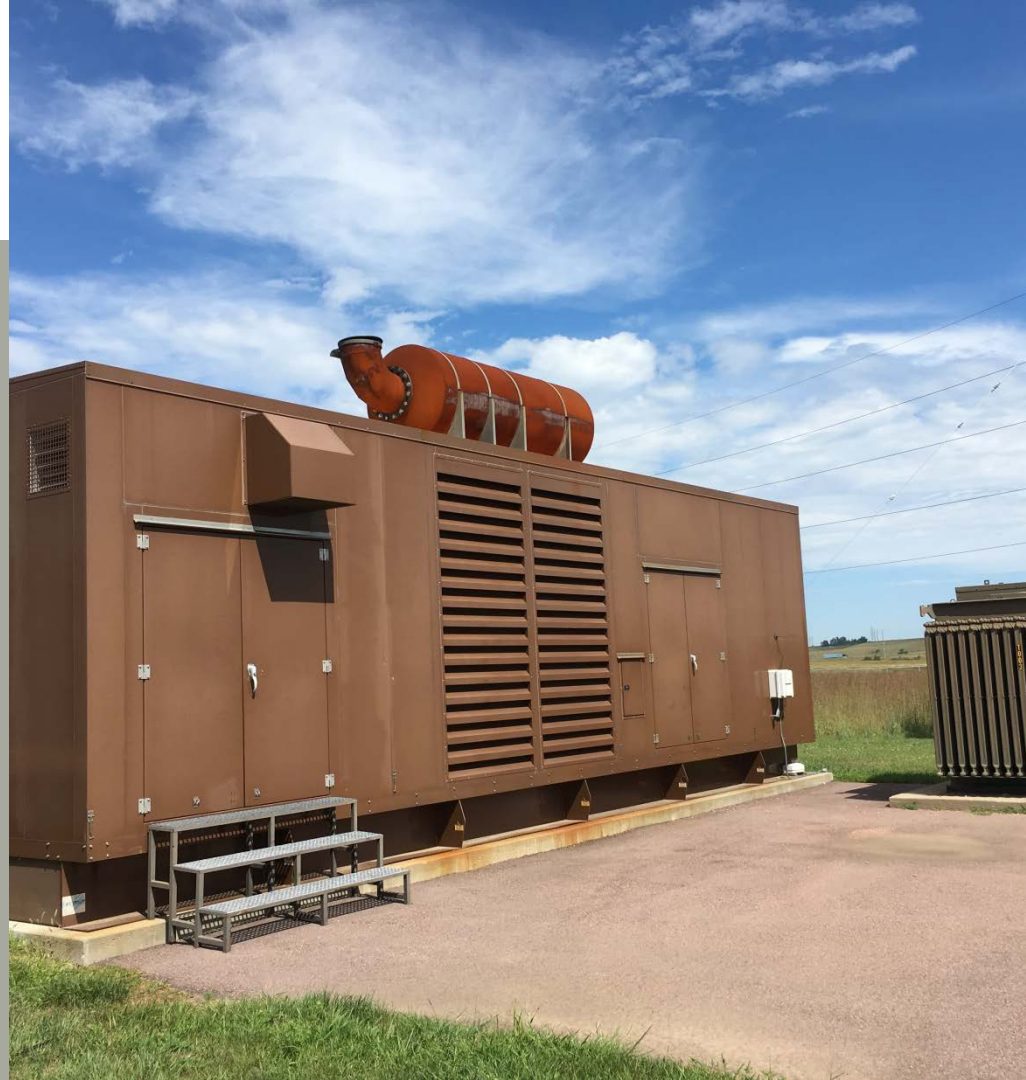
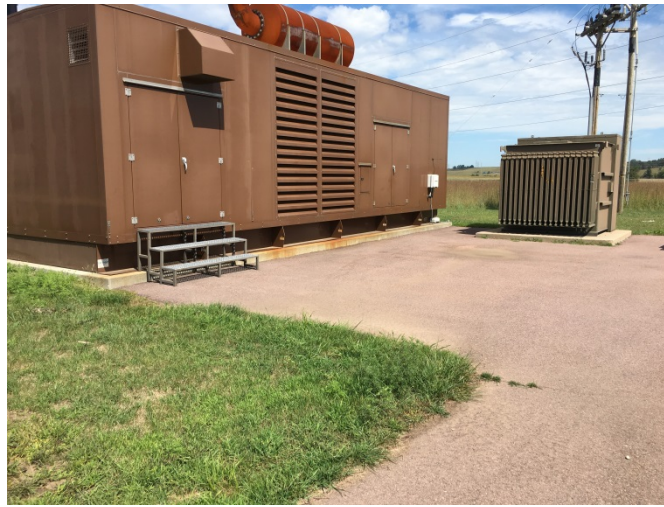
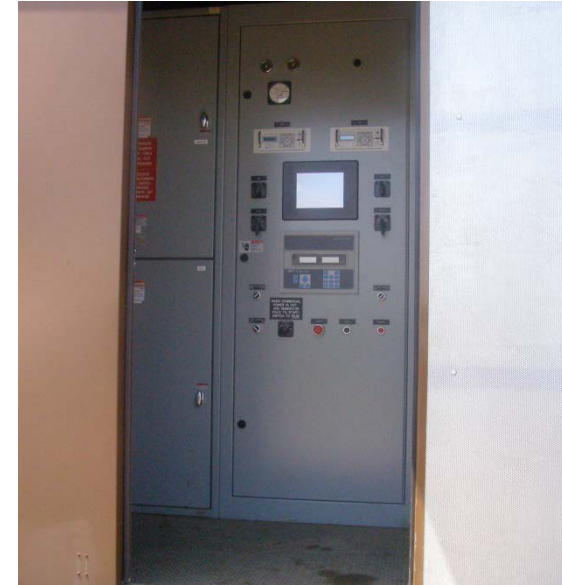
ENGINE GENERATOR AND UTILITY SERVICE ENTRANCE (15)

- Muffler/exhaust is rusty.
- Rust on the enclosure.
- Rust/discoloration of concrete support slab.
- Step up to enclosure has no hand rail or platform creating and unsafe condition.
- Deteriorate pavement – low spots, worn surface.
- Generator room extremely hot.
- *Generator redlines if two aeration blowers are operating.*

- Medium Priority
 - Install utility bypass for service reliability.
 - EPA emissions upgrades required to run the generator to feed back to the utility.
 - Replace pavement.
 - Remove rust spots from enclosure.
 - *Verify Generator meets future capacity requirements.*

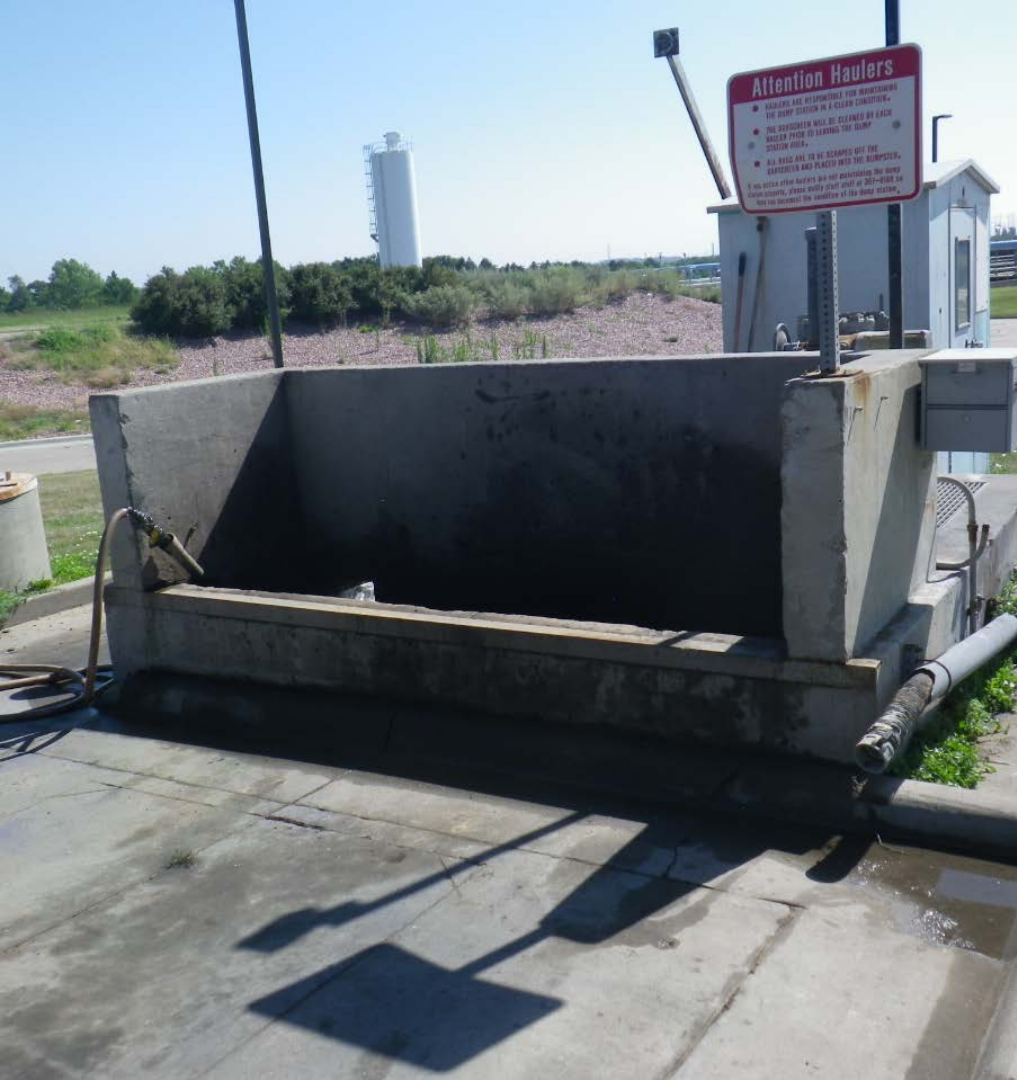
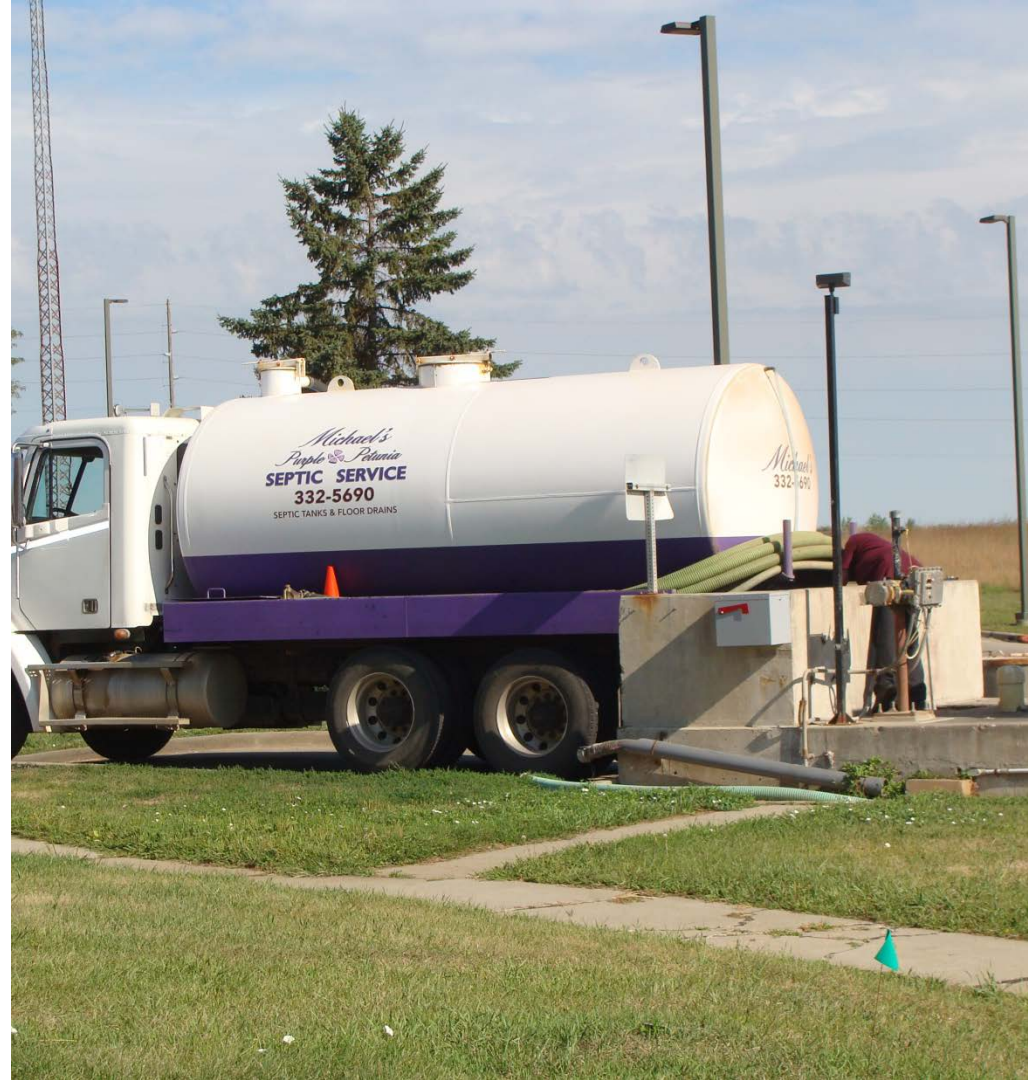
DUMPING STATION (16)

- *Dumping station at WRF to be maintained for backup.*

- *Medium Priority*
 - *Continue to maintain dumping station.*
