Appendices

Sioux Falls Wastewater Treatment and Collection System Master Plan

Existing Facilities Condition Assessment Technical Memorandum

Appendix 3.C – Existing Facilities Condition Assessment Lift Station Review Power Point Presentation

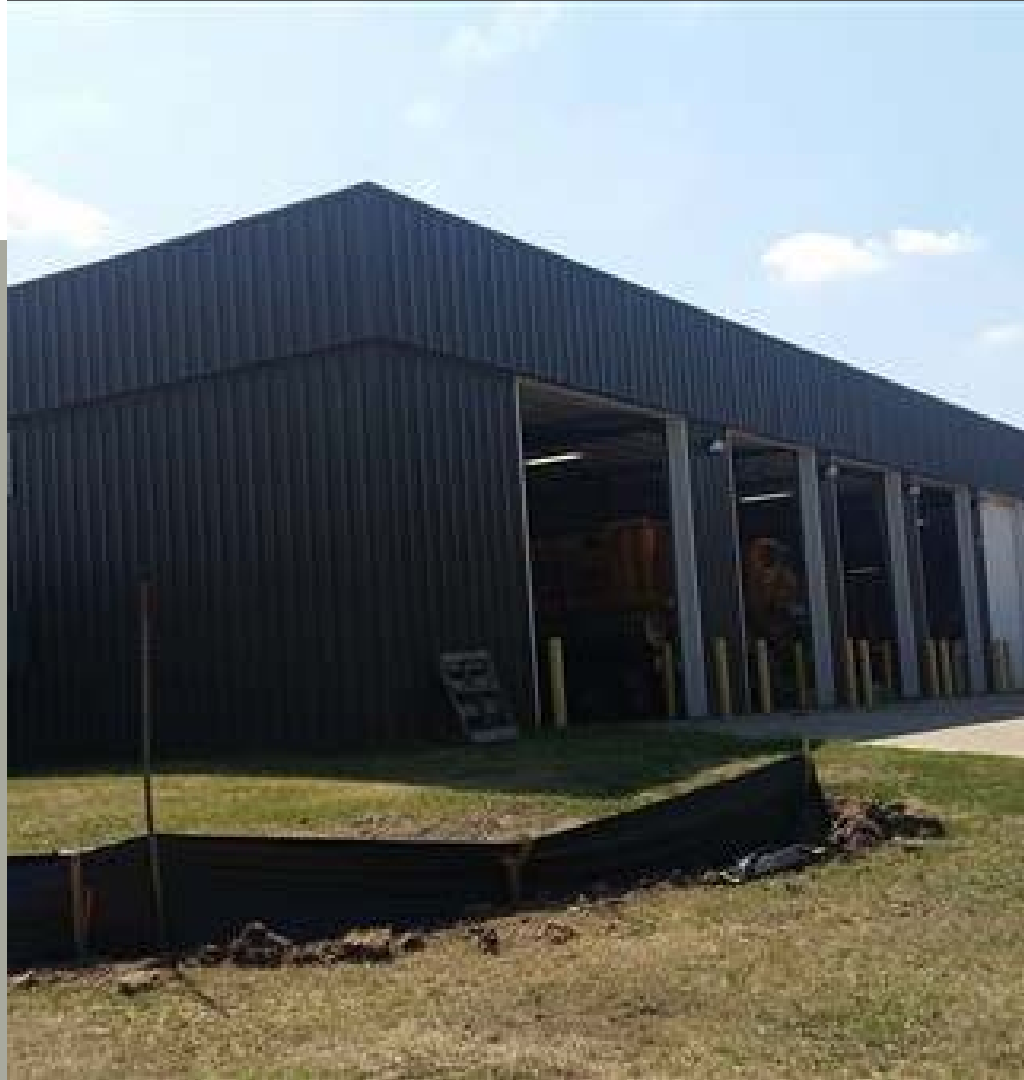
EQUIPMENT STORAGE BUILDING (17)

- Original metal roof installed in 1995.
- Limited office space *for 21 persons*.
- *There are no shower and locker room facilities for personnel.*
- HVAC has old tube heaters that soot.

- High Priority
 - Update HVAC system.
 - Expand office area into SW corner of Building *and add shower and locker room facilities.*
- Medium Priority
 - *Address when replacement of the metal roof should be replaced.*

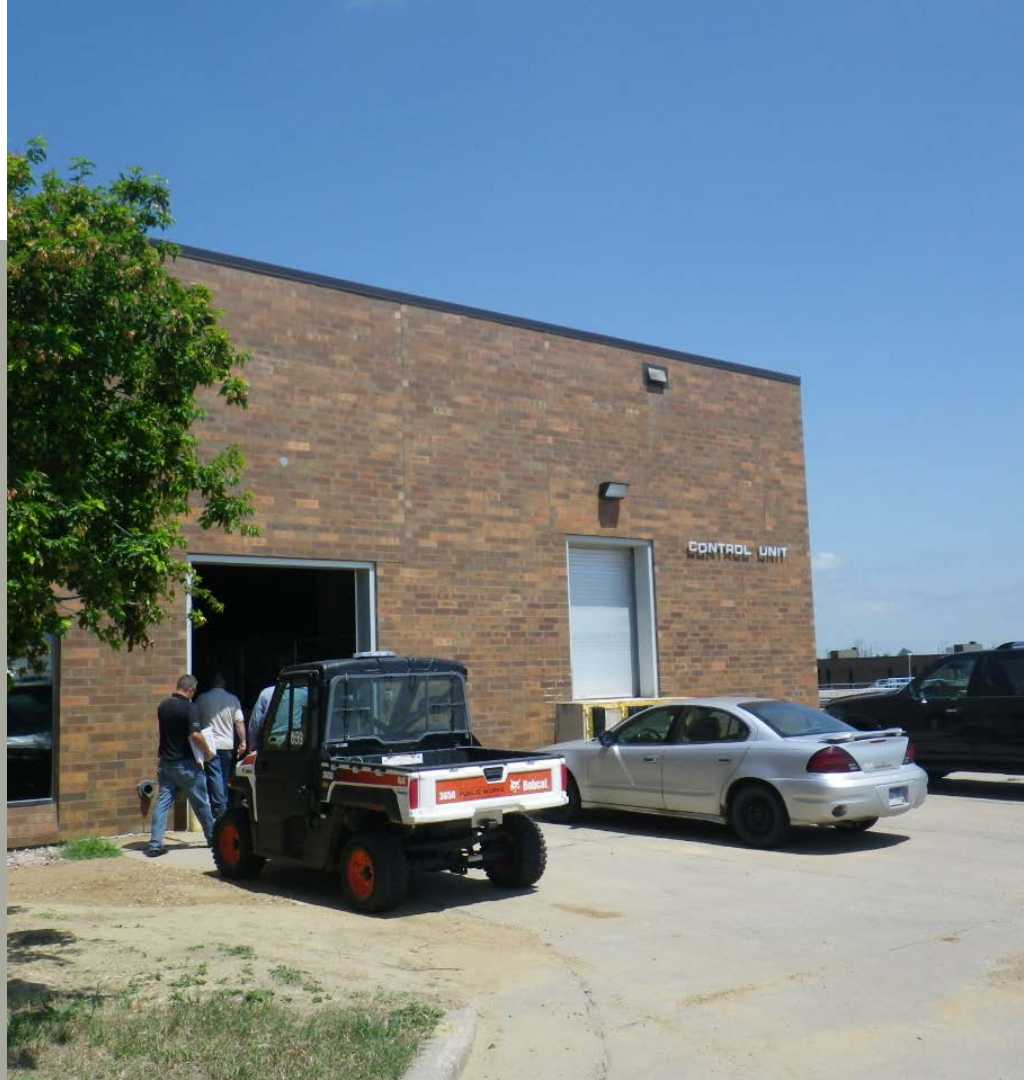
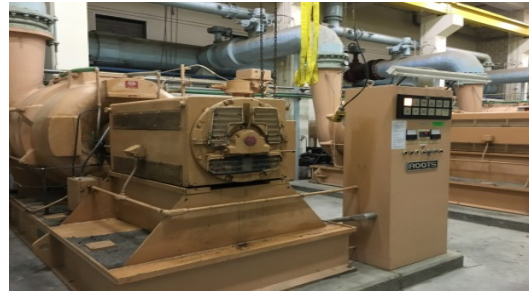
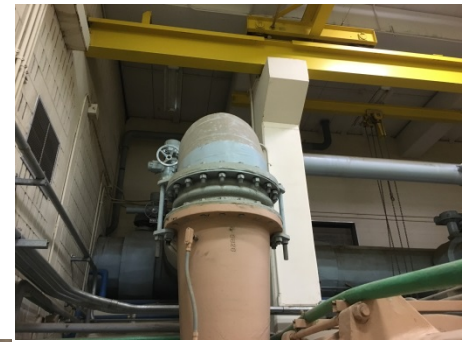
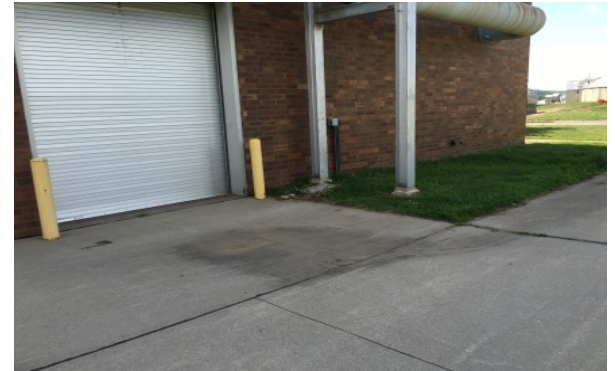
CONTROL UNIT (18)

- Water ponds in NE area of bldg and runs into blower room.
- Blowers use a large amount of energy.
- Deterioration of ext. bldg sealant and backer rod .
- Old and outdated control system.
- HVAC is old and unreliable.
- Original pad mounted switches and transformers show deterioration of enclosures.
- Location of switchgear is a potential hazard at overhead door.

- Re-grade NW side of bldg to reduce water ponding – possibly install intake and tie into storm sewer.
- *Replace /upgrade entire HVAC system.*
- *Replace and relocate switchgear – Group with new blowers and fine bubble aeration system.*

- Replace blowers with more efficient blowers.
- Remodel interior for more efficient use of space.
- Tuck point brick.
- Replace all exterior masonry sealant and backer rod.
- Update control system.

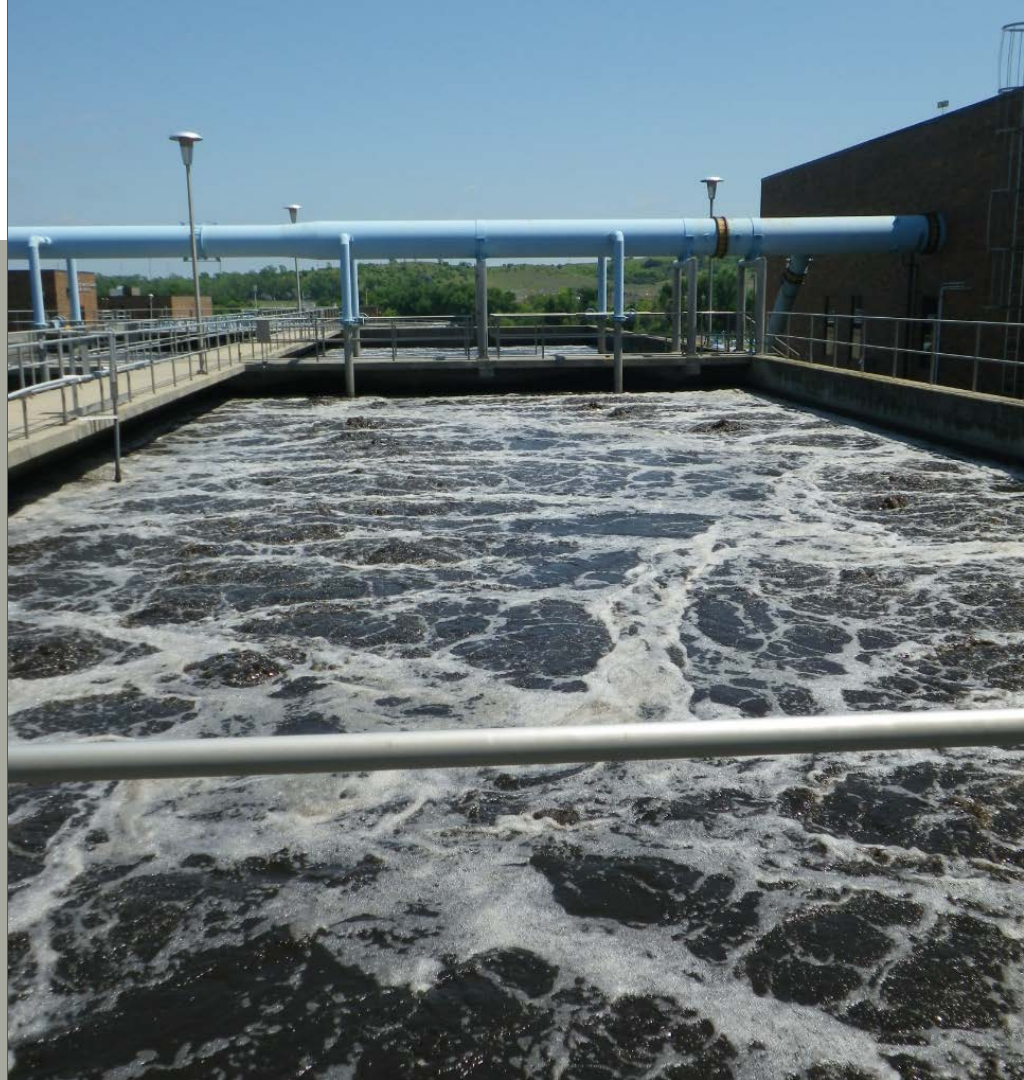
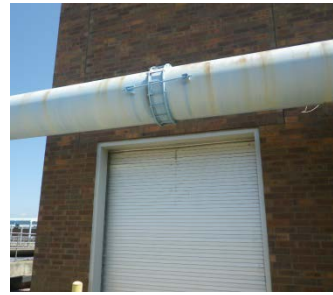
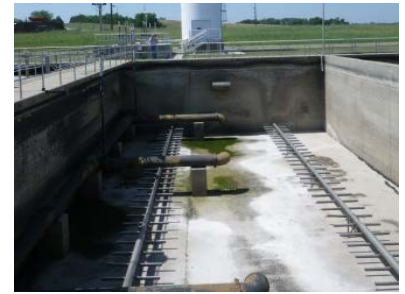
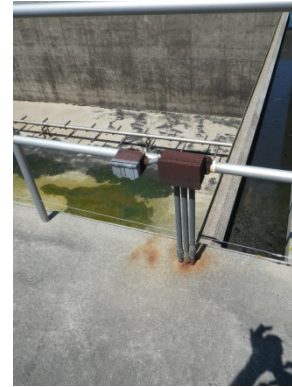
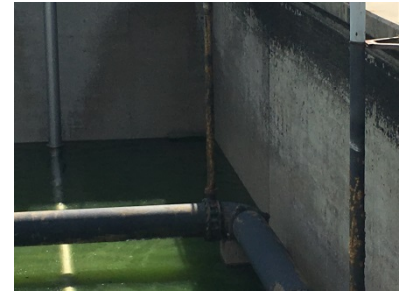
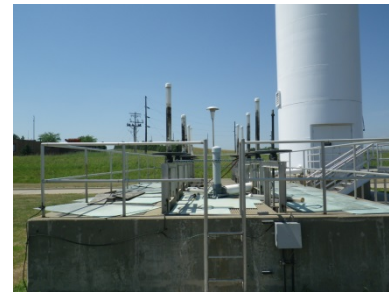
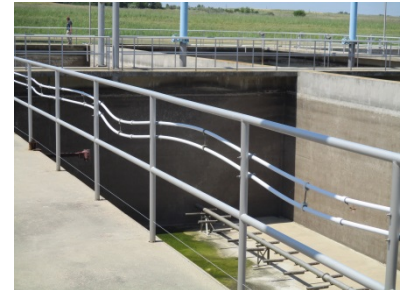
AERATION BASIN (18C)

- Water splashes out of Splitter MH#1 during high flows.
- Mineral (calcium) buildup on grating of MH#1.
- Corrosion on air header piping and leaking at couplings.
- Basin air piping and valves leak.
- Unable to drain basins without sump pump.
- Minor cracking of concrete on the basin floors and walls.
- PVC electrical conduit is expanding and contracting due to weather.
- Corrosion on the electrical j-boxes and supports.

- *High Priority*
 - *Replace air valves and actuators.*
 - *Replace electrical j-boxes, support systems and PVC conduit.*
- Medium Priority
 - Evaluate raising walls of Splitter MH#1 and MH#1.
 - Evaluate updating the aeration system with fine bubble aeration.
 - Repair concrete basin floors and grout slope for better draining.
 - Repair concrete wall surfaces.

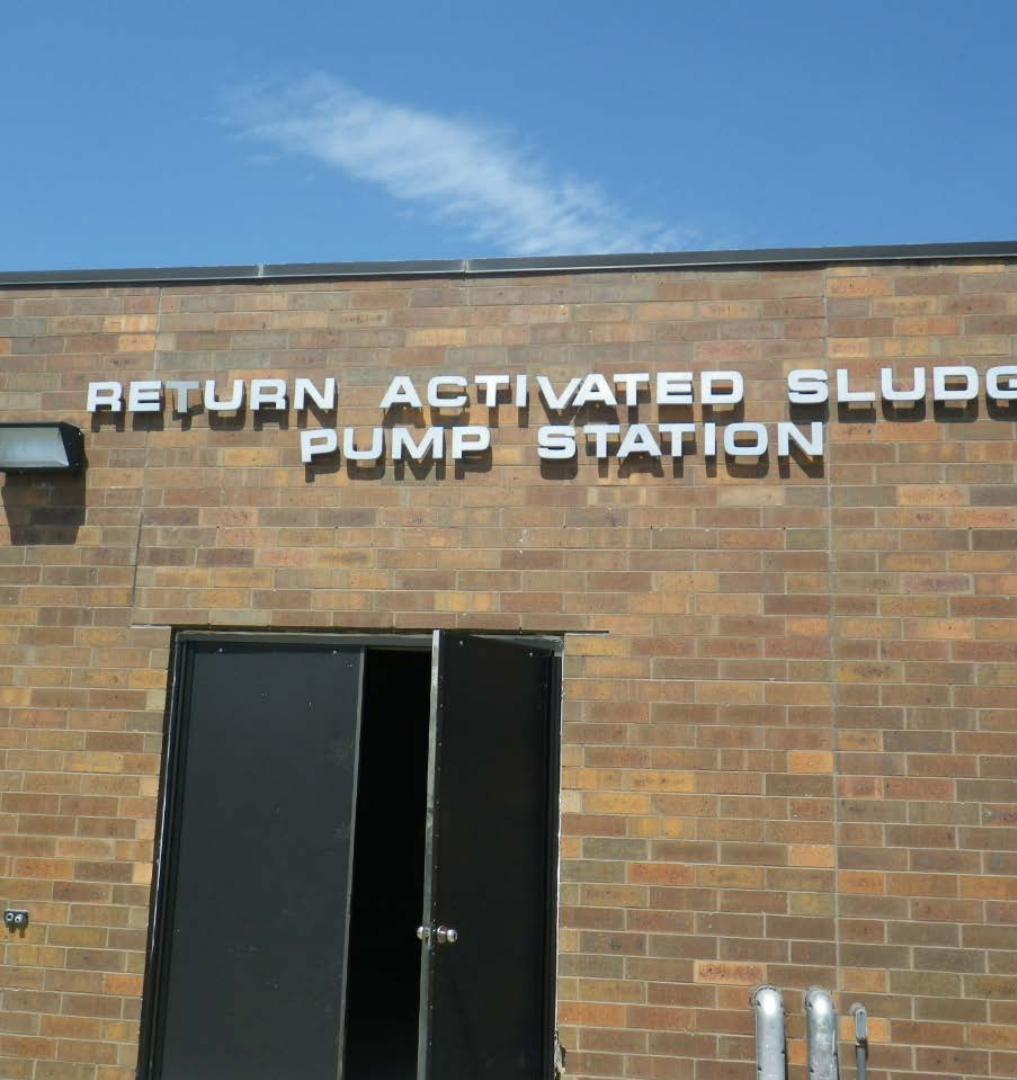
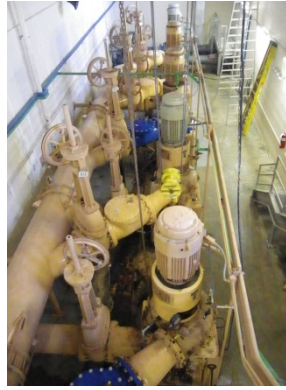
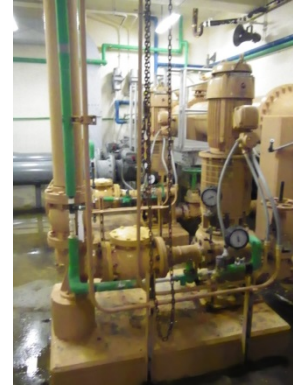
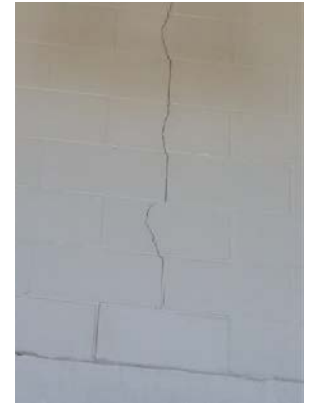
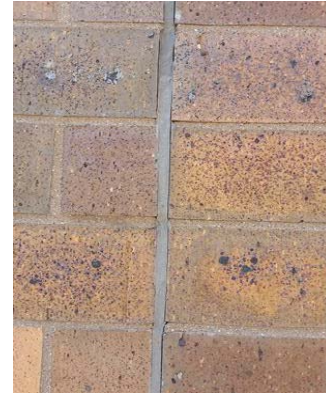
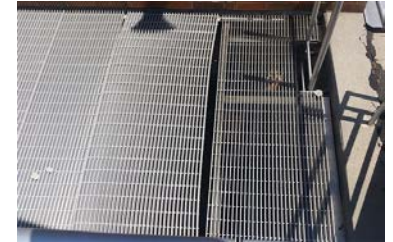
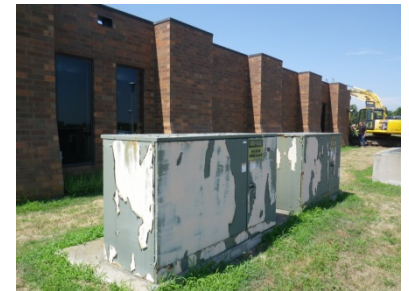
RAS BUILDING (19)

- RAS and WAS pumps are original.
- Slight grinding/vibration in RAS Pump #3
- Wet Well has limited capacity.
- Building showing signs of settlement.
- Roof is original.
- Grating on north side of building is bent.
- Moderate cracks on interior masonry.
- Exterior sealant is deteriorated.
- Water intrusion into drywell
- HVAC is original
- Electrical Transformers are in bad condition.

- High Priority
 - Upgrade electrical.
 - Determine what needs to be done for nutrient removal.
 - *Replace roof system and* replace/upgrade HVAC System.
- Medium Priority
 - Check wet well capacity.
 - Replace RAS and WAS pumps.
 - Seal drywell to eliminate water intrusion.
 - Mitigate building settlement and repair exterior masonry.

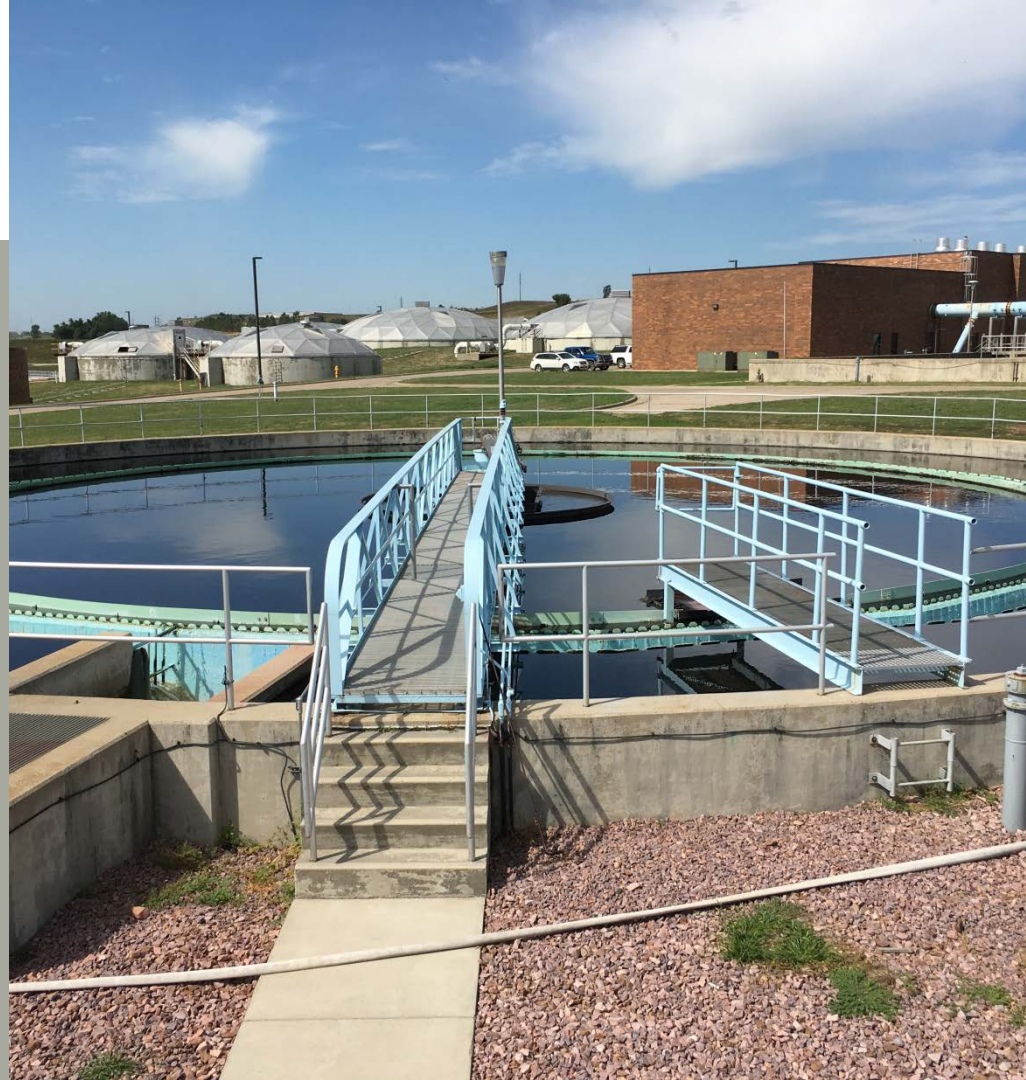
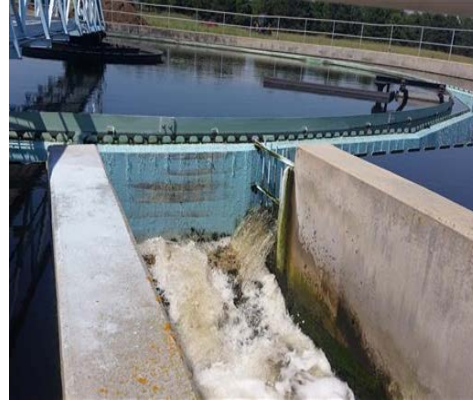
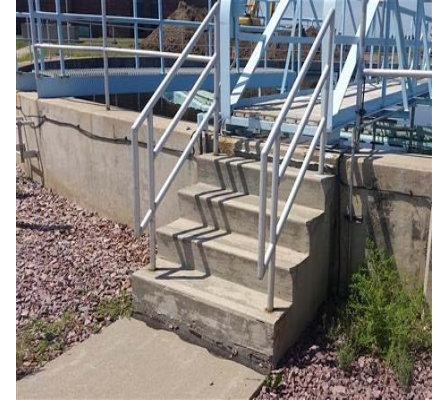
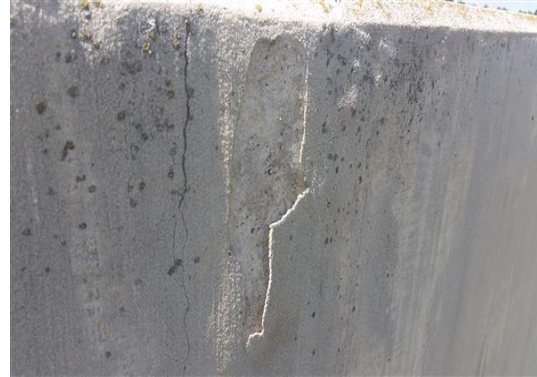
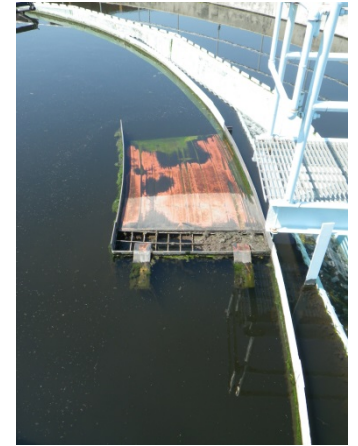
FINAL CLARIFIERS (20)

- Mechanisms old with corrosion.
- Draft tubes provide suboptimal sludge removal.
- Center well is outdated.
- **Weirs** are hard to access for cleaning.
- Past issues with floating/rising sludge.
- Concrete steps and sidewalks have settlement.
- Moderate delamination of the parge/skin coating on the concrete tanks.

- Medium Priority
 - Perform hydraulic analysis to evaluate relocation of the launders and add baffles.
 - Consider in-board weirs mounted off external walls.
 - Replace mechanism with stainless steel mechanism/components.
 - Replace draft tube mechanism with update removal system.
 - Install weir covers to control algae.
 - Repair and recoat concrete surfaces.

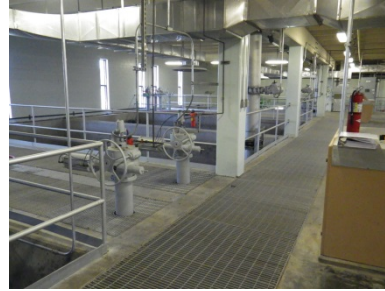
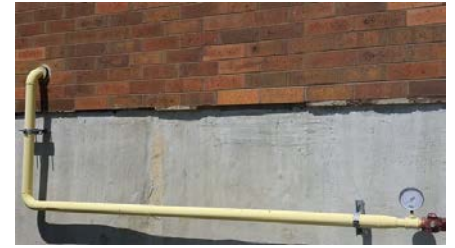
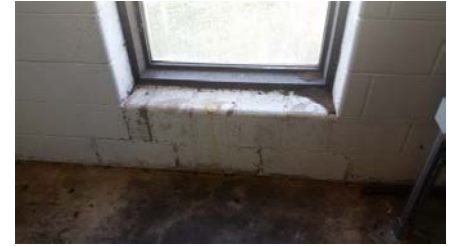
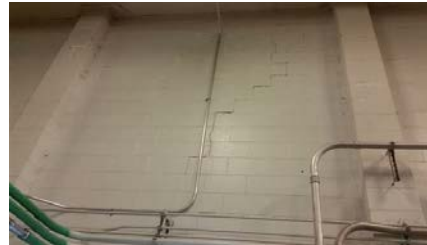
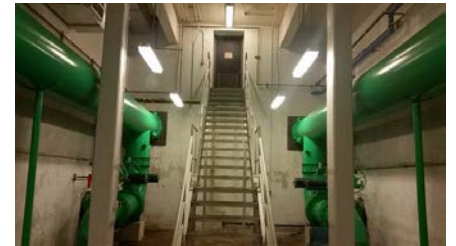
- *Issues with elevation of bypass weir.*
- Valve actuators are original.
- Deteriorating masonry grout on south side exterior concrete wall – *this has been fixed.*
- Moderate cracking on inside face of SE wall.
- Deteriorating exterior masonry sealant.
- Deteriorating paint due to condensation and water intrusion around window.
- Deteriorating wall paint finish in lower pipe gallery.
- Surface rusting of electrical equipment due to building humidity.

- High Priority
 - Update electrical conduit and wiring.
- Medium Priority
 - *Adjust bypass weirs to direct more flow to filters.*
 - Replace valve actuators.
 - Repair masonry damage and tuck point.
 - Replace sealant and backer rod on all windows.
 - Repaint walls in the lower pipe gallery.

Alternatively, this weir could be replaced with an adjustable weir gate to allow for bypass directly to the chlorine contact basins in the future.

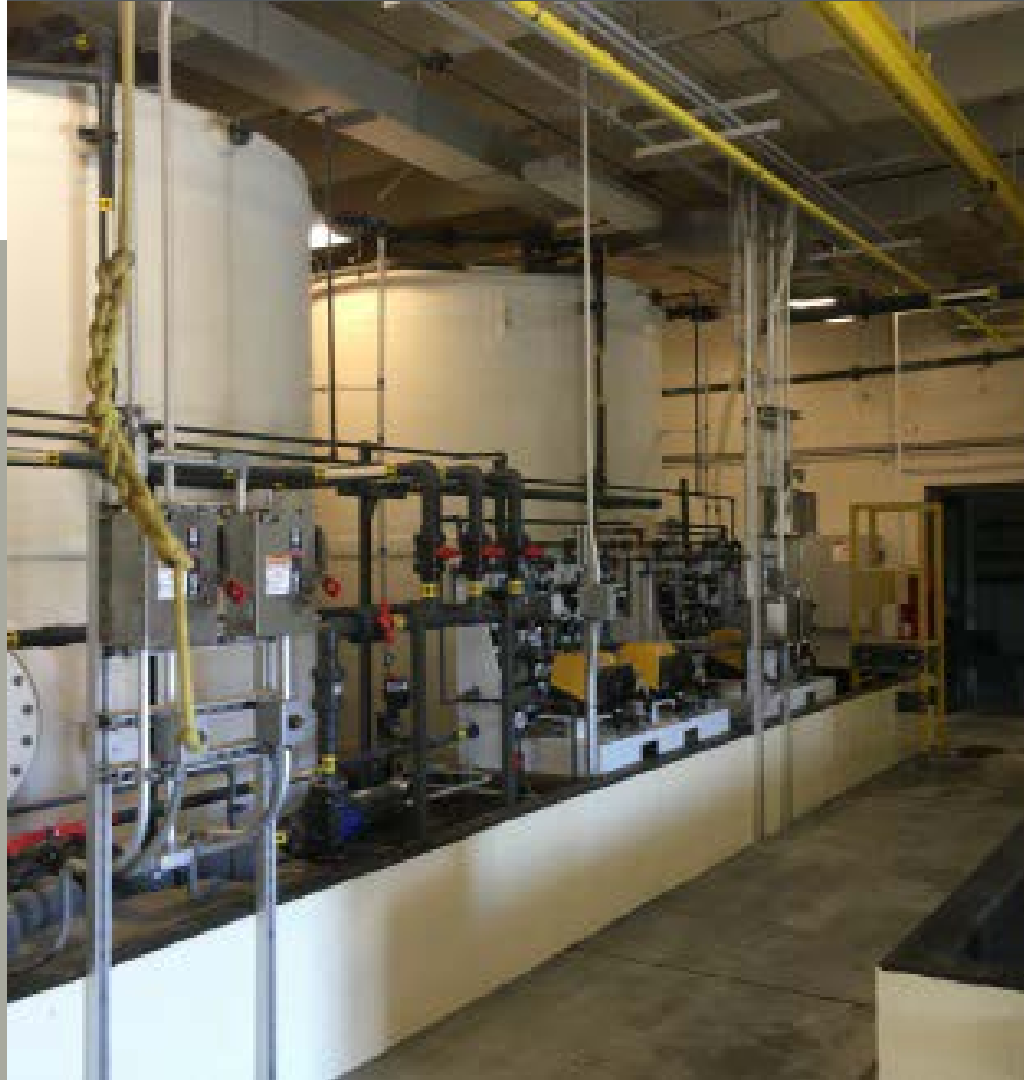
CHEMICAL FEED BUILDING (22)

- Concrete sidewalk is settling away from Bldg.
- Exterior stairs are deteriorating on north side of building.
- Corrosion on pad mounted transformer.
- Issues overriding PLC on Chem Feed Pumps.
- Some outdated electrical conduit and wiring.

- High Priority
 - Update electrical conduit and wiring.
 - *Update electrical transformer.*
 - *Review PLC Override Issue on Chemical Feed Pumps with Manufacturer to correct problem.*
- Medium Priority
 - Replace sidewalks.
 - Rehabilitate exterior stairs.

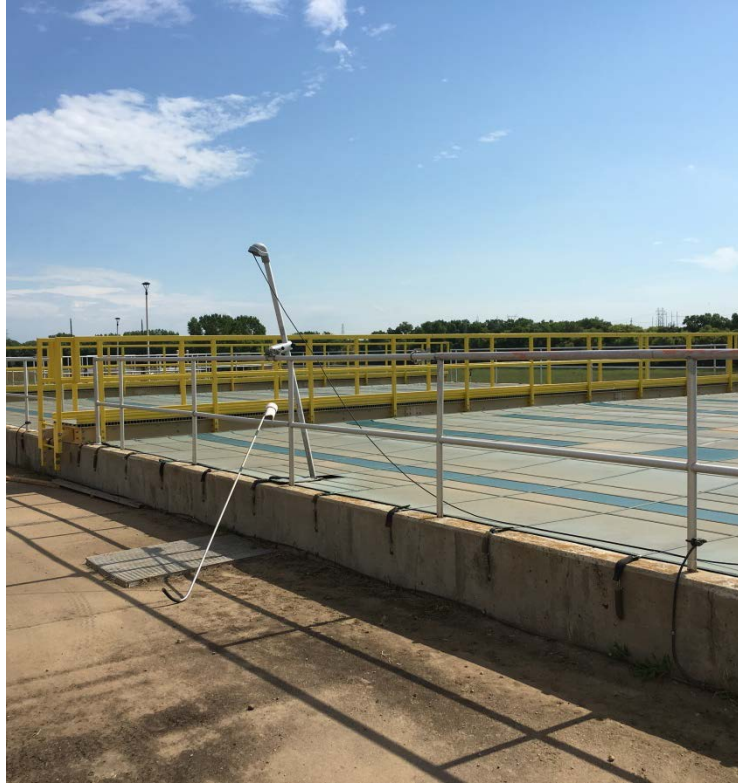
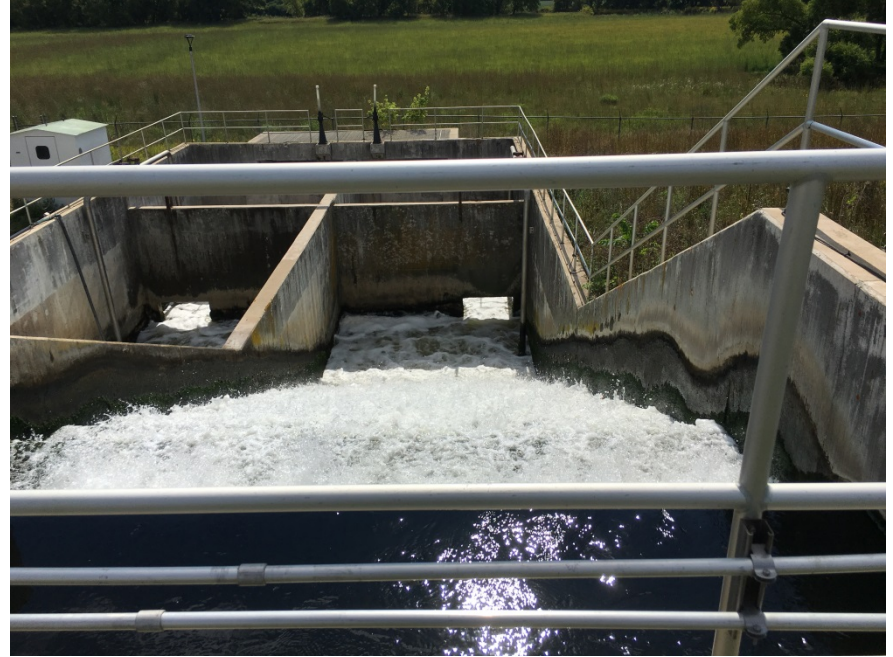
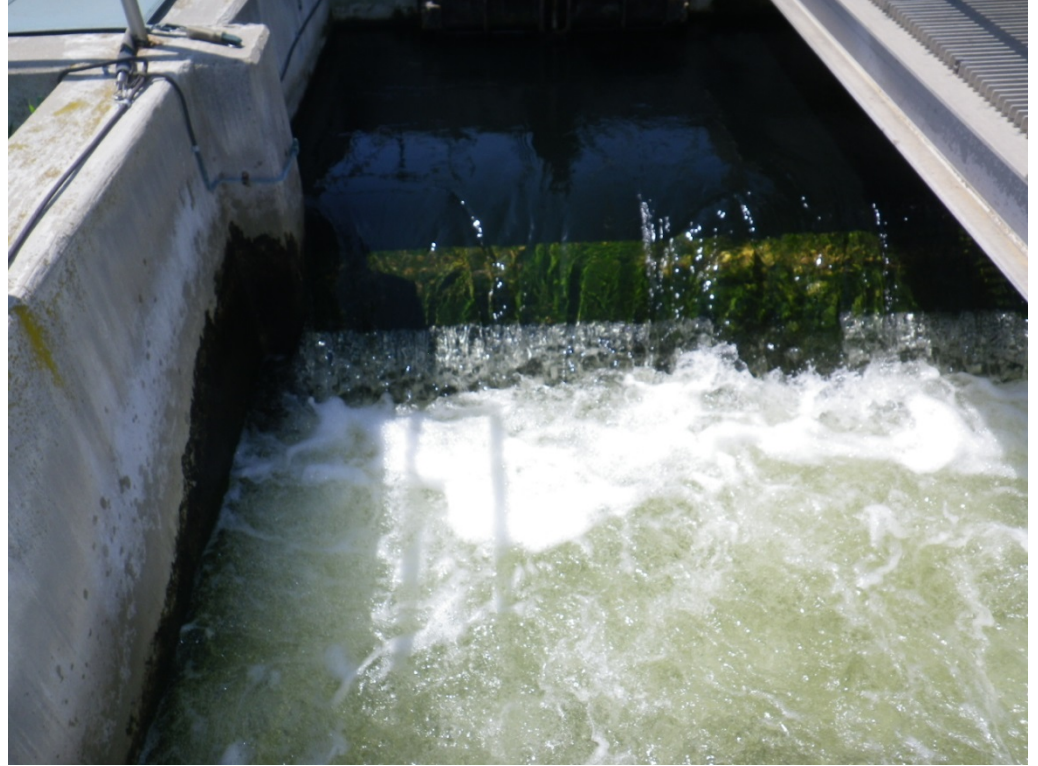
CHLORINE CONTACT BASIN AND CASCADE AERATOR (23)

- Effluent meter – unreliable due to installation/location.
- Additional capacity required for future.
- Foaming at MH#3 Structure.

- Medium Priority
 - Expand contact basin for future capacity.
 - Change effluent meter to partial flow mag.
 - Determine if MH#3 structure can be eliminated.

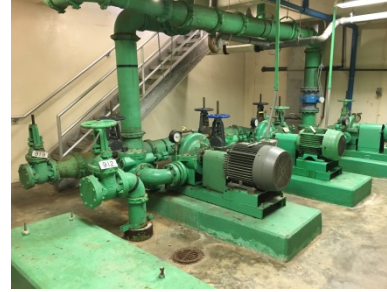
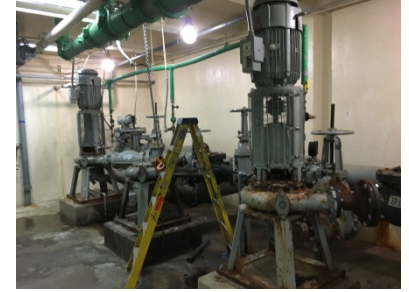
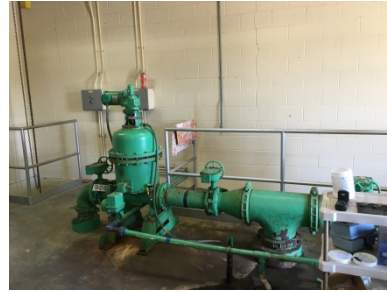
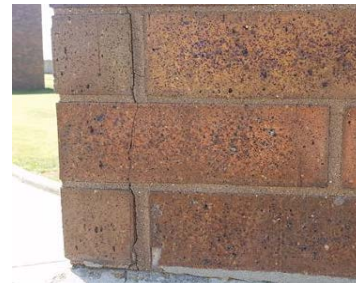
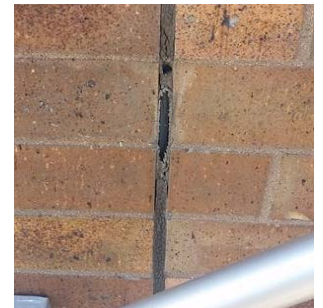
- NPW and In-Plant Waste Pumps are original.
- Corrosion visible on In-Plant Waste Pumps.
- NPW pumps run continuously.
- NPW strainers are original.
- Water intrusion through link seals.
- Drywell leaking through gap between floor and wall.
- Exterior sealant severely deteriorated.
- Moderate cracking on exterior face (SW corner).
- HVAC is original and unreliable.
- Plumbing is original.
- Roof is original and is unreliable.

- High Priority
 - Replace/upgrade HVAC system
 - Replace roof system.
 - Update electrical.
- Medium Priority
 - Replace NPW and In-Plant Waste Pumps.
 - Install constant pressure NPW system with VFDs.
 - Add VFDs to In-Plant Waste Pumps.
 - Replace/update NPW strainers.
 - Replace pipe link seals.
 - Repair brick, replace exterior sealant, and tuck point masonry.

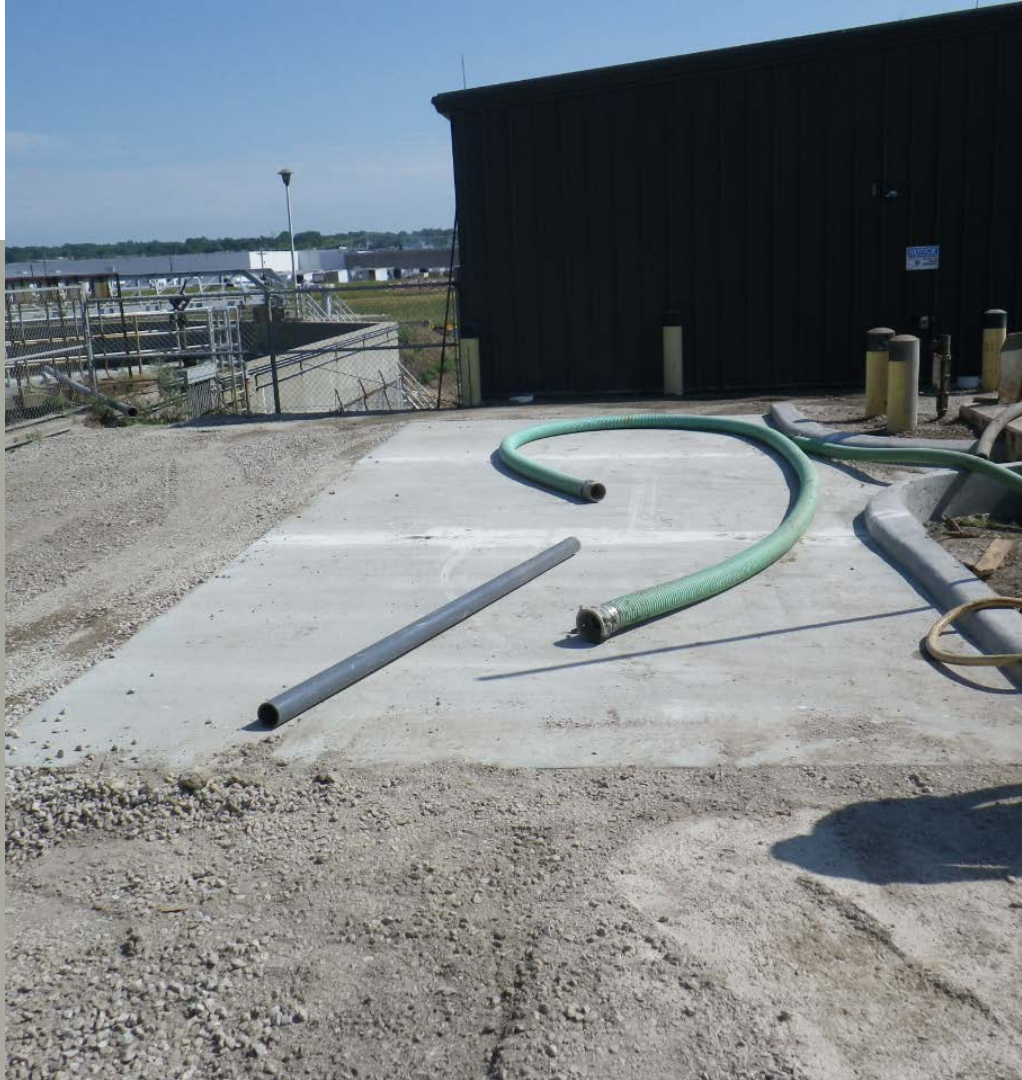
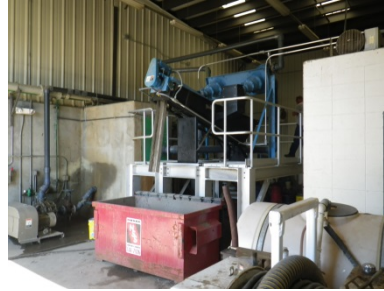
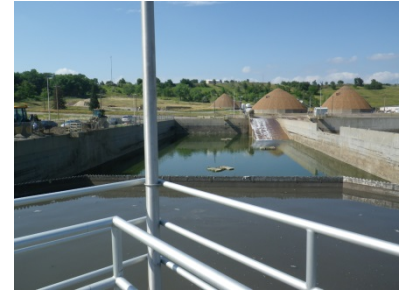
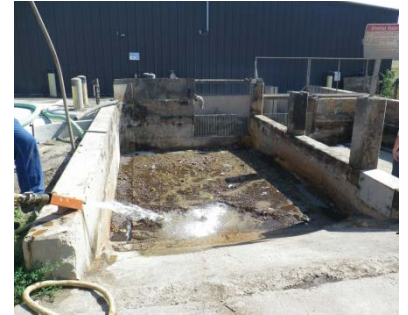
EQUALIZATION BASIN (32)

- Labor intensive.
- Electrical is outdated.
- Turn radius is insufficient.
- Non-septage loads need separate location i.e. drying beds.
- Drainage issues on northwest dump site.
- Corrosion on center well of clarifier.
- Corrosion on bypass pipe and valve.
- Concern over freezing in dump station with water continuously running.
- Bottom channel of MCC is corroding.
- Conduit supports on basin are corroding.

- High Priority
 - Extend building over dumping pit for freeze protection.
 - Replace bottom channel of MCC
 - Update light fixtures
 - Replace conduit supports in basins.
 - Automate Screening, Wash Water, Grit Removal, Grit Conveying.
 - Provide manifests
 - Sampling
 - Scale House for billing loads
 - Take out fence on NW side to expand access for larger trucks.
- Medium Priority
 - Construct non-potable water line.
 - Sandblast and recoat piping valves and other metal surfaces with corrosion.
